# **ANALYSIS OF RAIL CAR COMPONENTS EXPOSED TO A TUNNEL FIRE ENVIRONMENT**

**U.S. Nuclear Regulatory Commission  
Contract NRC-02-02-012**

**Center for Nuclear Waste Regulatory Analyses  
San Antonio, Texas**

**November 2002**

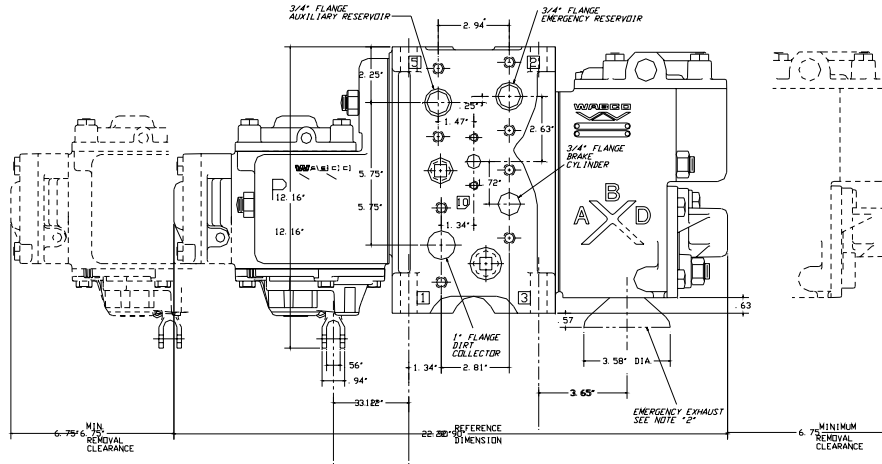
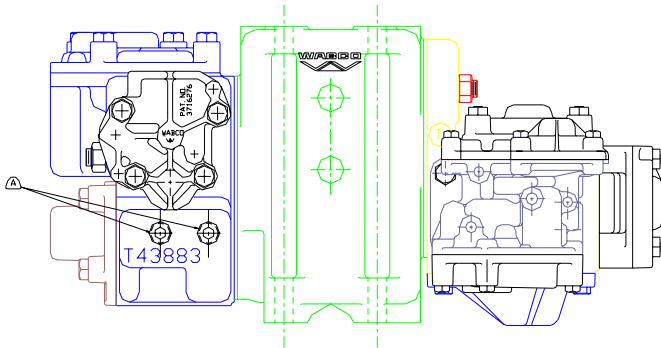
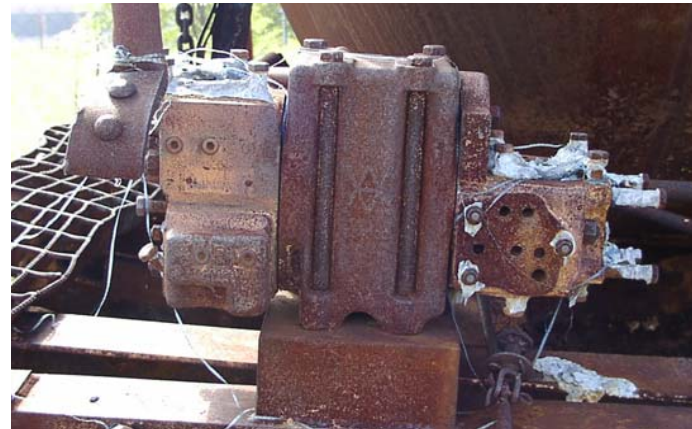
**Remainder of ABDX-L Air Brake Valve from Car 52**—This air brake valve exhibited evidence of prolonged fire exposure. The valve includes several die-cast aluminum covers, which had completely melted as a result of the fire. The valve was found approximately 10 m [33 ft] uphill from the spill site, and approximately 1 m [3.3 ft] from the tunnel floor. A similar valve assembly was found at the midpoint of Car 51, approximately 20 m [66 ft] uphill from the fire source. Although the exact model type was not determined, the valve cover was clearly from the same family of products and was composed of the same aluminum alloy. A third air brake valve was found approximately 30 m [100 ft] from the spill site, and analyzed.

Figure 3-1. The ABDX-L Control Valve (Clockwise from Top: Valve Body Schematic, Photograph of Damaged Valve on Car 52, Corresponding Outline of the Valve Body)

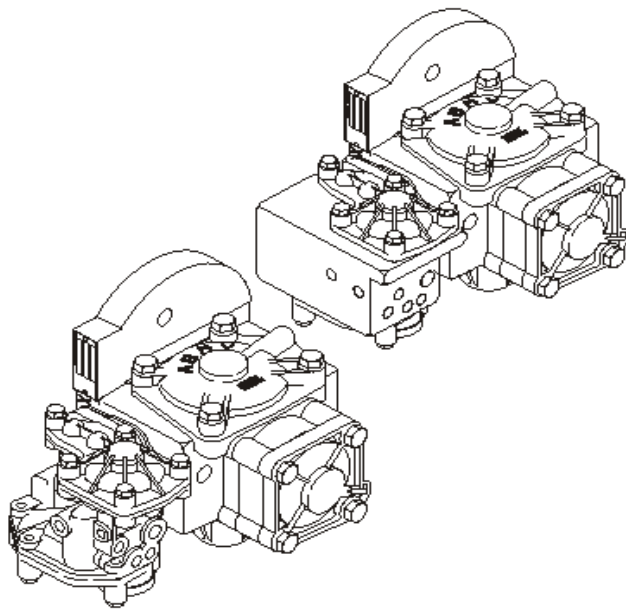
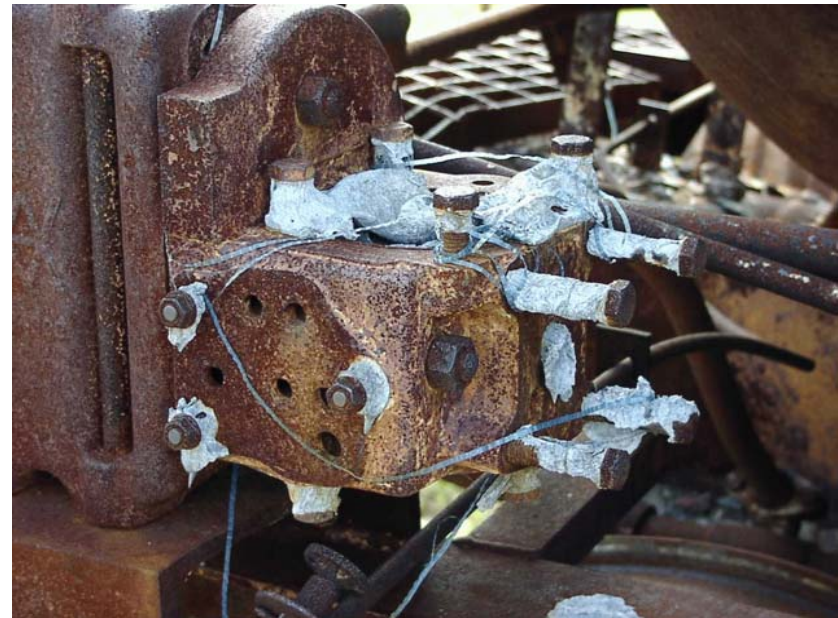
**Figure 3-2. ABDX-L Service Portion Outline and Photograph**

The standard ABDX-L-style valve consists of a normal service valve and an emergency valve. For this analysis, the damage observed on the service portion of the valve was analyzed (see Figure 3-2).

**Complete Melting**—The aluminum section reached its liquidus temperature. This is a good assumption considering the condition of the covers in Figure 3-2.

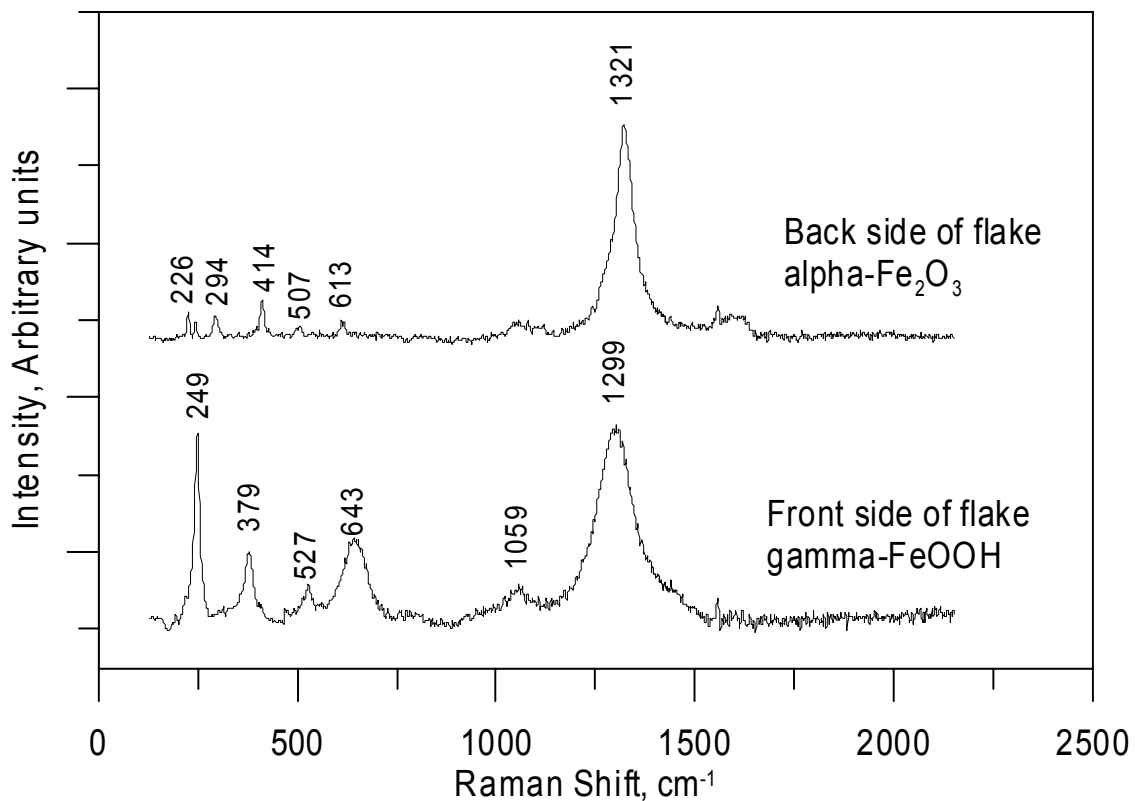
Both Raman spectroscopy (Figure 4-4) and x-ray diffraction (Figures 4-5 and 4-6) of the scale obtained from Car 51 indicate the presence of lepidocrocite ( $\gamma\text{-FeOOH}$ ), hematite ( $\alpha\text{-Fe}_2\text{O}_3$ ) and possibly magnetite ( $\text{Fe}_3\text{O}_4$ ). It should be noted that magnetite can easily be oxidized in air to hematite. The presence of  $\gamma\text{-FeOOH}$ , which covered large sections of the scales, indicates that the specimens were exposed to either a humid environment or water. Formation of  $\gamma\text{-FeOOH}$  may have occurred as a result of water contact after rupture of the water main, fire fighting efforts, or subsequent storage of the train cars involved in the derailment.

Figure 4-4. Raman Spectra for Scales Recovered from Car 51

Analyses of the scale obtained from Car 51 suggest the oxide was initially formed as a result of high-temperature oxidation. Subsequent exposure to water or humid air resulted in the formation of iron hydroxides that are typical of corrosion products for steel structures exposed to a humid or aqueous environment. Calculations of the time and temperature required to form oxide scales of similar in thickness to the specimens obtained from Car 51 or from the roof of Car 50 do not consider changes in thickness that may result from subsequent exposure to humidity or water.

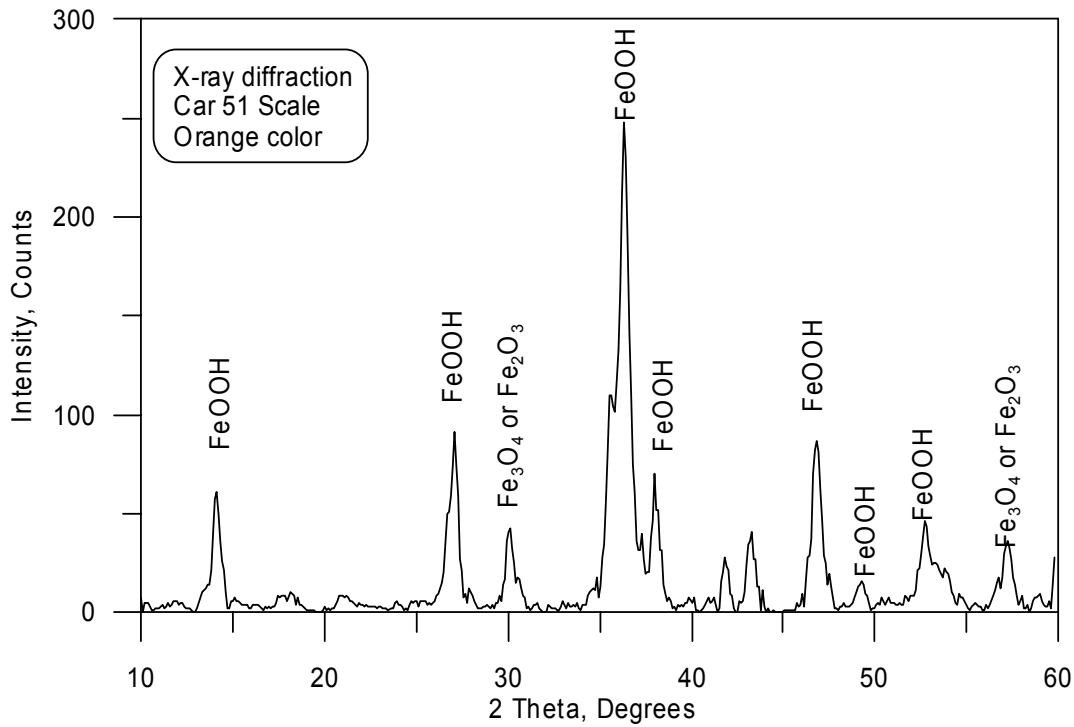
**Figure 4-5. X-Ray Diffraction of Orange Colored Oxide Scales from Car 51**

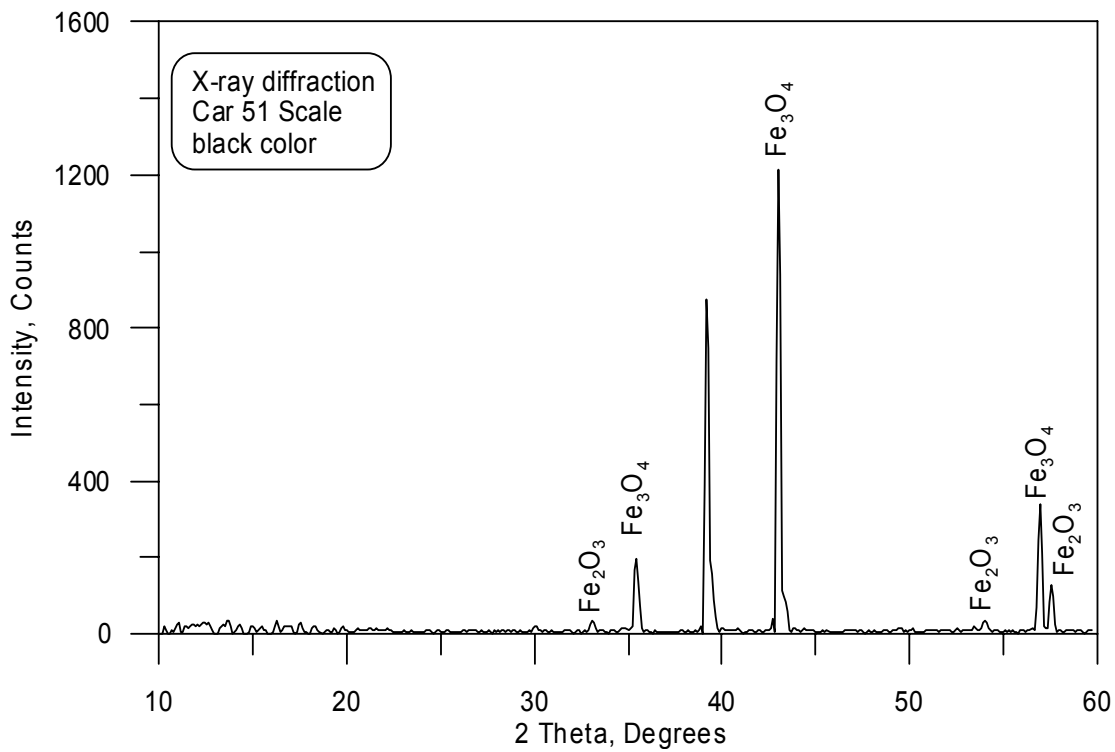
**Figure 4-6. X-Ray Diffraction of Black Colored Oxide Scales from Car 51**

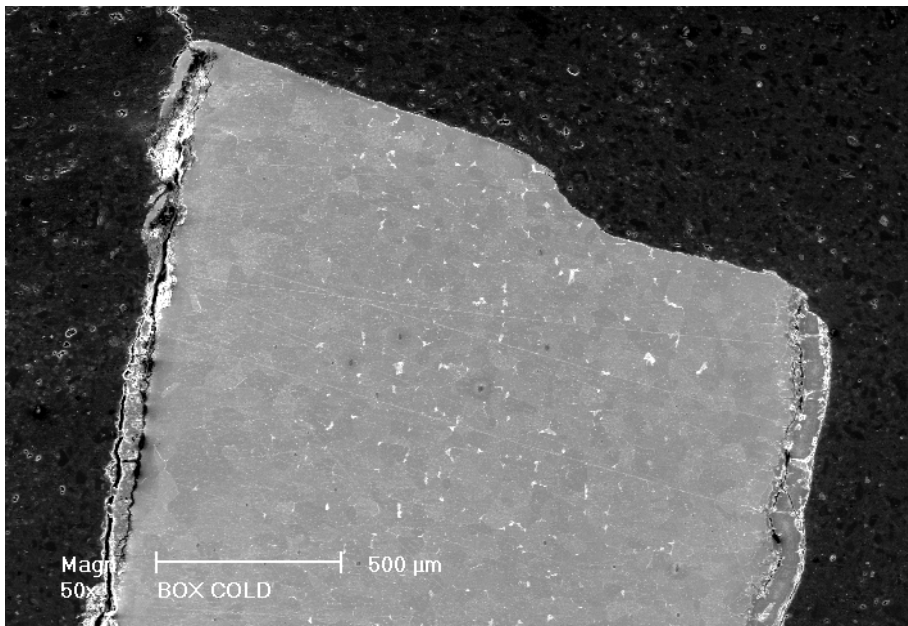
Specimens from the roof section of Car 50 were analyzed for oxide scale thickness as well as the thickness of the remaining steel section. The first specimen was cut from the opposite end of the roof panel section that may not have been directly exposed to the fire (Figure 4-7). The second specimen was cut from the edge of the roof panel section that was directly exposed to flames from the paper inside the box car (Figures 4-8 and 4-9). From the cross section of the roof shown in Figure 4-7, the remaining metal thickness was determined to be 1,761  $\mu\text{m}$  [0.069 in]. Near the edge of the roof, the metal thickness varies from 829  $\mu\text{m}$  [0.033 in] at the edge (Figure 4-9), to 1,464  $\mu\text{m}$  [0.058 in] at a distance approximately 3 cm [1.2 in] from the exposed edge (Figure 4-8). Although it is apparent that the metal thickness of the roof section shown in Figure 4-7 has been reduced by oxidation, the metal thickness of this section was used as a basis to determine metal loss. Assuming that metal loss occurred at equal rates on both sides of the specimen shown in Figures 4-8 and 4-9, the metal loss from each side varied from 148 to 466  $\mu\text{m}$  [0.006 to 0.018 in]. Based on the calculated reduction in metal thickness as a function of time and temperature shown in Figure 4-2, temperatures in the range of 750 to 850  $^{\circ}\text{C}$  [1,382 to 1,562  $^{\circ}\text{F}$ ] for approximately 4 hours would be required to achieve the reduced metal thickness.

**Figure 4-7. Cross section of Car 50 Roof Approximately 40 cm [16 in] from the Opposite End of the Roof Panel Section that May Not Have Been Exposed to the Fire. Thickness of the Metal was Approximately 1,761  $\mu\text{m}$  [0.069 in].**

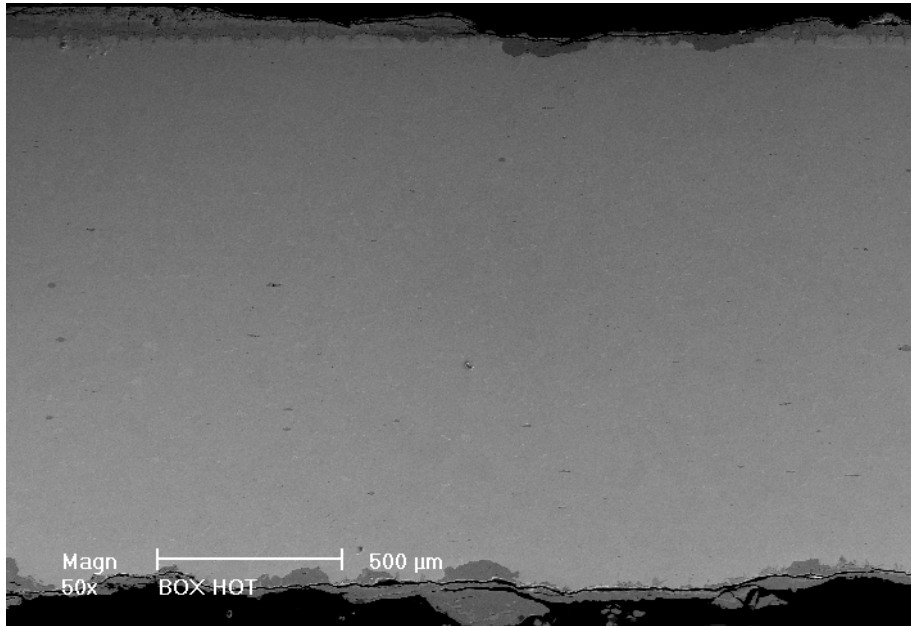
**Figure 4-8. Cross Section of Car 50 Roof Approximately 3 cm [1.2 in] from the Edge Directly Exposed to the Fire. Thickness of the Metal was Approximately 1,464  $\mu\text{m}$  [0.057 in].**

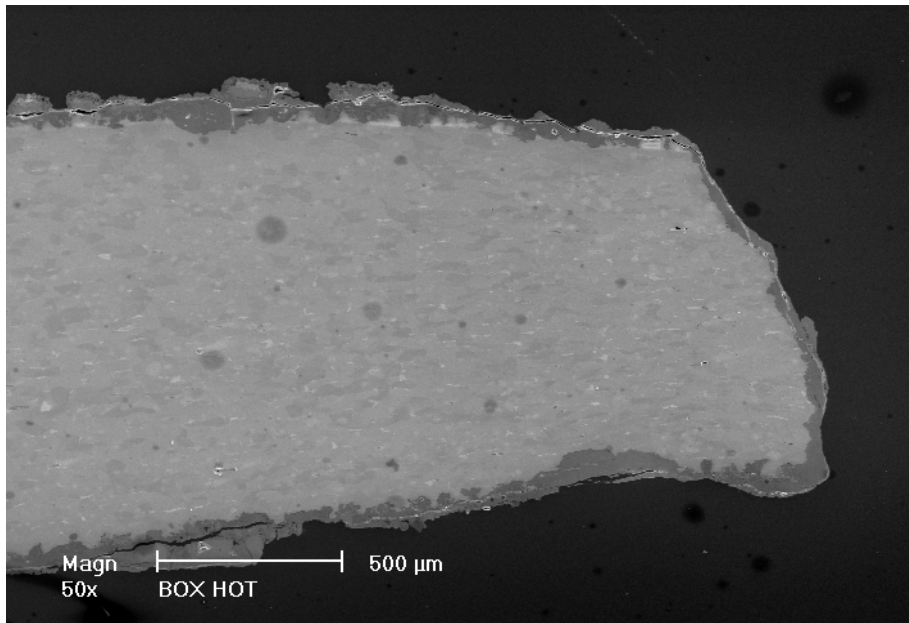
**Figure 4-9. Cross Section of Car 50 Roof at Edge Directly Exposed to the Fire. Thickness of the Metal Ranged from 829 to 930  $\mu\text{m}$  [0.033 to 0.037 in].**

The thickness of the oxide scales recovered from Car 51 and the reduced metal thickness observed in the roof panel of Car 50 correspond to temperatures in the range of 750 to 850 °C [1,382 to 1,562 °F] for a period of approximately 4 hours. The estimation of the temperature does not consider the effects of steel composition and microstructure (Runk and Kim, 1970; Hauffe, 1965) or the partial pressure of oxygen (Kubaschewski and Hopkins, 1962) on the oxidation kinetics. Cross sections of the roof panel from Car 50 clearly indicate significant cracking of the oxide, suggesting the roof panel reached temperatures where spalling of the oxide may be expected. Cracks in the oxide scales tend to increase the oxidation rate of the underlying metal. Assessment of the oxide layer thickness is compromised by scale thickness variation and scale spalling. As a result, assessments of the temperature of the component and fire duration using the thickness of the oxide scales may have significant errors.

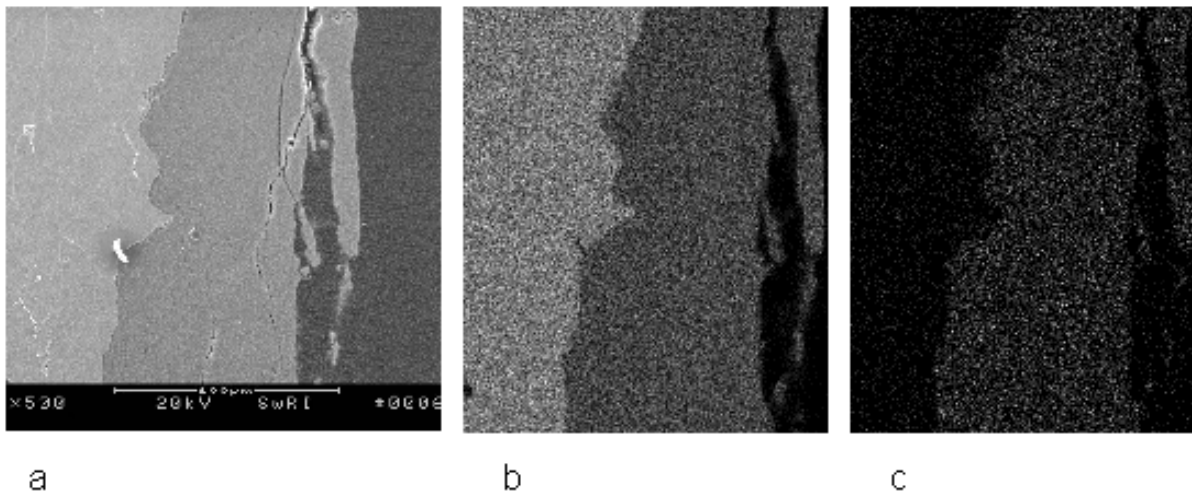
Figure 4-10(a) shows a closeup of the metal oxide scale of the Car 50 roof section near the edge exposed to the fire. Cracks and spalling of the oxide are apparent from the cross section. Figure 4-10(b) shows the scanning electron microscope-energy dispersive spectrometer element map for iron, and Figure 4-10(c) shows the element map for oxygen which confirms the scale is an iron oxide. Based on the analyses of the cross-sectioned specimen, the oxide scale on the roof section exposed to the fire ranged from 50 to 81  $\mu\text{m}$  [0.0019 to 0.0032 in] in thickness. According to the calculations shown in Figure 4-3 scales of this thickness can be produced at temperatures below 700  $^{\circ}\text{C}$  [1,292  $^{\circ}\text{F}$ ] for a period of 4 hours. However, the oxide scale shown in Figure 4-10(a) has clear signs of spalling which may have reduced the scale thickness that remained attached to the damaged roof section.

**Figure 4-10. (a) Secondary Electron Image from Car 50 Roof at Edge Directly Exposed to the Fire, (b) Iron Image Map, (c) Oxygen Image Map**

Spalling of the oxide may also be problematic for the assessment of temperature because of uncertainty in the conditions necessary for spalling to occur and the uncertainty in the oxidation rates after spalling of the oxide scale. On the other hand, the adhesion of iron oxides to iron is a function of temperature and scale thickness (Kubaschewski and Hopkins, 1962) and may provide a marker for the temperature achieved by the steel components. For scales of 200 µm [0.0079 in] thickness, the adhesion increases as temperature increases from 650 to 775 °C [1,202 to 1,427 °F] and then decreases to zero at 950 °C [1,742 °F]. When the adhesion strength decreases, the oxide can be easily removed from the metal, and spalling can occur. Spalling of oxide scales on iron and steel is generally observed at temperatures of 850 °C [1,562 °F] but has been observed as low as 700 °C [1,292 °F] (Kubaschewski and Hopkins, 1962). The scale recovered from the brake end of Car 51 adjacent to Car 52 was completely separated from the underlying steel, suggesting the steel reached temperatures above 700 °C [1,292 °F].

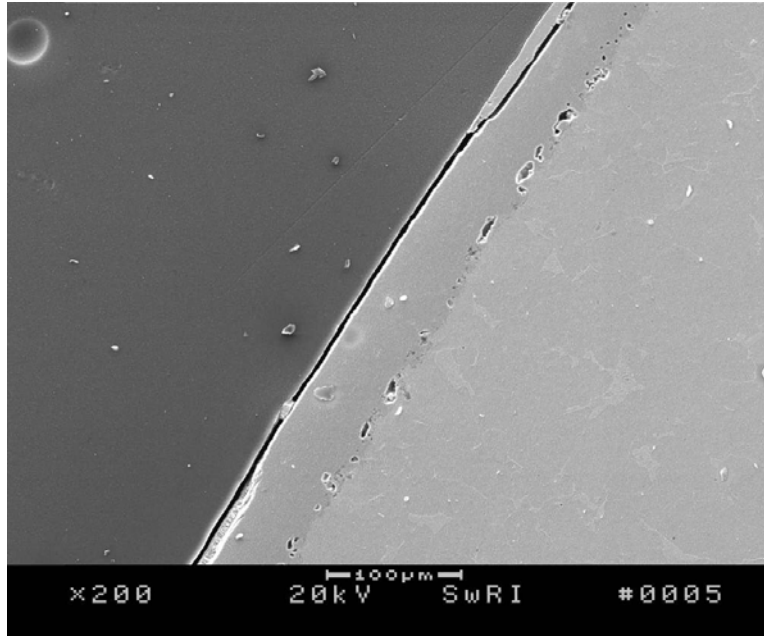
The cross section of the air brake bolt is shown in Figure 4-11. The oxide scale on the bolt shank was determined to be 53  $\mu\text{m}$  [0.0021 in]. Little spalling or cracking of the oxide layer was observed, suggesting the temperature was less than that achieved by the roof panel of Car 50. Based on the predicted metal oxide thickness shown in Figure 4-3, a 53  $\mu\text{m}$  [0.0021 in] oxide scale could be expected in 4 hours at 627  $^{\circ}\text{C}$  [1,160  $^{\circ}\text{F}$ ]. At higher temperatures, spalling of the oxide would be expected.

**Figure 4-11. Scanning Electron Microscope Secondary Electron Image of Car 52 Air Brake Valve Bolt Showing Metal and Oxide Layer**

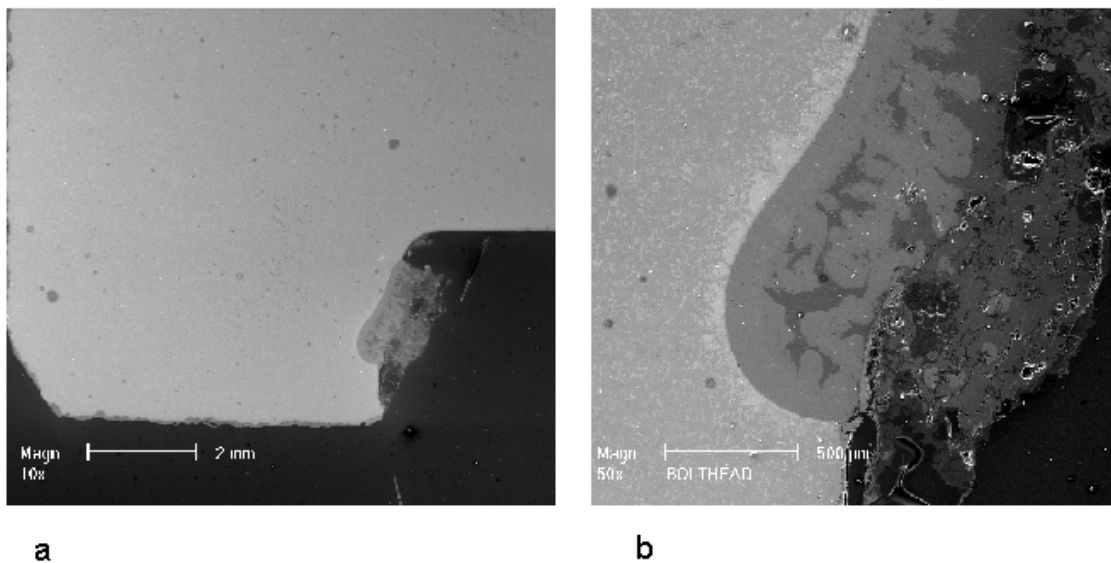
Figure 4-12(a) shows a cross section of one of the air brake assembly bolts. During the analysis of the specimen, several regions were found where an aluminum–iron phase had formed. A higher magnification of such a region is shown in Figure 4-12(b). Using an energy dispersive spectrometer, the composition of the bolt was determined to be 98.4 atomic percent iron with no measurable concentration of aluminum. In the mixed aluminum–iron region, the composition was found to be 66 atomic percent aluminum, 4 atomic percent silicon, and 30 atomic percent iron. The liquidus temperature for a 66 atomic percent Aluminum and 34 atomic percent iron binary is 1,180 °C [2,156 °F] and the solidus temperature is 1,165 °C [2,129 °F] (ASM International, 1992). The aluminum–iron binary phase diagram does not contain low melting point eutectic compositions. The addition of 4 atomic percent silicon is not expected to significantly alter the solidus or liquidus temperatures based on examination of the iron–silicon and aluminum–silicon binary systems.

**Figure 4-12. (a) Scanning Electron Microscope Secondary Electron Image of Car 52 Air Brake Valve Bolt Head Showing Iron and Aluminum and (b) Closeup of Iron with Aluminum**

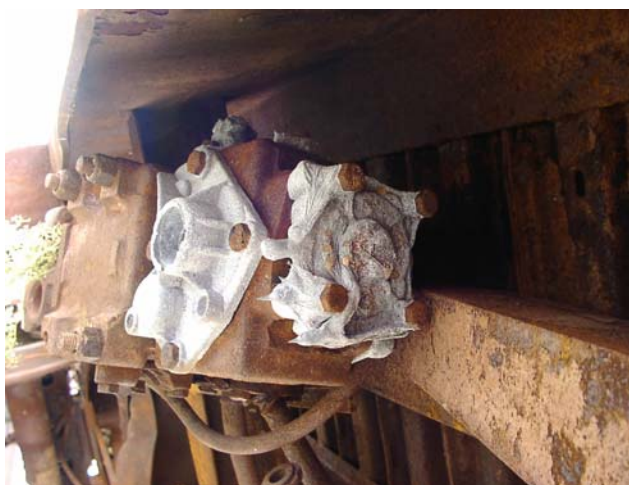
A second aluminum witness was found approximately 20 m [66 ft] uphill of the fire source. This piece is shown in Figure 6-1. It is interesting to note that this piece did not melt completely, which would indicate the very specific conditions required to melt the valve assembly on Car 52 were likely not encountered at approximately 20m [66 ft] away.

**Figure 6-1. Air Brake Valve Found 20+ m [66 ft] from Fuel Spill Site (Note Only Partial Melting at This Location)**

Closer analysis of the damage caused to the valve cover found at Car 52, indicates that a separation distance of approximately 20 m [66 ft] was sufficient to limit the exposure conditions in this area, as evidenced by the level of damage to the valve cover. Considering only partial
