SCOPING TEST ON CONTAINMENT
PURGE AND VENT VALVE SEAL MATERIAL

B.E. MILLER

ENGINEERING ANALYSIS AND HUMAN FACTORS GROUP

Date Completed - May 1984
Date Published - December 1984

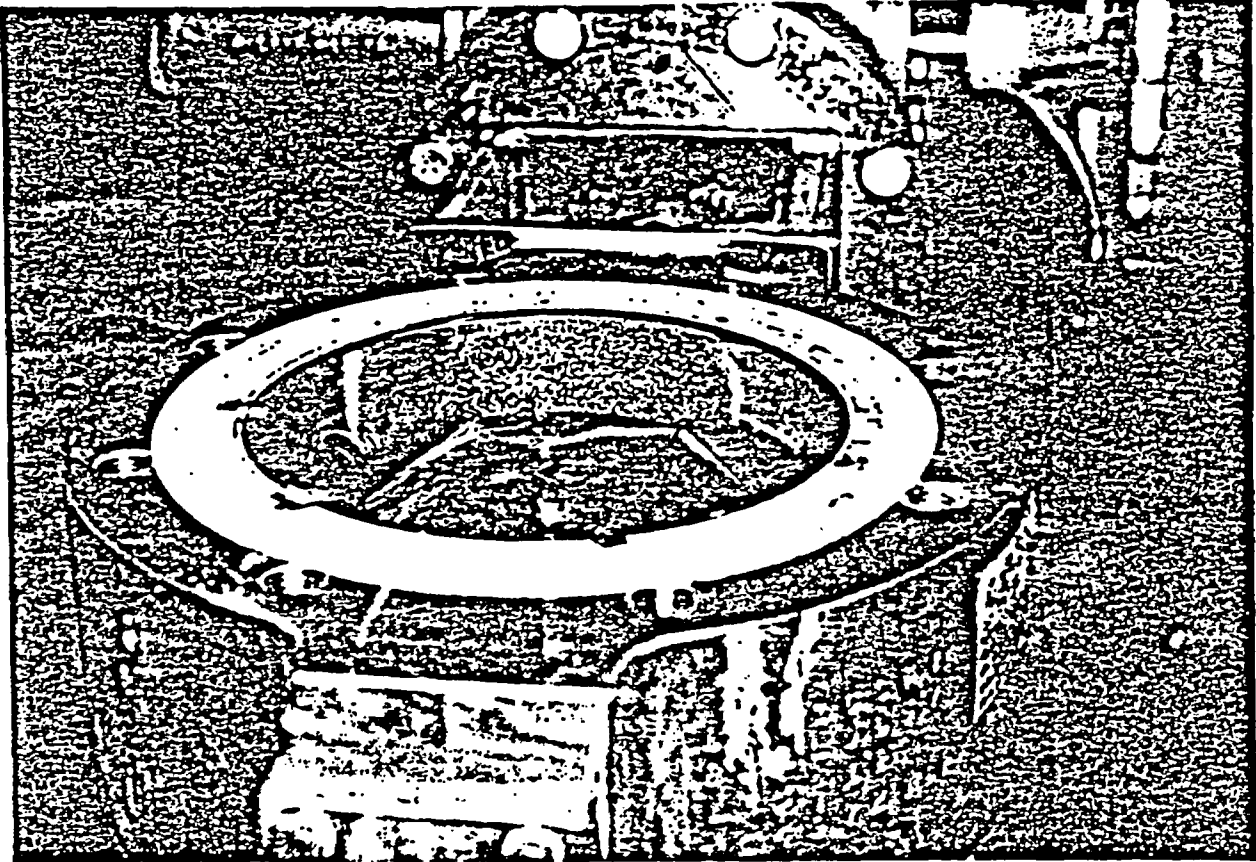
The bubble test performed following the first test run revealed that the minor leak previously mentioned was at the disc/pin connection (Figure 8). The leak was caused by a manufacturing error in squeezing the pin and the disc together, Figures 6 and 7. The resultant leak, very minor in magnitude, had no effect on the seating or seal integrity of the valve. (Note: the manufacturer of the valve states that the valve had not been processed through final quality inspection as would be the case for all valves shipped and is not a significant concern.)

Figure 6. Valve closed - area indicated by arrow shows where pin/shaft leak defaced valve body. Leak was passed pin then down the cavity between the shaft and disc.

Note: There was sufficient time between test sequence 2 and 3 permitting the specimen to be sent to the manufacturing facility and the pin re-squeezed into the disk. The following leak test revealed no pin leakage.

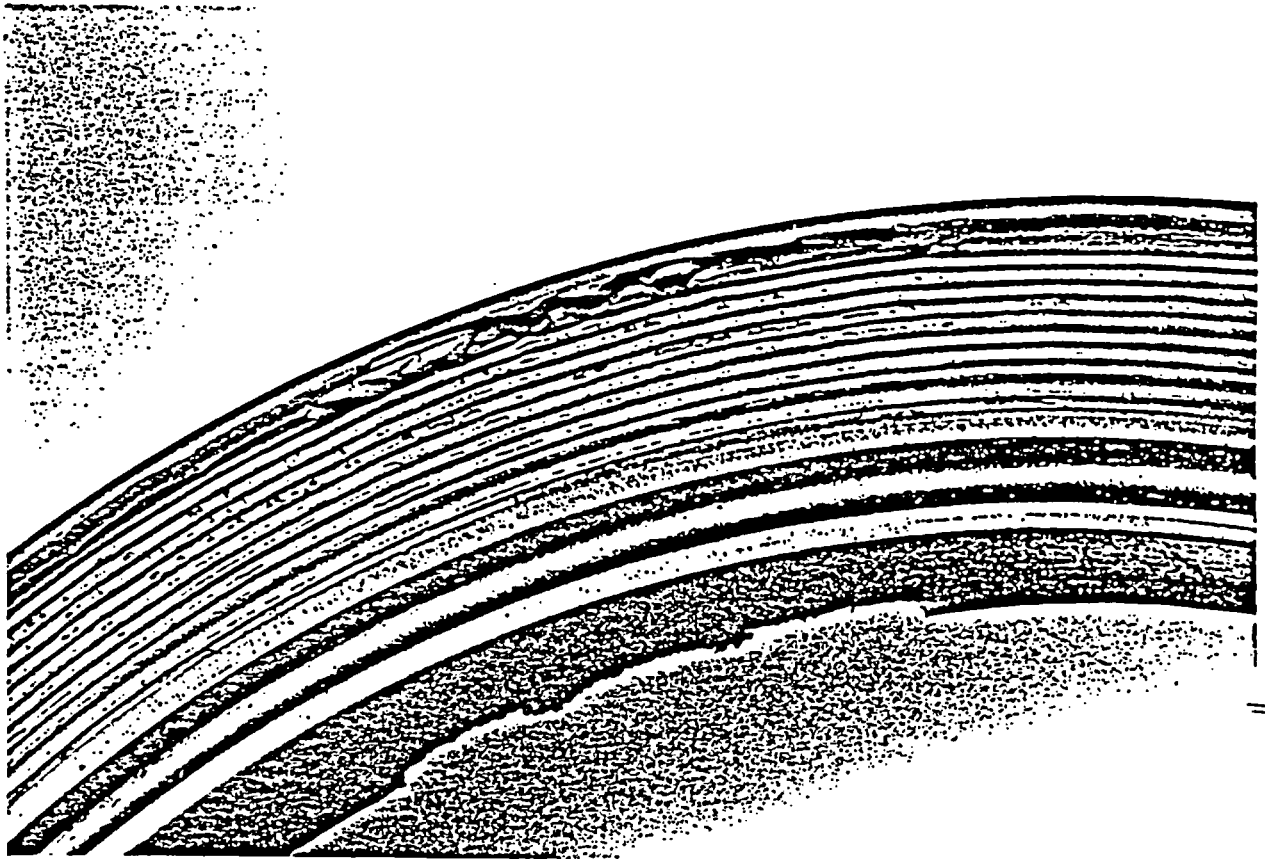
Inspection of the seat upon removal, revealed minor circumferential cracks at the edge of the retaining ring (Figure 11). The seat profile had been remolded to conform to the mating surface.

Inspection, upon removal of the seat, revealed minor circumferential cracks at the edge of the retaining ring. The seat profile had been remolded to conform to the mating surface.

These discrepancies do not effect the seat integrity of the valve for normal containment isolation purposes.

Figure 11. Degradation as a result of test sequence 3.
