NUREG/CR-6043  
PNL-8614  
Vol. 1

# Aging Assessment of Essential HVAC Chillers Used in Nuclear Power Plants

Phase I

**Pacific Northwest Laboratory**

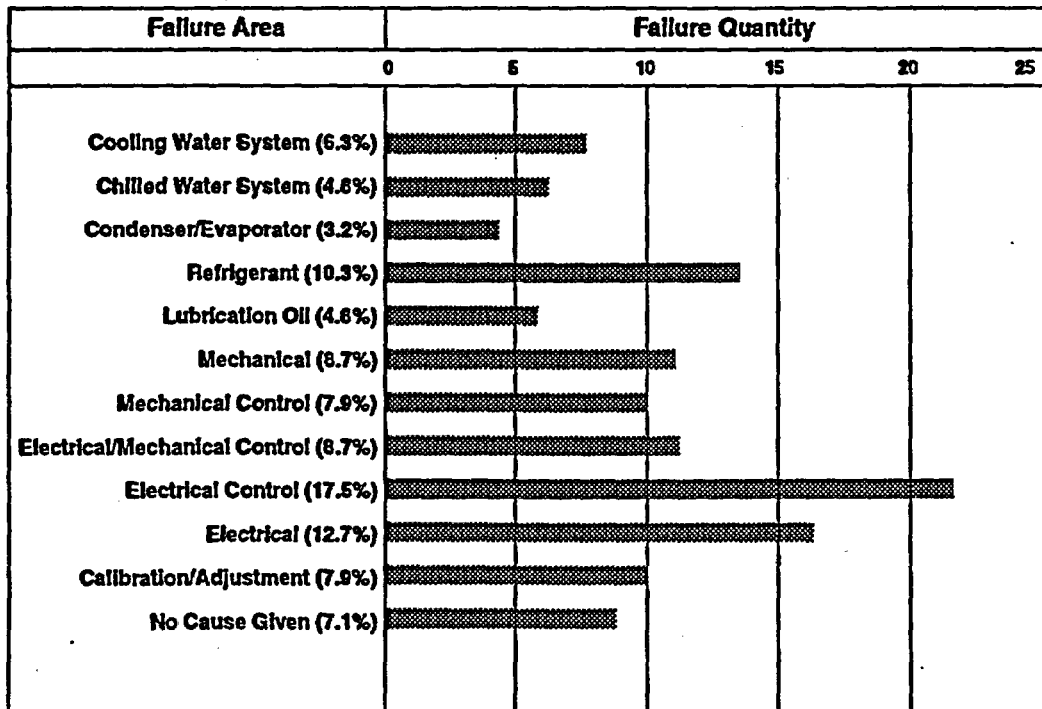
Figure 7.1 Summary of Chiller Failures (LER and NPE Databases)

The information shown in Figure 7.1 summarizes the quantities and failure areas from the LER and NPE

databases. Duplicate failures were removed for this summary. Only failures that caused the chiller to shut down were included. About 11% of the failures were partially caused by flow rate variations in the cooling and chilled water systems and partially by the chiller condition (e.g., chiller fouling, load and capacity limitations, entrance strainers, etc.). Condenser/evaporator failures were only about 3% because most of the age degradation occurs gradually, maintenance access is usually easier, and it is handled during scheduled downtime. The refrigerant/lubrication oil system-related failures accounted for about 15% of the failures. About 17% of the failures were mechanical and mechanical control related. Electrical/mechanical control components caused about 9% of the failures. Electrical and electrical control components made up about 30% of the failures. Misadjustment and miscalibration resulted in approximately 8% of the failures, and the 7% balance
