# Three Selected Accidents

# Samut Prakarn

# Istanbul

# Goiania

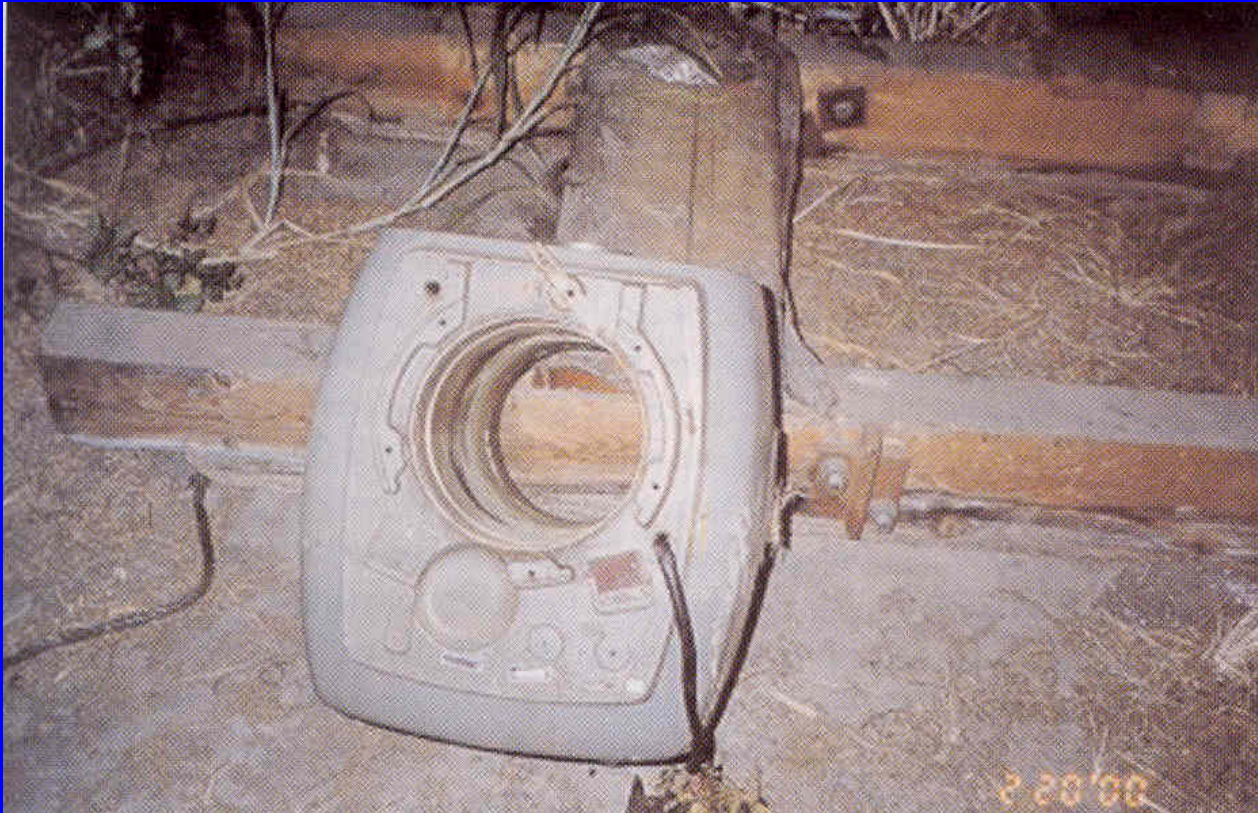
Teletherapy Head with Source Drawer Missing

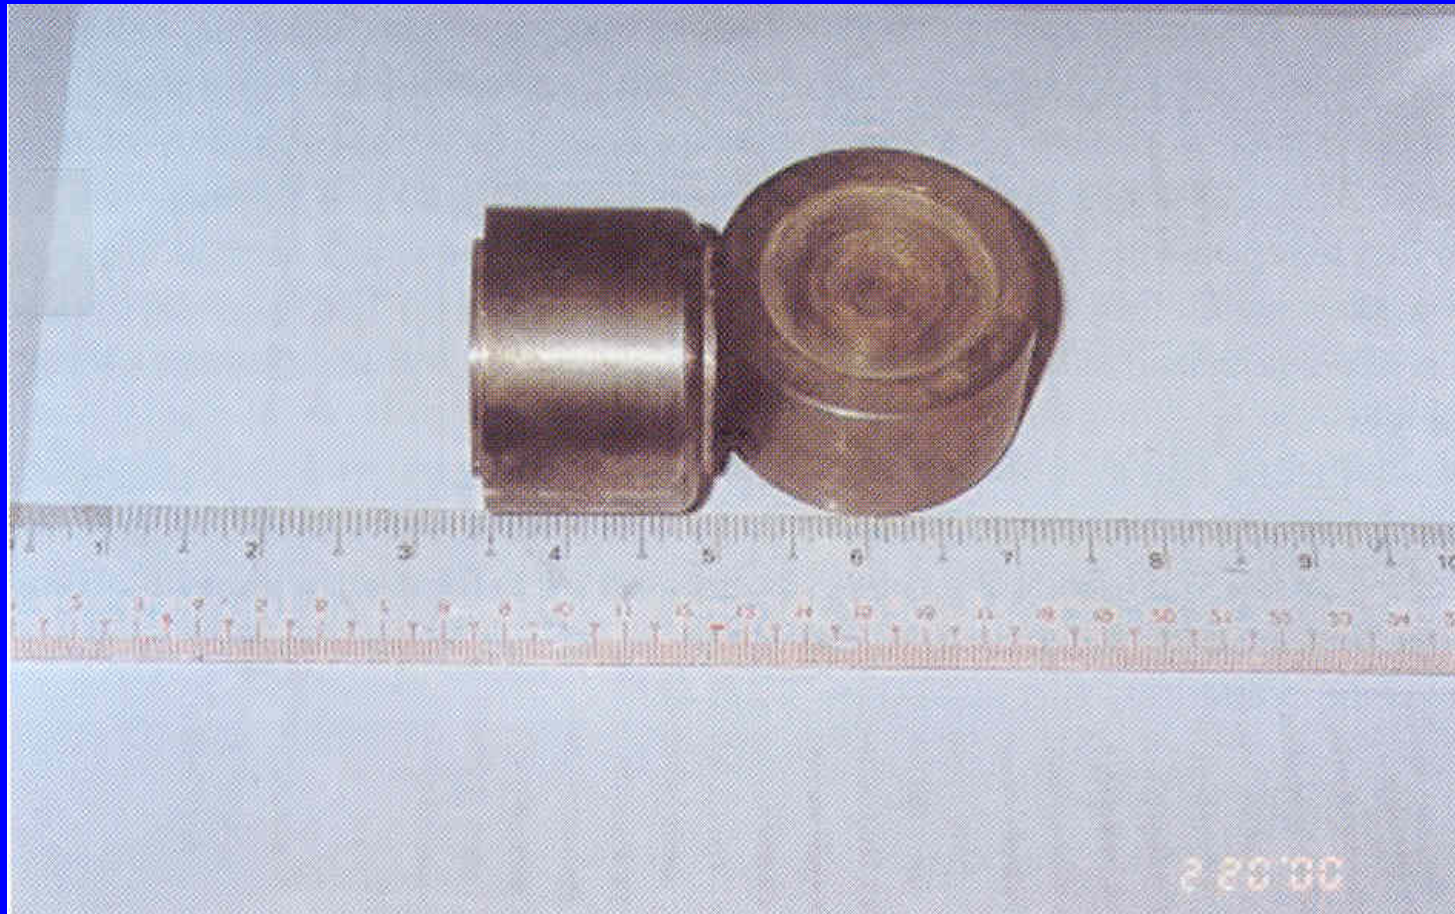
Parts of source assembly

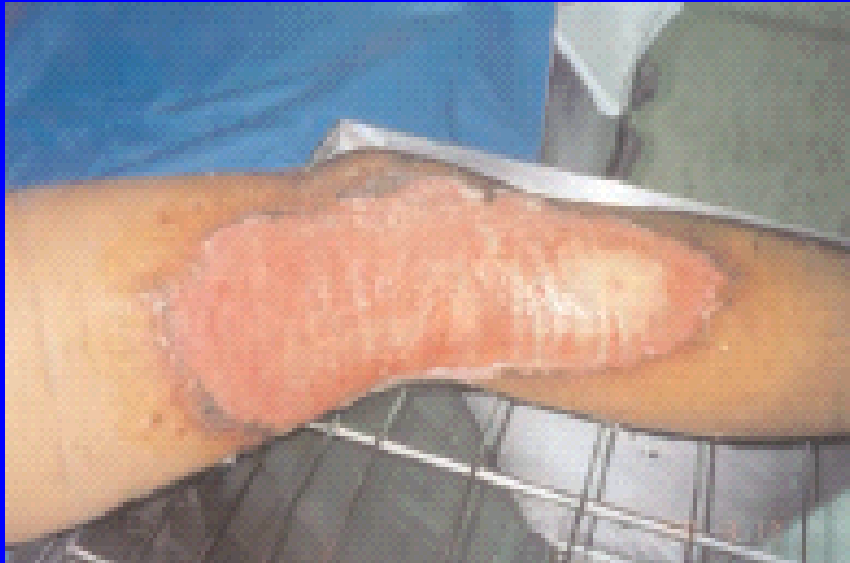
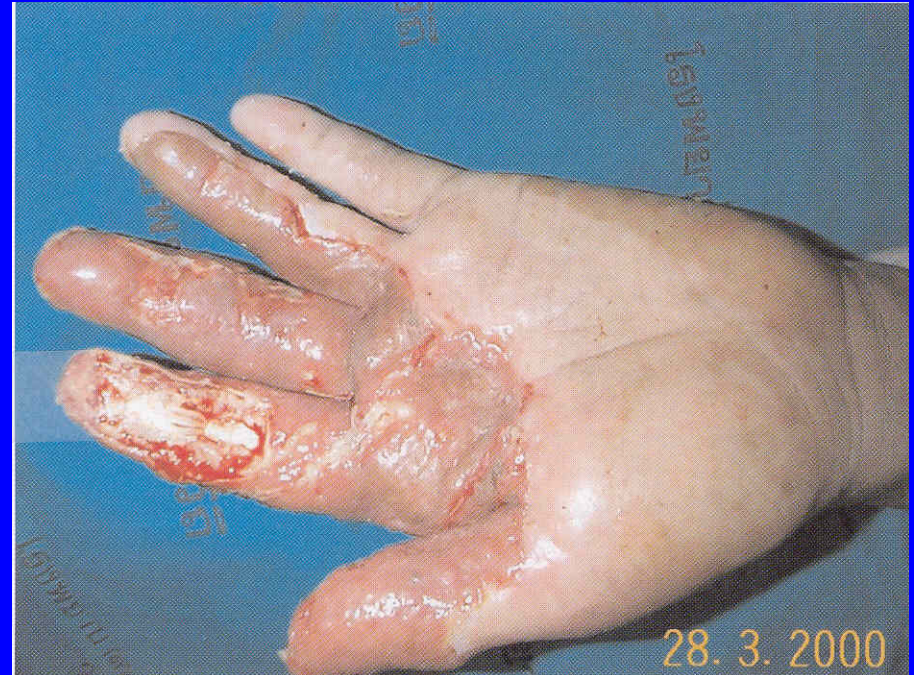
Damage to skin – desquamation  
Note swelling of fingers

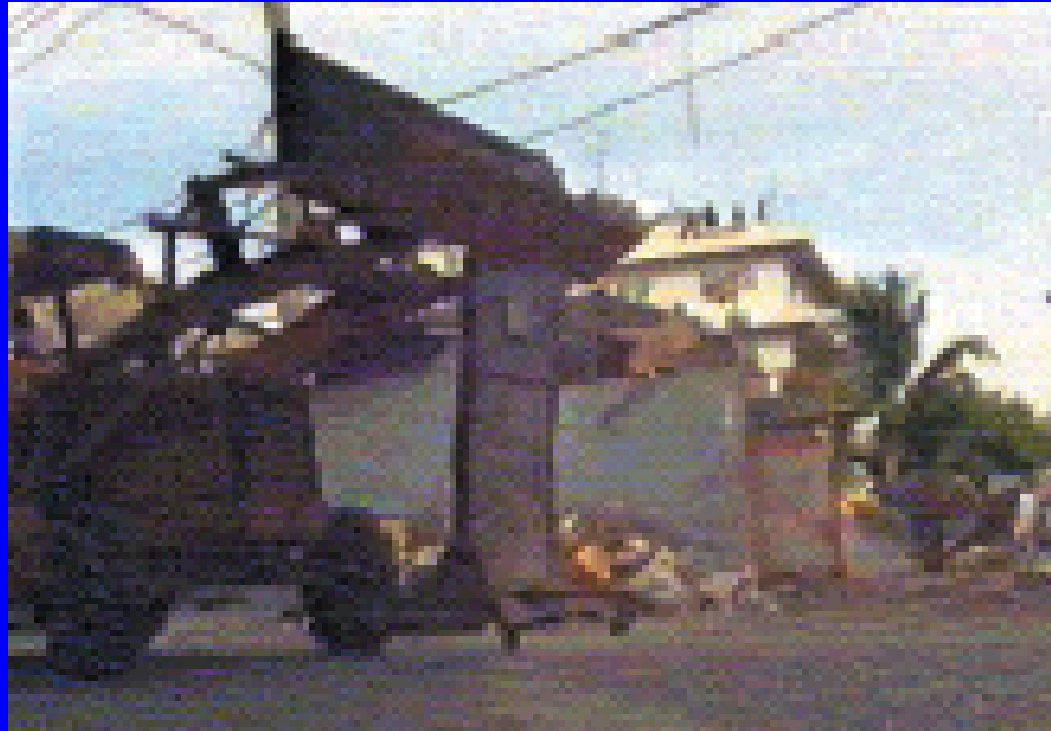
Front loader used to move shield for operations

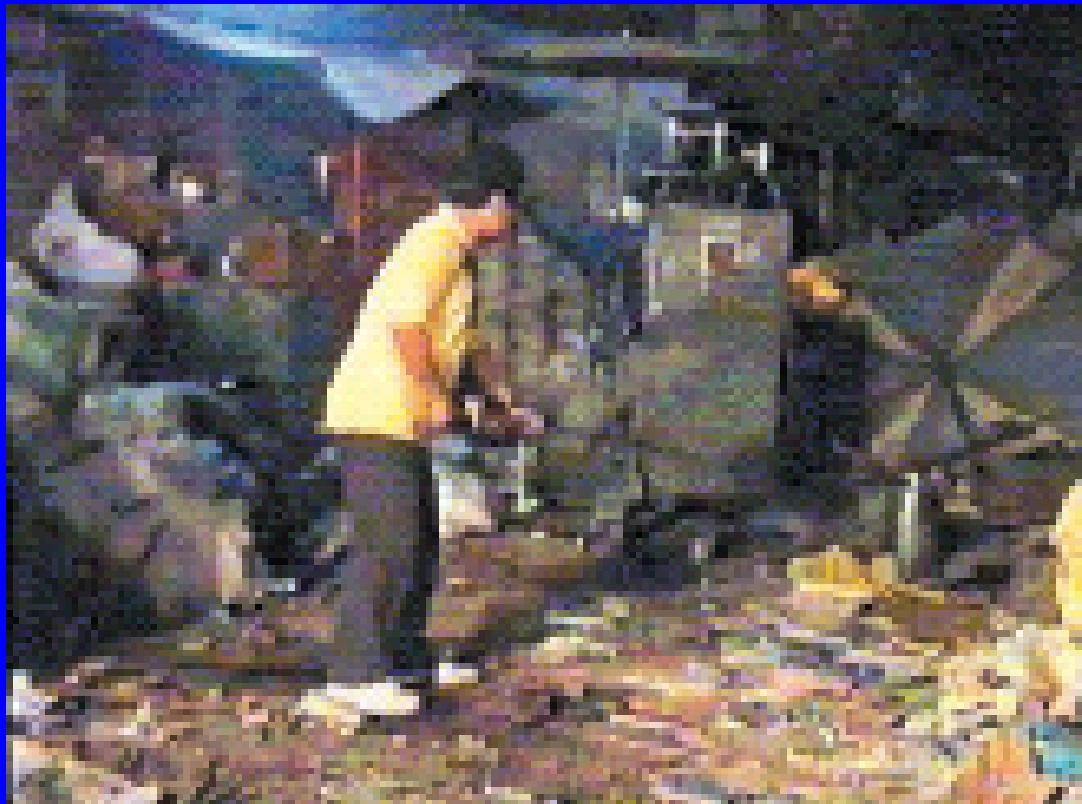
Putting recovered source into shielded container using two meter long tongs

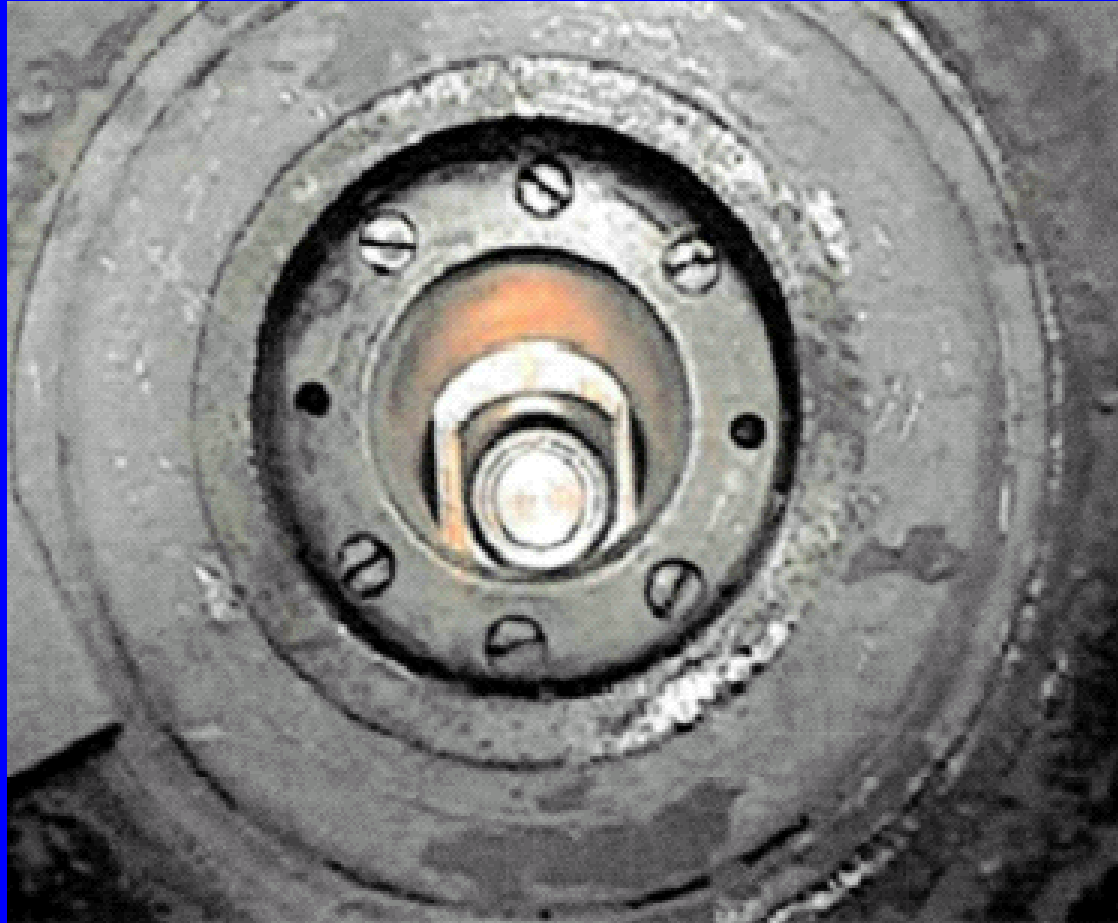
Source Inside Housing

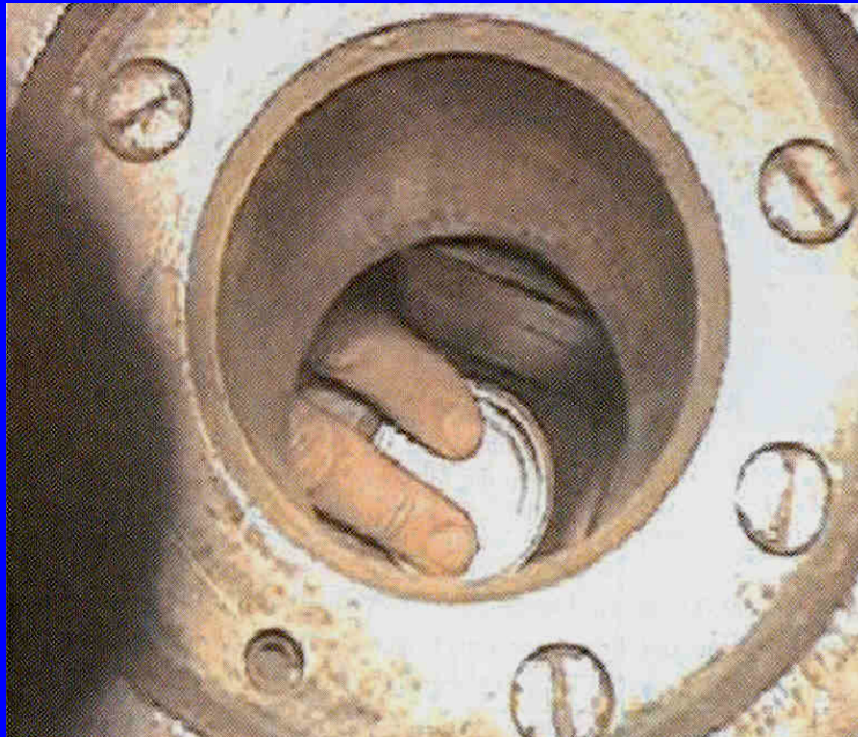
Source Removed from housing

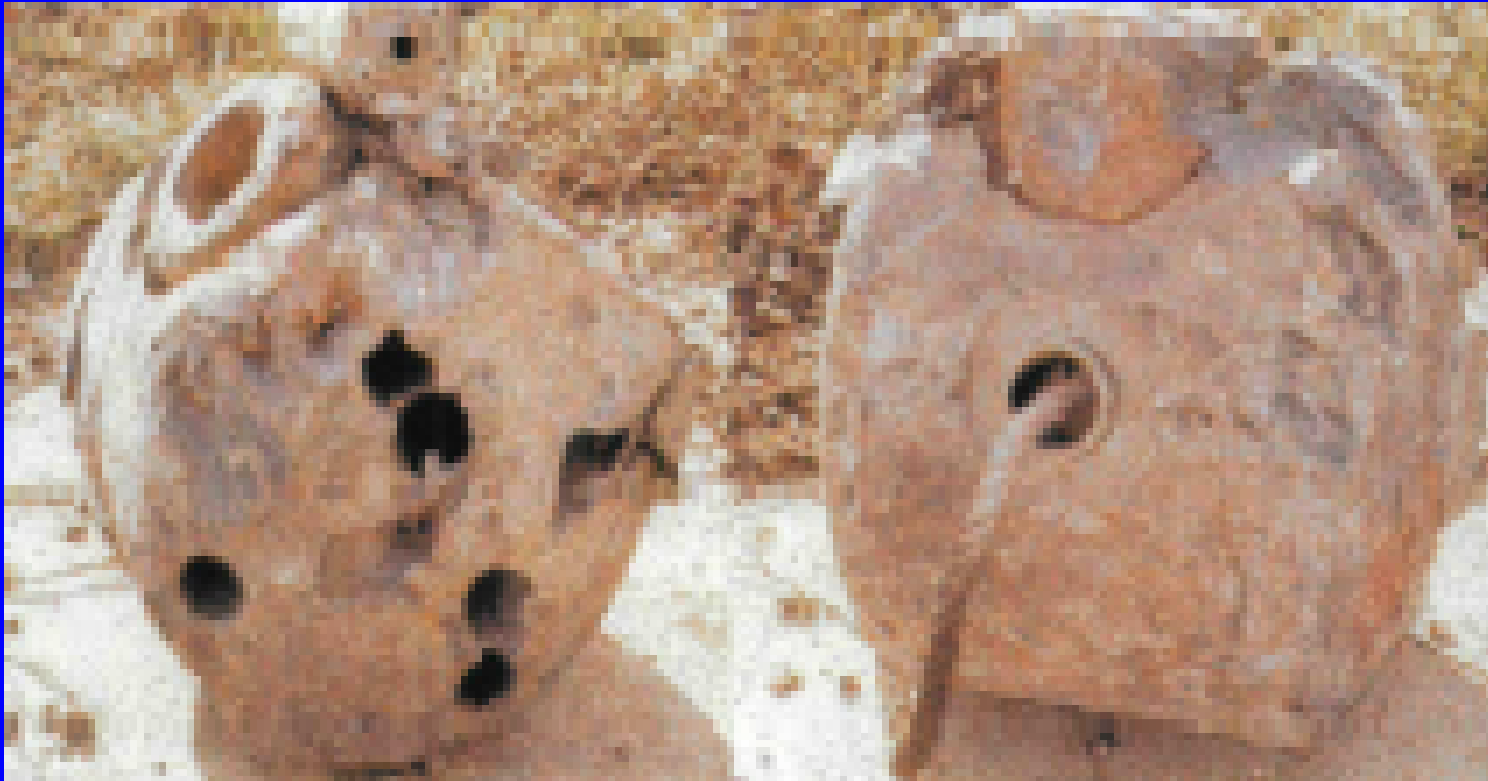
Damaged source exchange containers

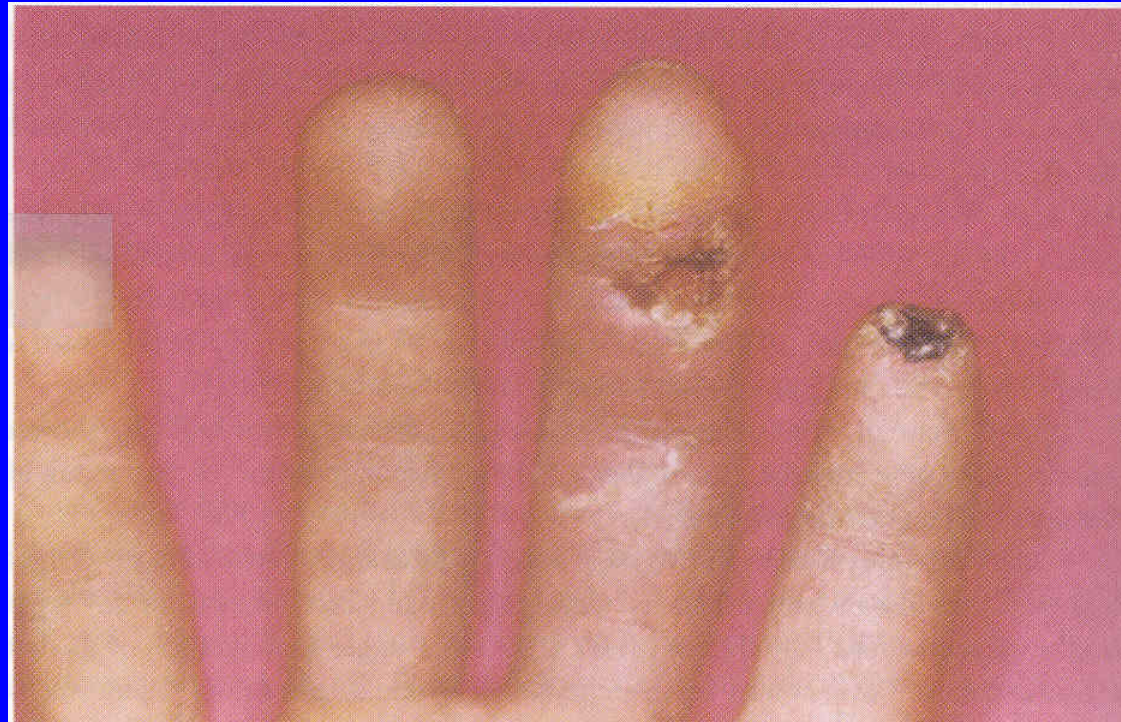
Injury to hand 14 months after accident. Portion of one finger removed.

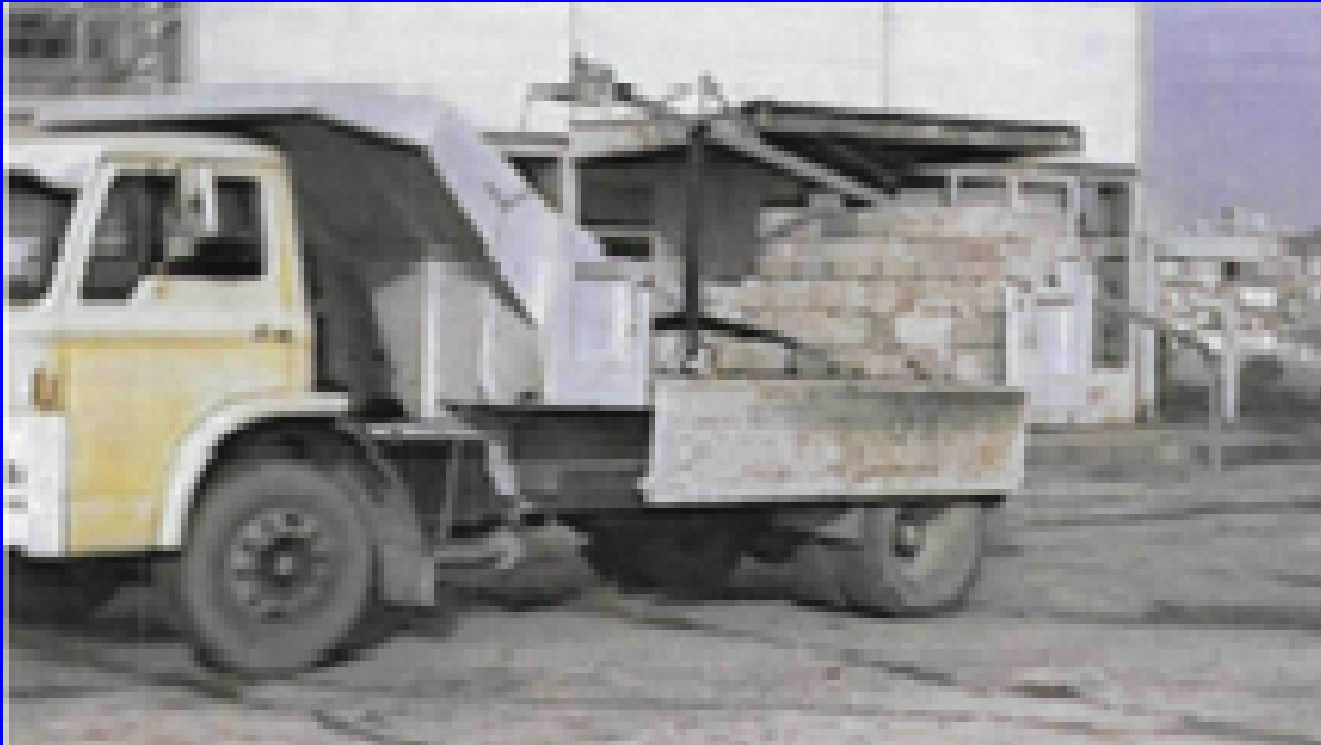
An empty shield was loaded on the back of a truck.

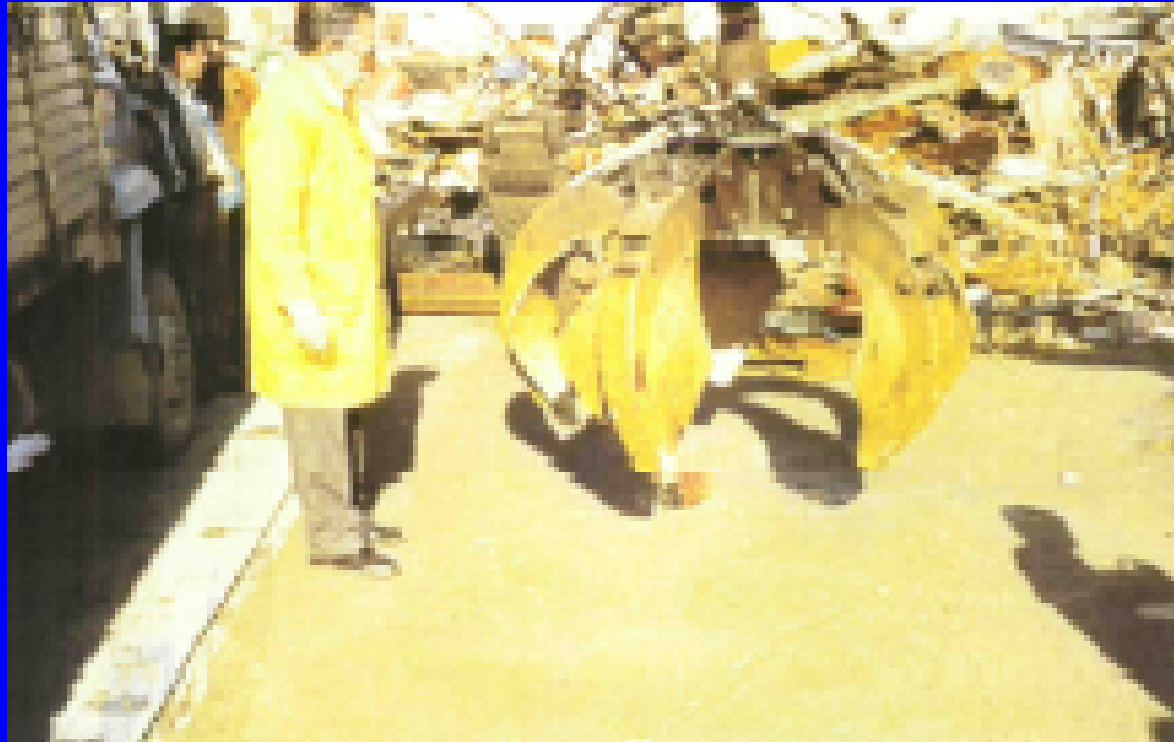
Operators of mechanical grab at scrap yard asked to help. Their dose limit was set at 1 mSv (100 mrem).

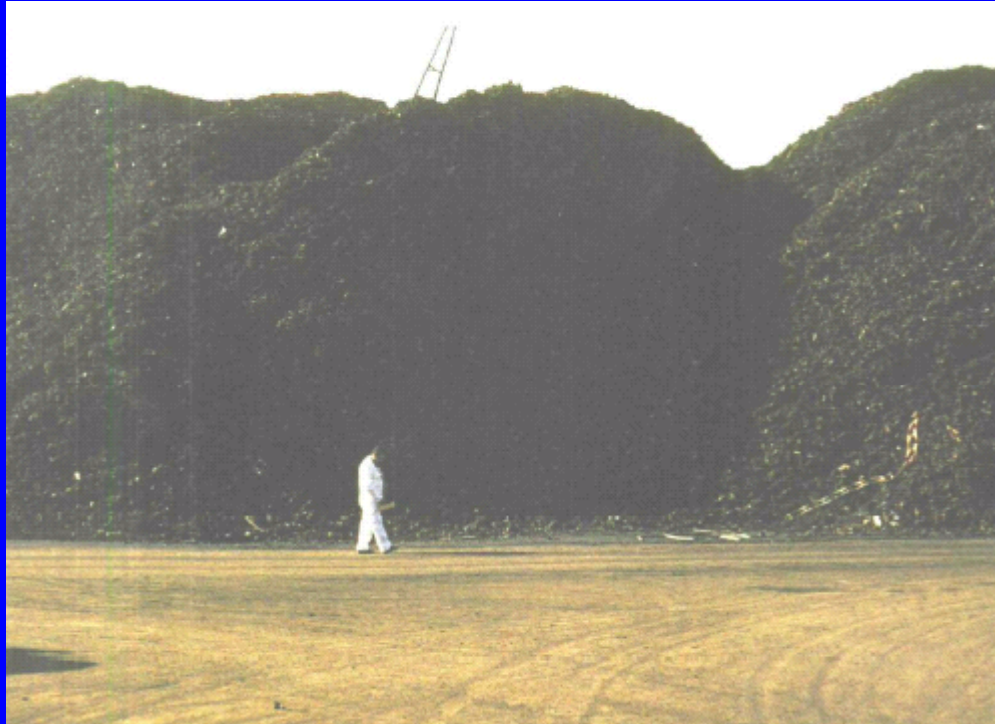
Surveying scrap at another scrap yard for other possible sources.

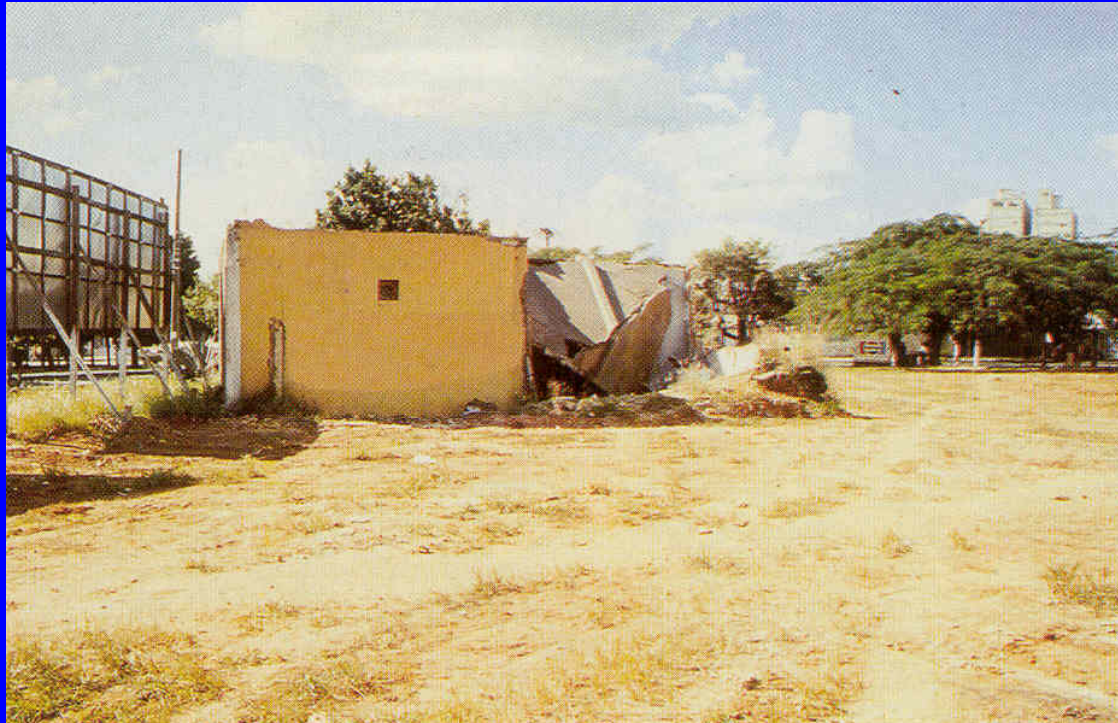
Two people removed the source assembly from a cesium-137 teletherapy unit left behind in an abandoned medical clinic. It contained 51 TBq of Cs-137.

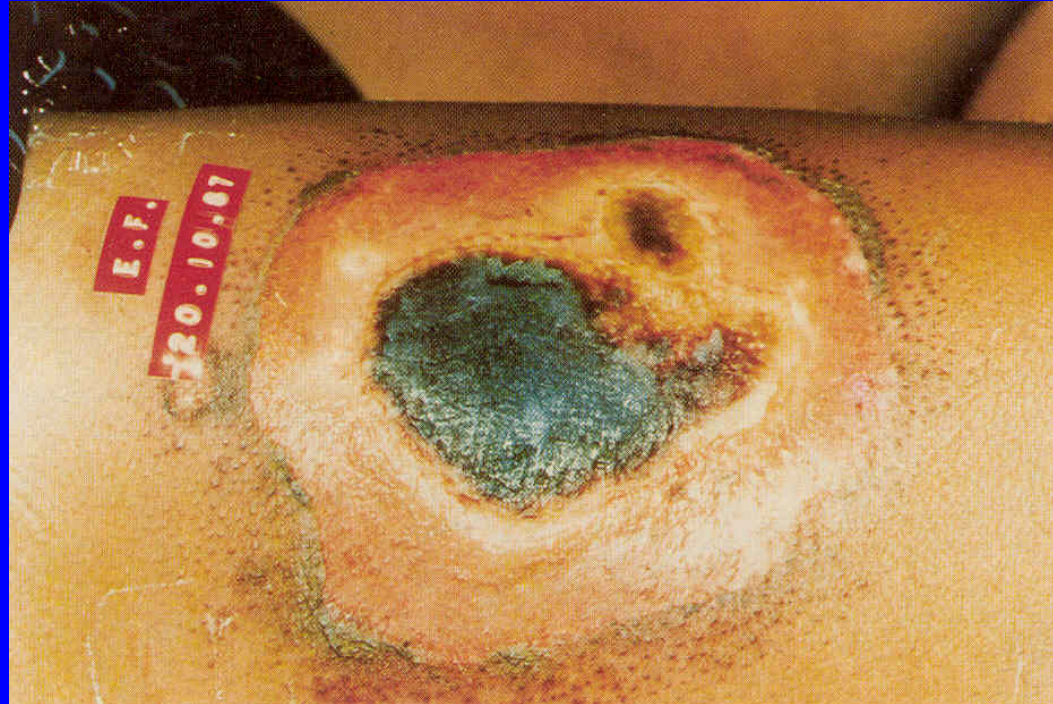
Radiation lesion in thigh one month  
after the accident

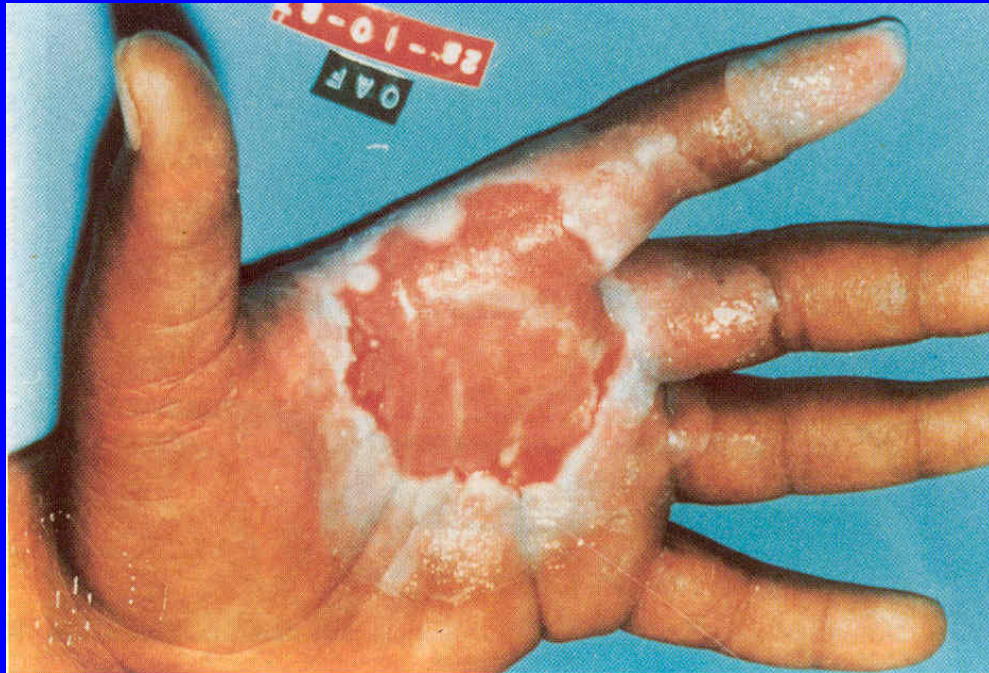
Desquamation

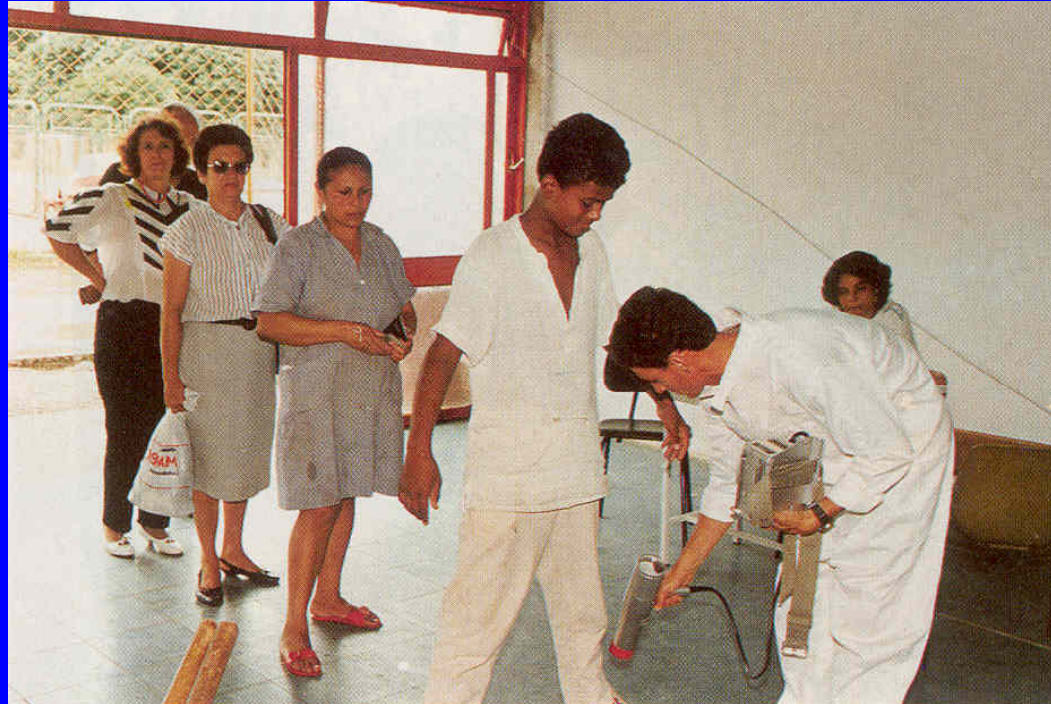
People being surveyed at football stadium. Of those surveyed, 249 had measurable contamination. Of these, 129 had internal contamination.

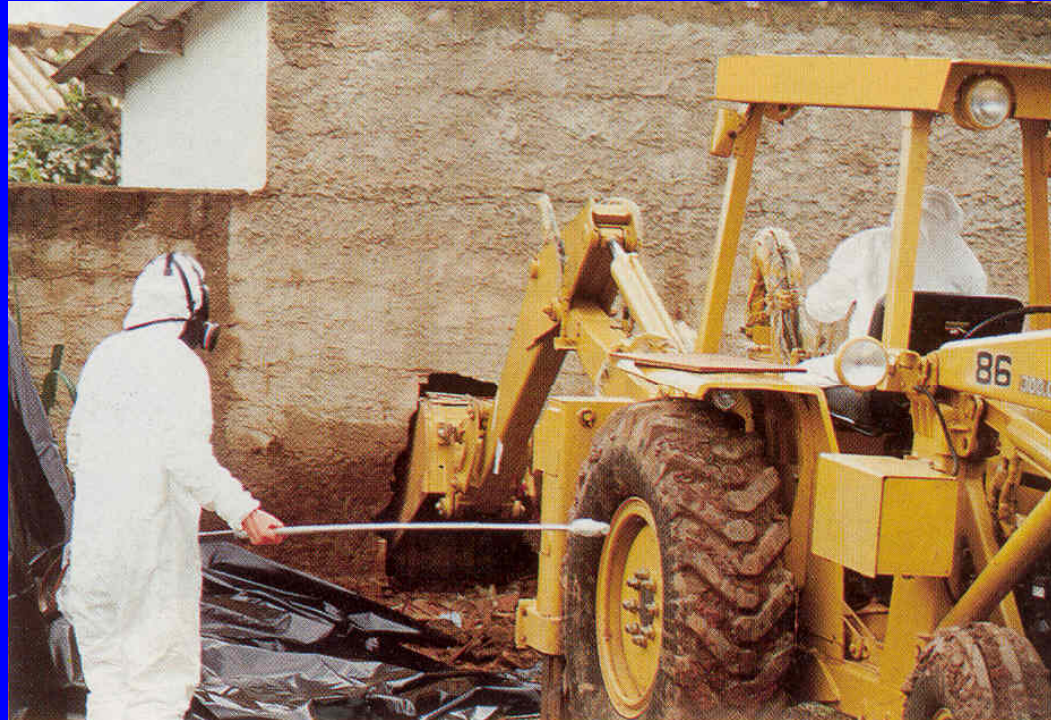
Hole being made in wall to remove a radiation hot spot of 0.5 Sv/hr (50 R/hr)

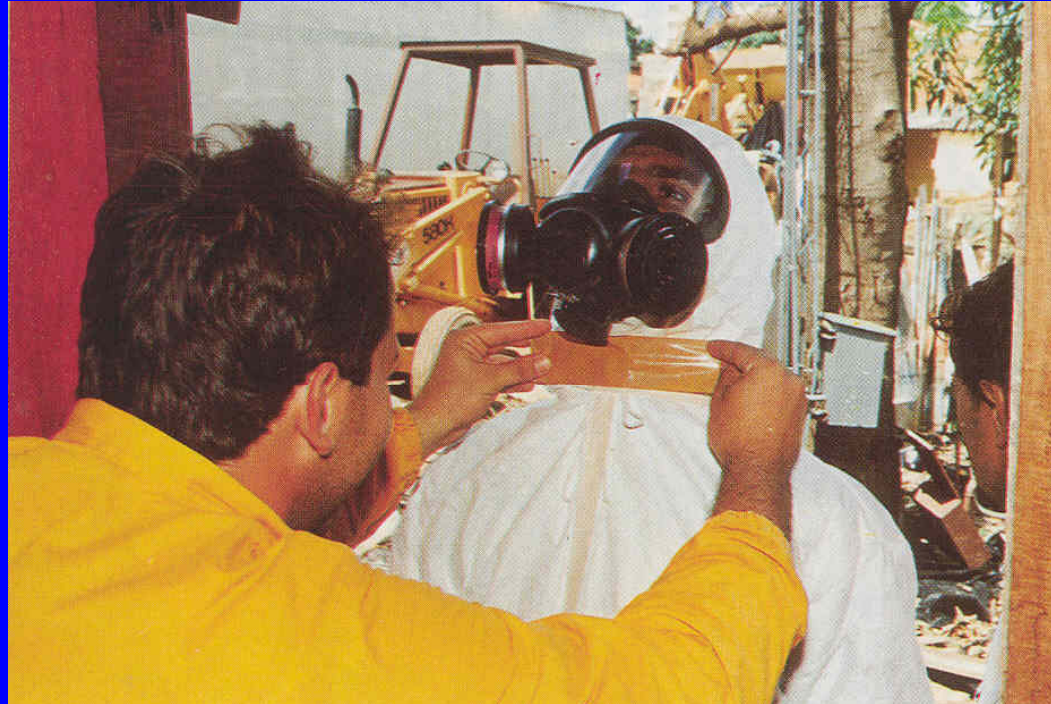
Preparing to demolish contaminated house

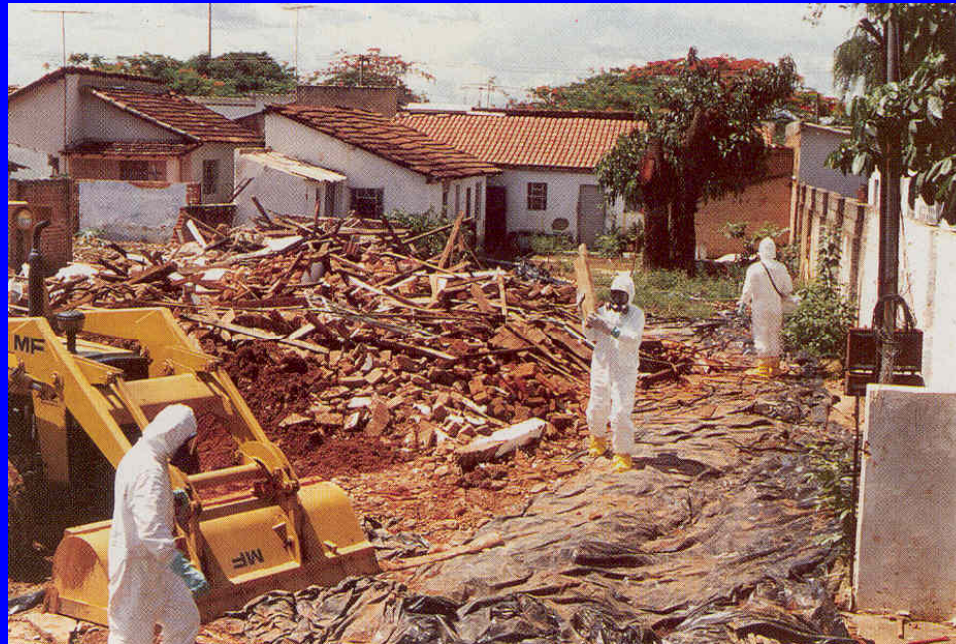
Demolished house

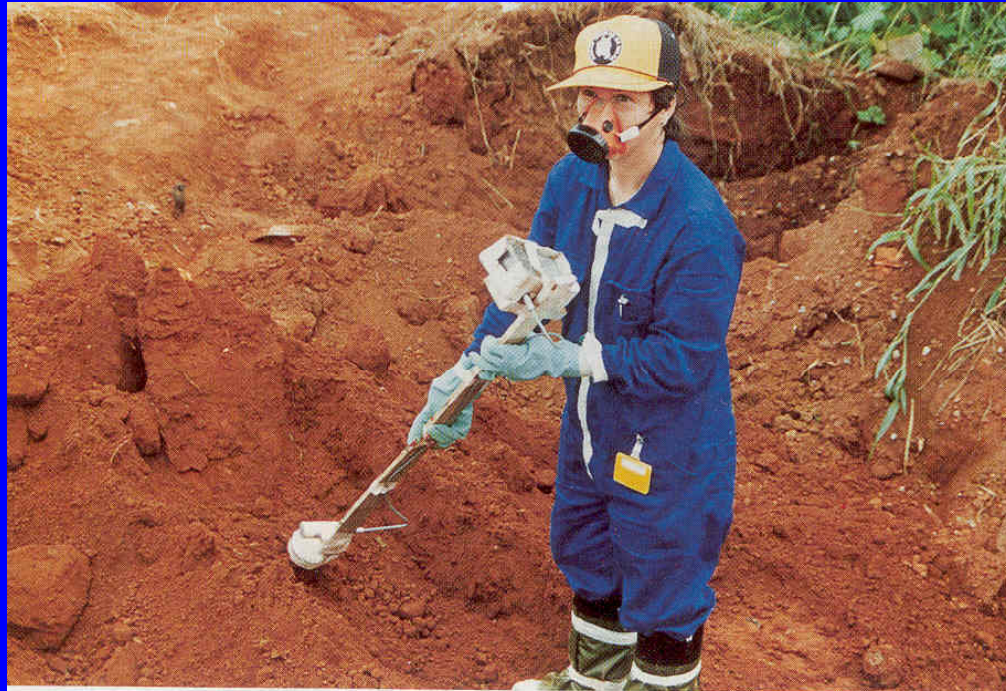
Surveying soil

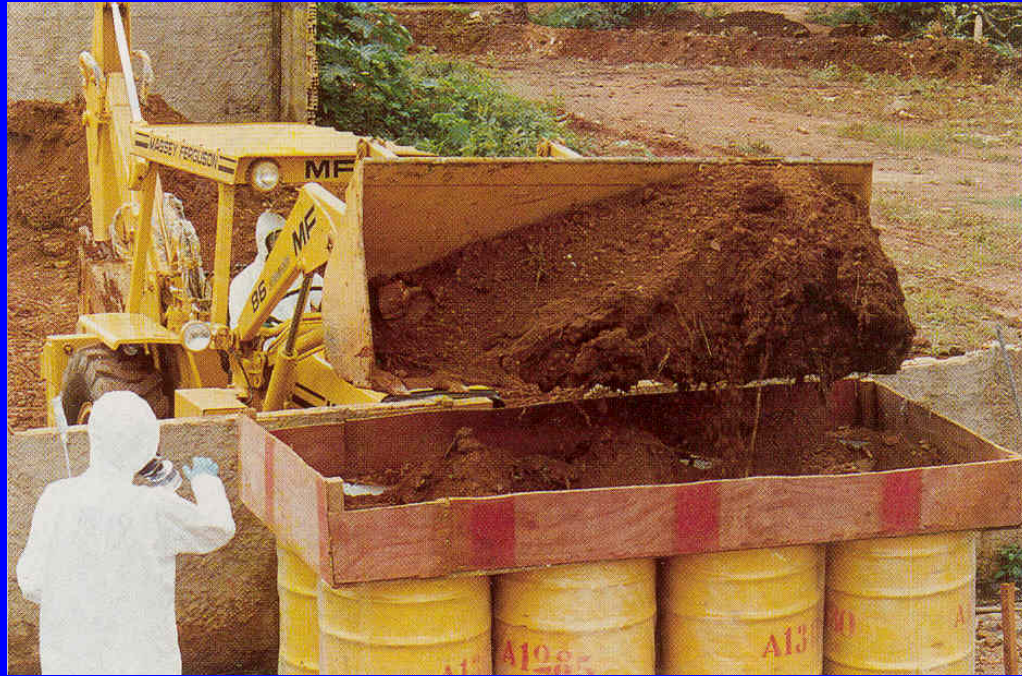
Filling drums with contaminated soil

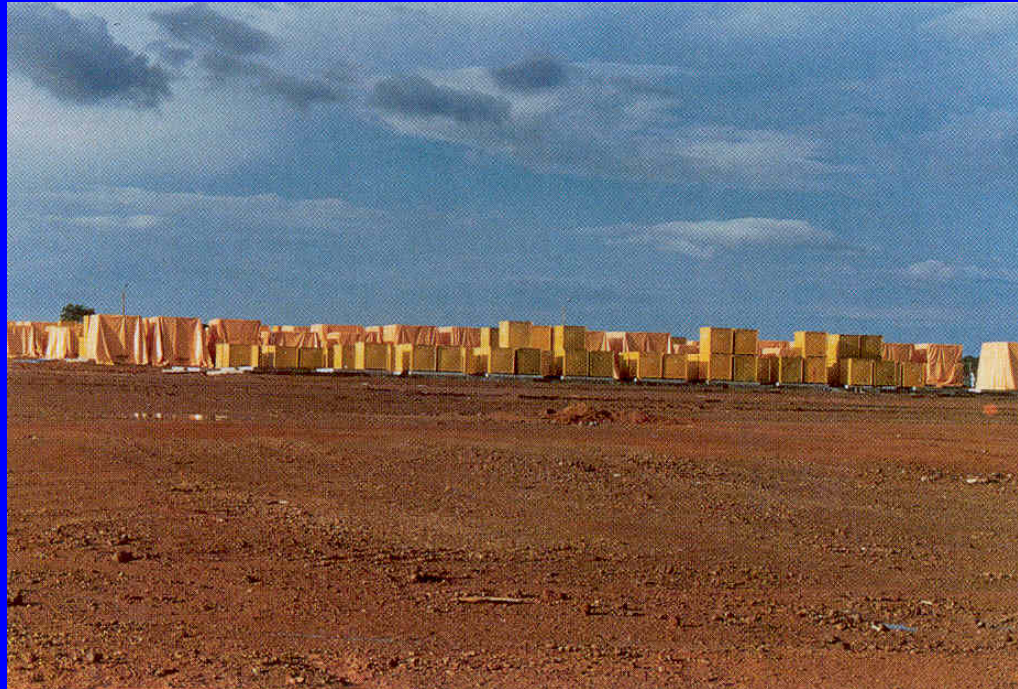
Waste containers at temporary storage site
