**UNITED STATES
NUCLEAR REGULATORY COMMISSION**

**SUBJECT: DAVIS-BESSE NUCLEAR POWER STATION REACTOR VESSEL HEAD
REPLACEMENT AND SHIELD BUILDING CRACKING INSPECTION REPORT
05000346/2012007(DRS)**

Report No: 05000346/2012007(DRS)

Facility: Davis-Besse Nuclear Power Station

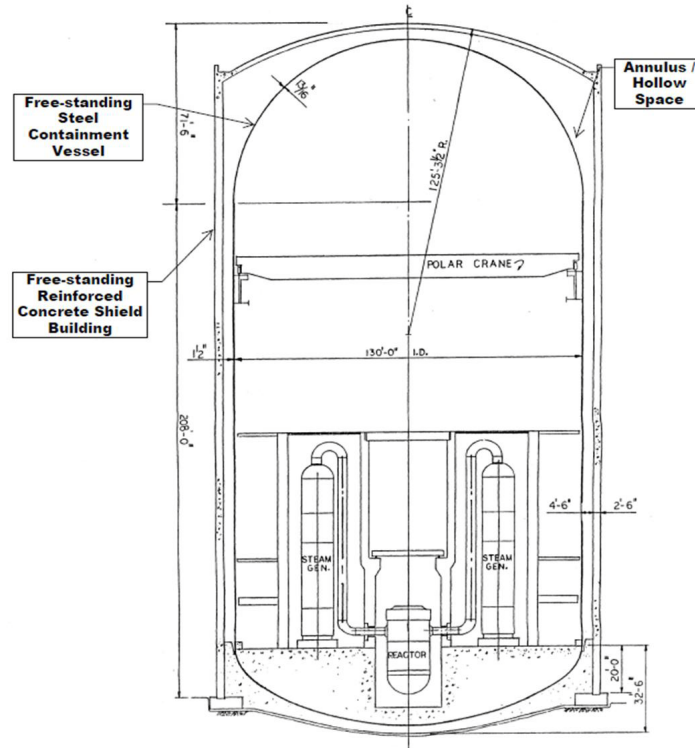
Figure 1: Simplified Davis-Besse Shield Building and Steel Containment Vessel

The containment system consists of three basic structures: a steel CV, a reinforced concrete SB, and the internal structures (Figure 1). The CV is a cylindrical steel pressure vessel which houses components and systems including the reactor vessel and reactor coolant piping. The SB is a reinforced concrete structure that surrounds the CV and has a cylindrical wall nominally 30 inches thick with vertical and horizontal reinforcement on both the inside and outside faces and a shallow dome roof. An annular space is provided between the wall of the CV and the SB, and clearance is also provided between the CV and the dome of the SB. With the exception of the concrete under the CV, there are no structural ties between the CV and the SB above the foundation slab.
