UNITED STATES  
NUCLEAR REGULATORY COMMISSION  
WASHINGTON, D.C. 20555-0001

November 18, 2020

SUBJECT: TECHNICAL REVIEW: U.S. DEPARTMENT OF ENERGY  
DOCUMENTATION RELATED TO TANK 12H GROUTING  
OPERATIONS WITH EMPHASES ON SPECIFICATIONS, TESTING,  
RECOMMENDATIONS AND PLACEMENT PROCEDURES  
(PROJECT NO. PRO0734)

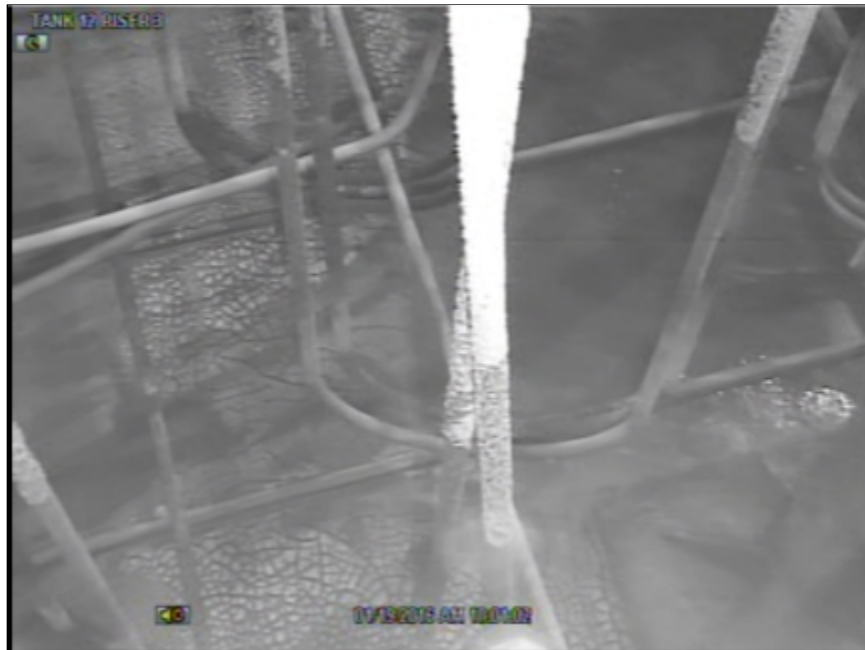
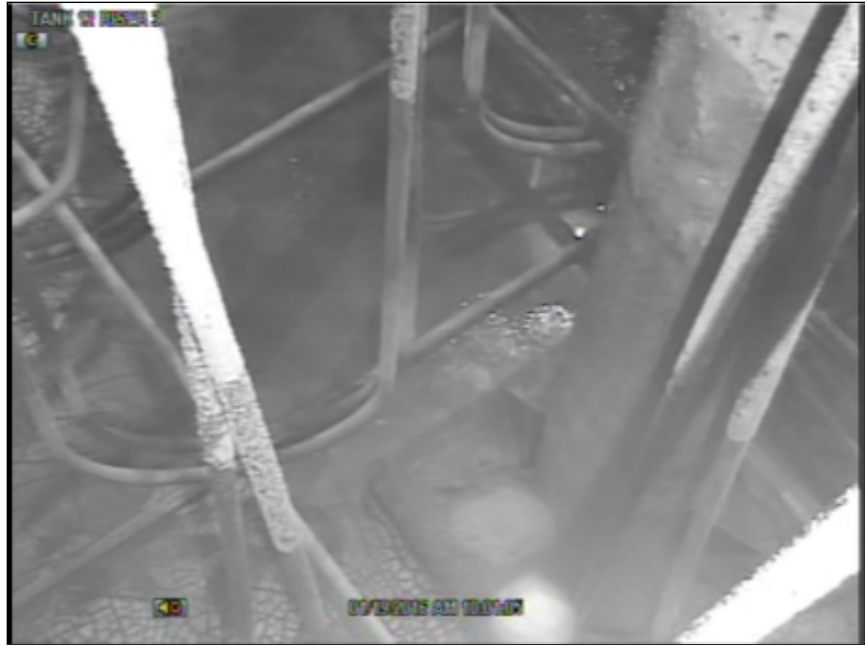
**Figure 1. Residual WIR on the Floor of the Tank 12H Primary Appears Similar to Mud Cracks. Light Reflects off a Pool of Water beyond the Column in the Bottom Image.  
Date of Video: January 19, 2016.**

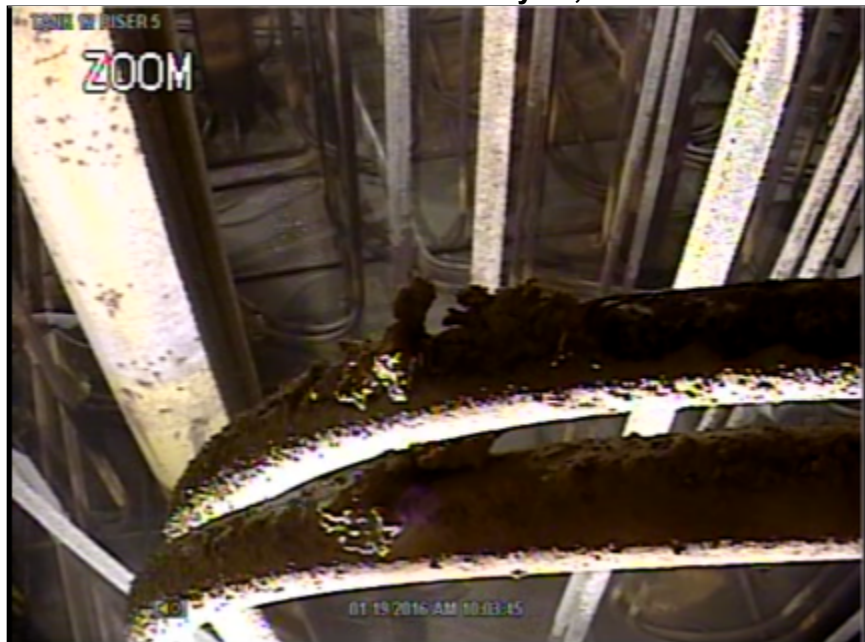
**Figure 2. Residual WIR on cooling coils within the Tank 12H Primary.  
Date of Video: January 19, 2016.**

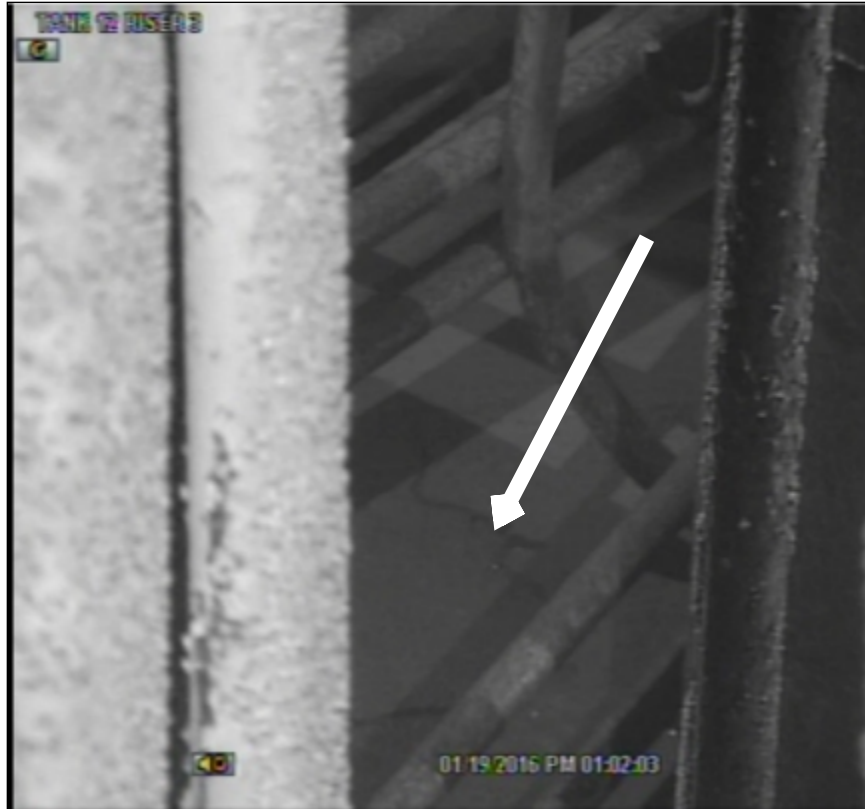
Staff reviewed some of the video footage that DOE provided of Tank 12H bulk tank and annulus grouting (ADAMS Accession No. ML20280A286). Rapidly migrating dark water was observed to bleed from slowly flowing, light-colored grout lobes as they moved away from the discharge zones of Tanks 18F, 19F, 5F, 6F, and 16H. NRC staff note the potential for bleed water to segregate from the grout mix during grout flow and distribution throughout the tank (see also VSL-14R3330-1, and its discussion of the bleed water effects of use of ADVA Cast 575), whereby potentially higher water-to-cement-ratio grout is delivered to outlying portions of the tank, far from the discharge riser (ADAMS Accession No. ML16231A444). Dark water emerges from the free surfaces of freshly flowing, light-colored grout lobes: from their front edges, side edges, and top surfaces (**Figure 3**). Video cameras recorded aqueous ponds forming at lower elevations near the tank perimeter, away from mounded grout located beneath the discharge riser (SRR-CWDA-2015-00170; ADAMS Accession No. ML16231A444). NRC staff found that bleed water was exuding from the bulk mass of flowing tank grout when it was being distributed throughout Tank 16H, and that this exudate increased the overall volume of water that collected

**Figure 3. Photo of Bleed Water Segregation Occurring in Grout Poured into the Tank 12H Primary. The Dark Outline Surrounding a Freshly Deposited Lobe of Grout is Segregated Water Separating from the Grout Mass. Date of Video: January 19, 2016.**

in pools at the tank wall beyond the amount introduced as slickline and tremie lubricant<sup>7</sup> (ADAMS Accession No. ML16231A444). Exposed grout lying above pools of water will hydrate in a relatively dry microclimate, whereas grout submerged under standing water at the tank perimeter will hydrate in a saturated microclimate; because of this, grout properties are unlikely to be uniform (ADAMS Accession No. ML13127A291). Tank grout that hydrates and hardens in a subaqueous environment may have different properties relative to that forming subaerially; although it is not entirely clear what environment will produce higher-quality, better-performing grout (ADAMS Accession No. ML16231A444). NRC staff recently reviewed the Tank 16H lessons learned document, which had a recommendation to analyze data from Tank 16H grout testing to develop an acceptable, non-zero range for bleed-water production.

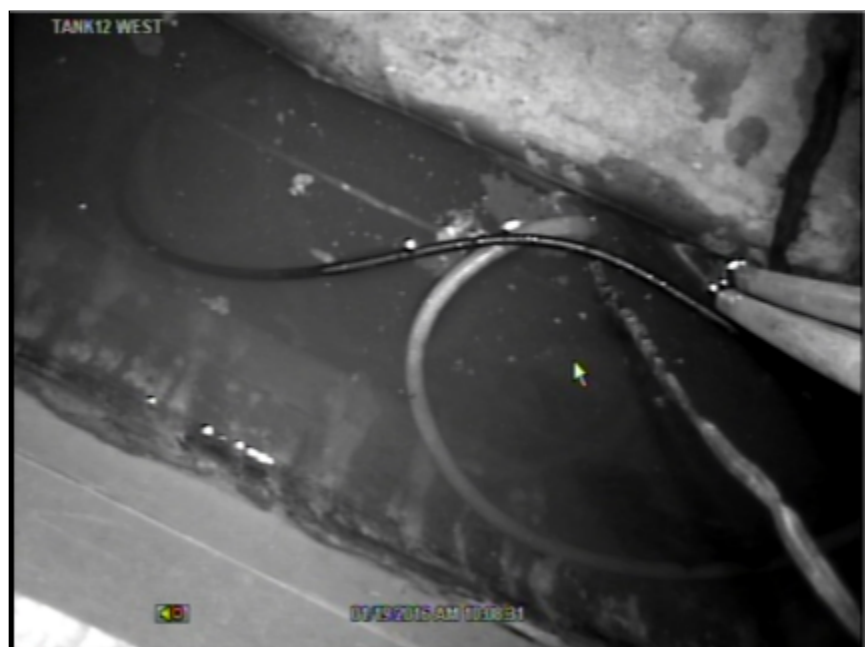
Placement of Lifts 2 and 3 in the Tank 12H annulus was delayed (ADAMS Accession No. ML16111B174) until 8 February 2016 (SRR-CWDA-2016-00068), due to groundwater accumulation in the annulus (**Figure 4**) when the temporary ventilation system, which forced unheated air through the annulus, was shut off (ADAMS Accession No. ML16167A237). As expected, groundwater accumulated in the annulus faster when air was “pulled” under negative pressure than it did when it was “pushed” with positive pressure (ADAMS Accession No. ML16167A237 and SRR-LWE-2015-00048). DOE estimated that ~3,785 L (~1000 gal) of groundwater was pumped out of the Tank 12H annulus (ADAMS Accession No. ML16167A237), reducing the water level to no more than 5 cm (2 in). Any standing water remaining in the annulus when grouting began likely would have enhanced bleed water segregation in Lift 2 (cf. RPT-5539-EG-0016, Test 2), leaving an as-yet-unquantified impact on the hydraulic conductivity of the bottom layer of grout (i.e., Lift 2) in the annulus (cf. SRNL-STI-2012-00576).

**Figure 4. Groundwater In-Leakage in the Annulus, as viewed from the West Riser.  
Date of Video: January 19, 2016.**

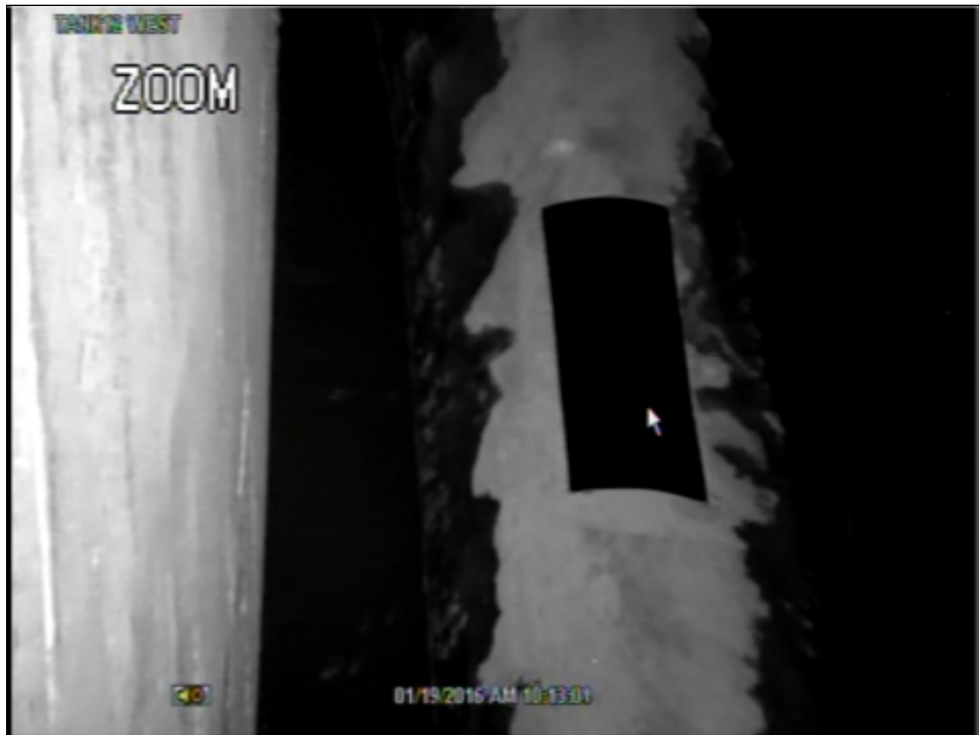
The continuity of grout placement when filling contaminated ducts is particularly important. Uninterrupted flow of grout is essential to ensure that permanent porosity does not develop inside ductwork. DOE should try to place and position cameras in such a manner as to maximize visualization of grout entry and exit from ventilation duct registers.

**Figure 5. Photograph of Rectangular Ventilation Register in the Annulus, as viewed from the West Riser. Date of Video: January 19, 2016.**

Improved visualization will increase the evidentiary support for ventilation duct voids having been filled, and will enhance DOE's ability to develop lessons learned related to grout placement strategies that will increase the likelihood that ducts are fully grouted and do not contain risk-significant void space (ADAMS Accession No. ML16231A444).
