SUBJECT: NATIONAL INSTITUTE OF STANDARDS AND TECHNOLOGY – REPORT ON  
THE REGULATORY AUDIT RE: RESTART REQUEST FOLLOWING  
EXCEEDANCE OF CLADDING TEMPERATURE SAFETY LIMIT  
(EPID: L-2021-LLN-0000)

REGULATORY AUDIT REPORT

REGARDING REVIEW OF THE RESTART REQUEST

NATIONAL BUREAU OF STANDARDS TEST REACTOR

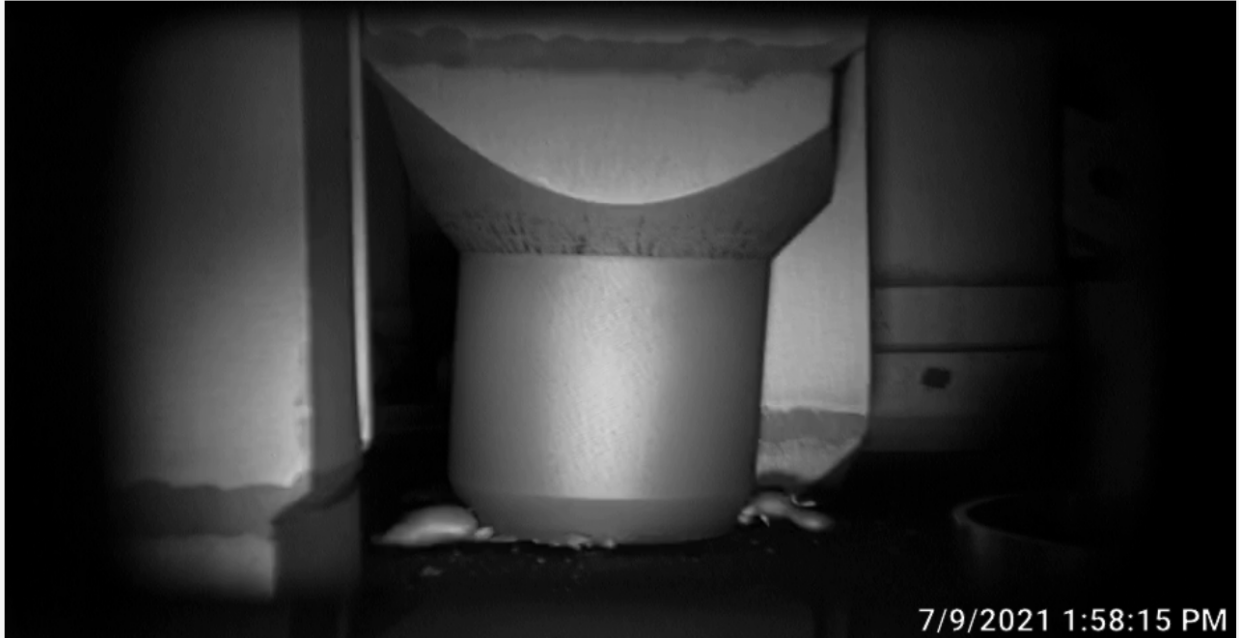
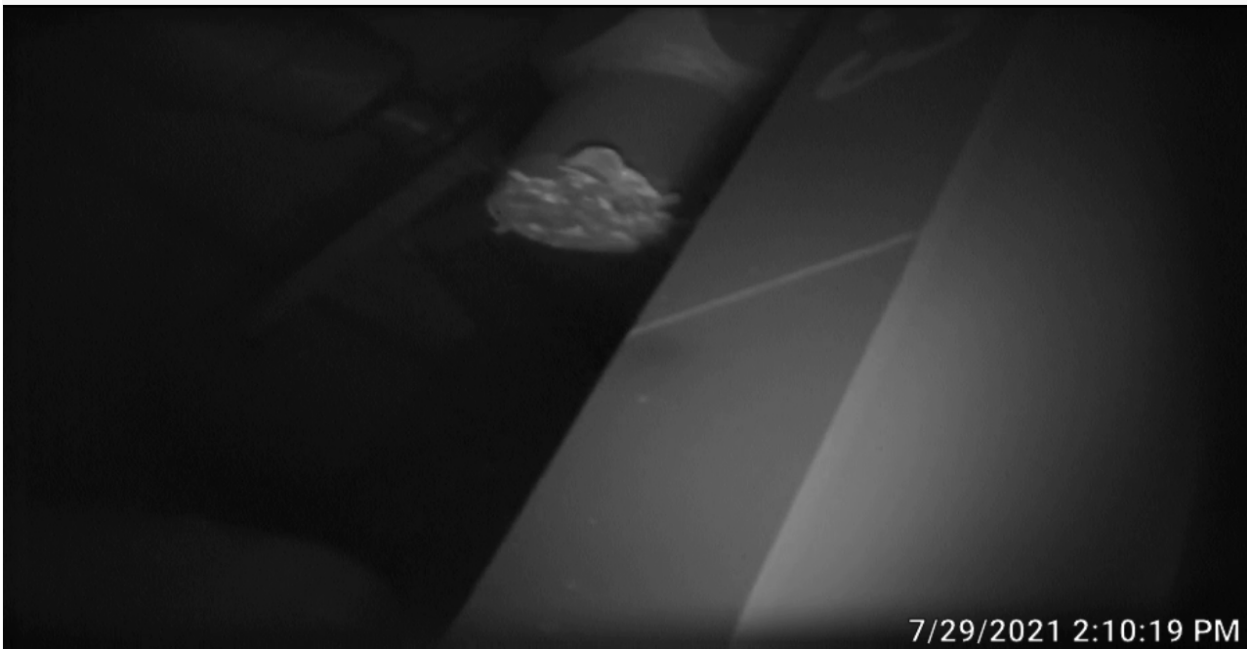
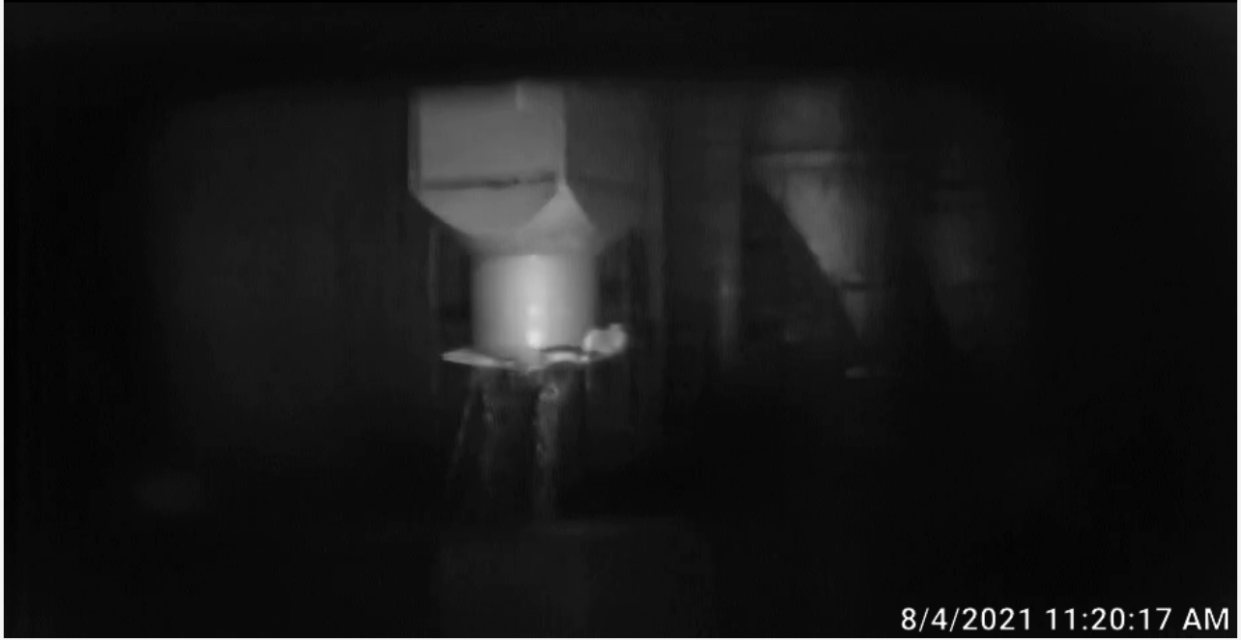
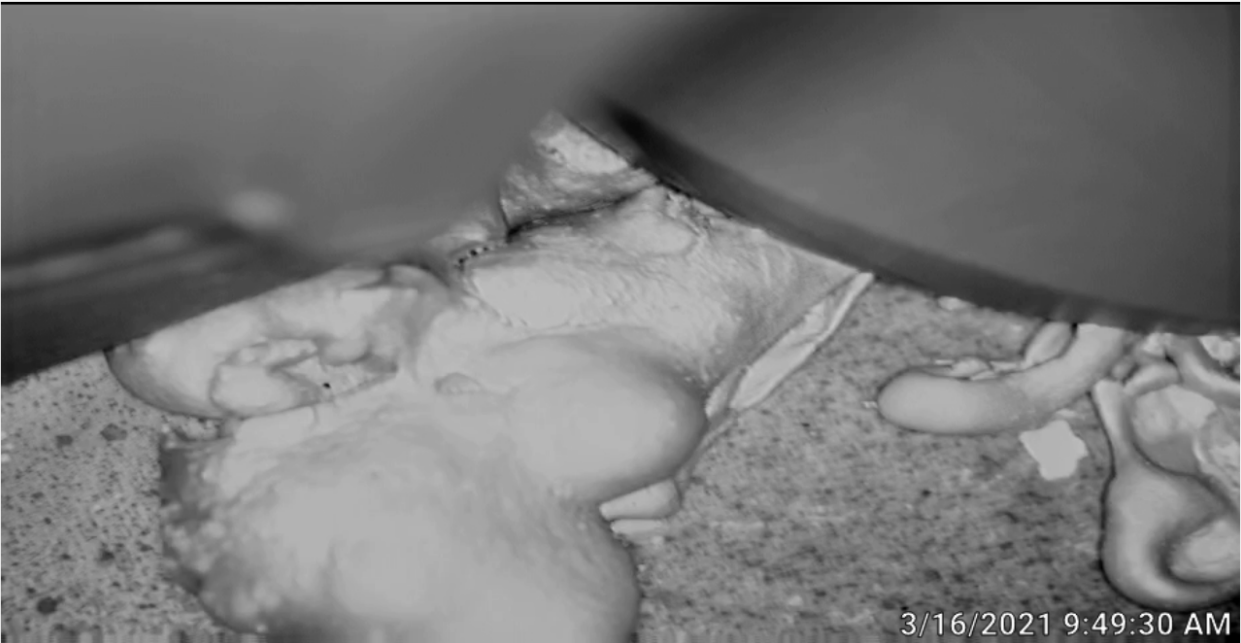
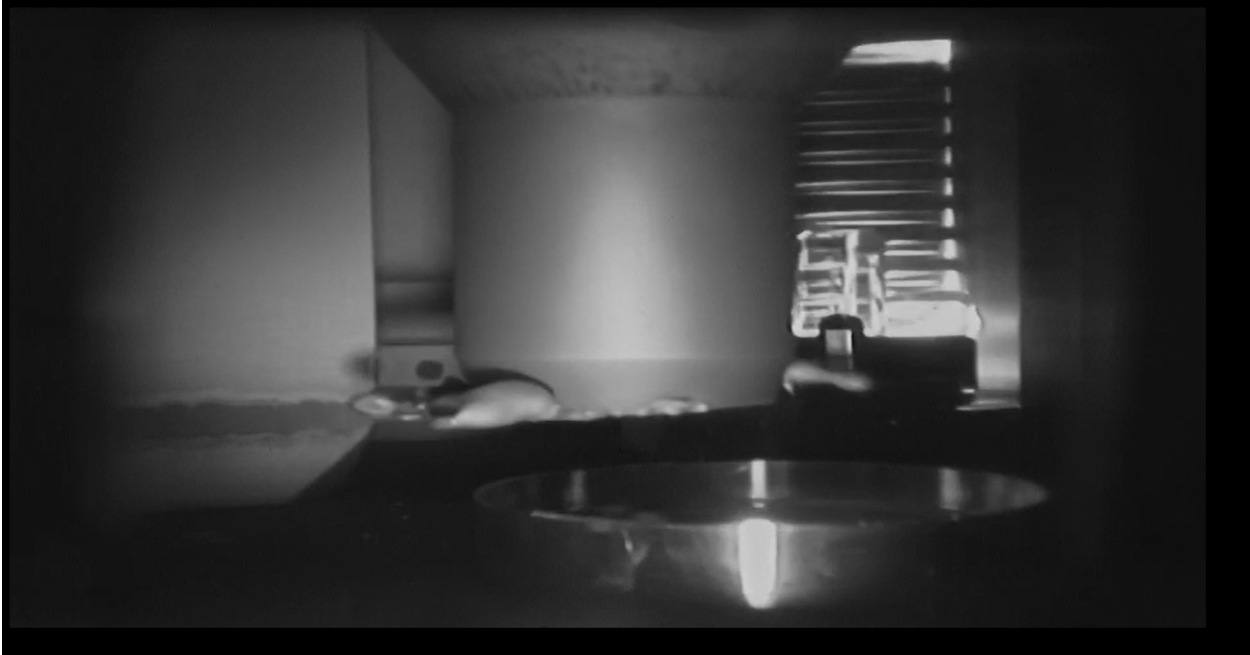
The licensee explained that material from the damaged fuel element can be addressed in two categories. The first is the once-molten material contacting the lower grid plate in the area of the nozzle of the damaged fuel element was resting on the lower grid plate. The second is debris that exited through the top of the damaged fuel element. Based on photos provided by the licensee, the NRC staff observed that for the first category of material, in general, the larger once-molten material debris was localized and limited to only the area where the nozzle of the fuel element rested on the lower grid plate. Based on photos and video during the removal of the damaged fuel element from the reactor core, the NRC staff observed the following:

- removal of the damaged fuel element from its as-found location was not difficult (i.e., once-molten material was not welded or bonded to the lower grid plate)
- much of the once-molten material remained attached to the nozzle of the damaged fuel element as it was removed from the reactor core
- the condition of the lower grid plate did not appear to be distorted, discolored or deformed in area of the once-molten material

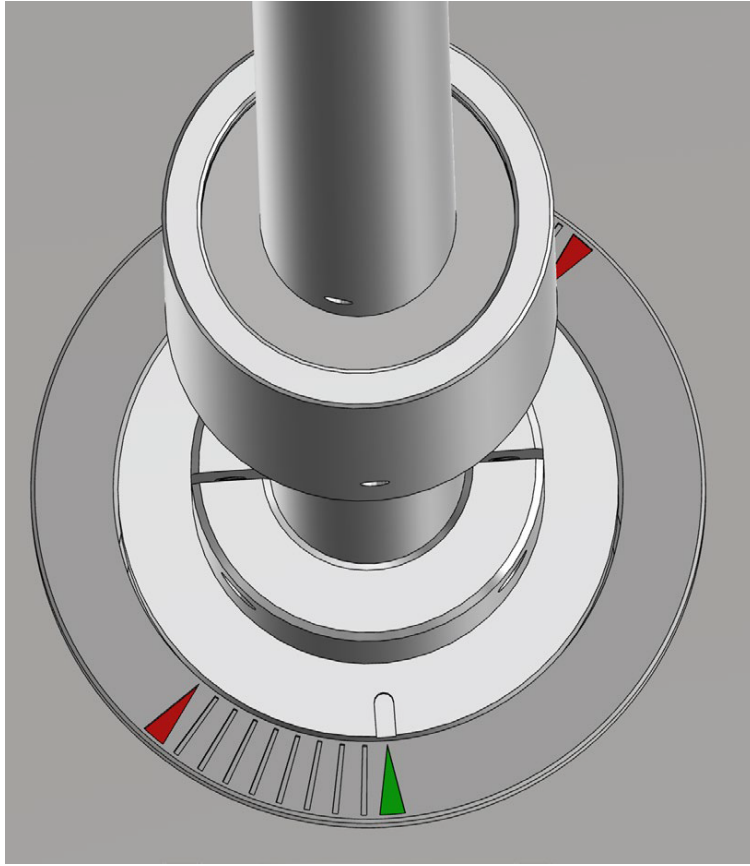
Figure 3 - "Proper Latch Indication,"

Figure 3, "Proper Latch Indication," in OI 6.1.7 (Revision 3) provides a visual depiction of a properly latched fuel element as shown below:

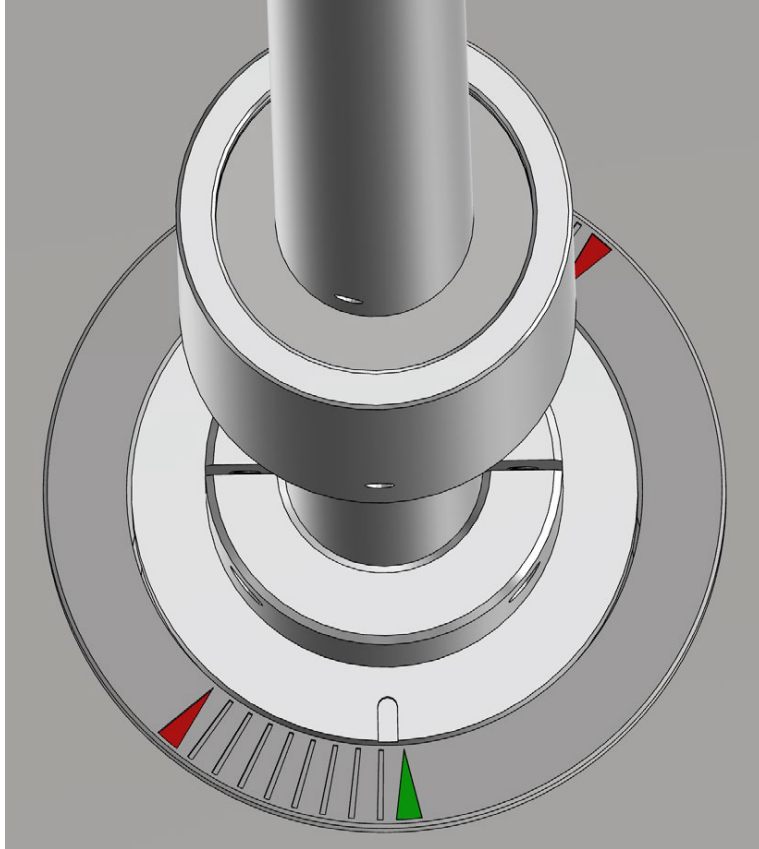
Figure 4 - "Improper Latch Indication"

Figure 4, "Improper Latch Indication," in OI 6.1.7 (Revision 3) provides a visual depiction of an improperly latched fuel element as shown below:

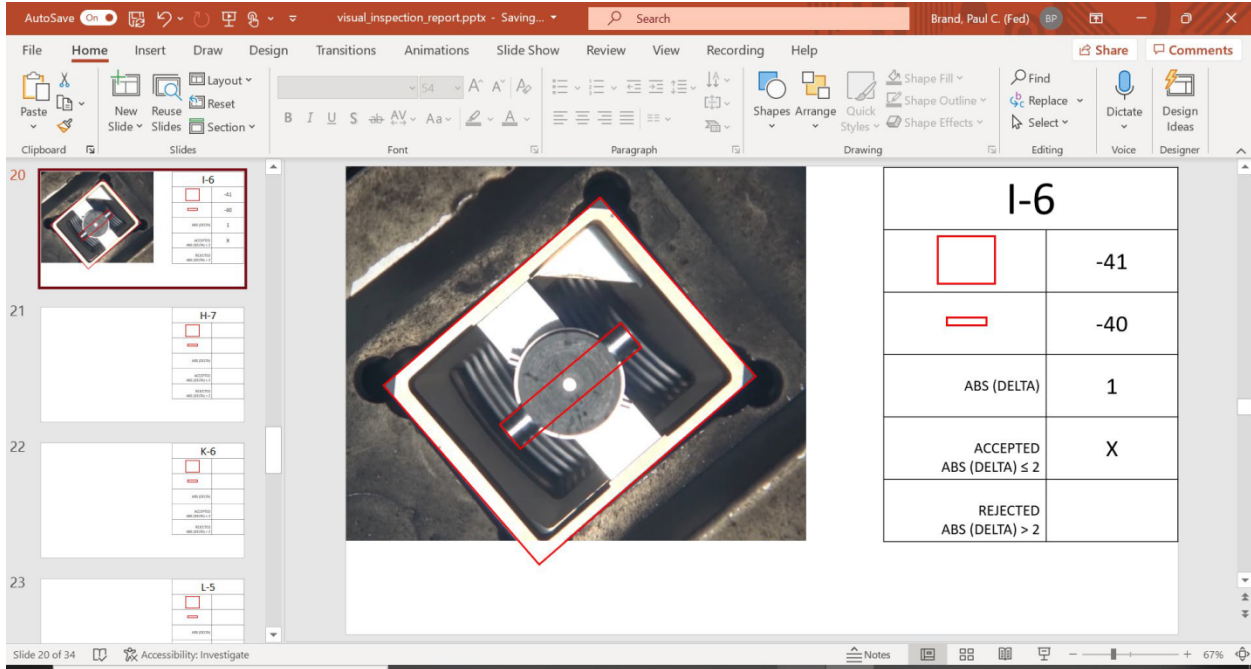
Figure 13 - "Completed Sheet for Fuel Head Visual Inspection Analysis – Accepted,"

Figure 13, "Completed Sheet for Fuel Head Visual Inspection Analysis – Accepted," in OI 6.1.9 (Revision 3) shows the accepted position for the visual latch check verification as follows:

The photographs in these figures provide a clear demonstration that each fuel element is properly latched or is rejected as part of the visual latch check verification analysis.

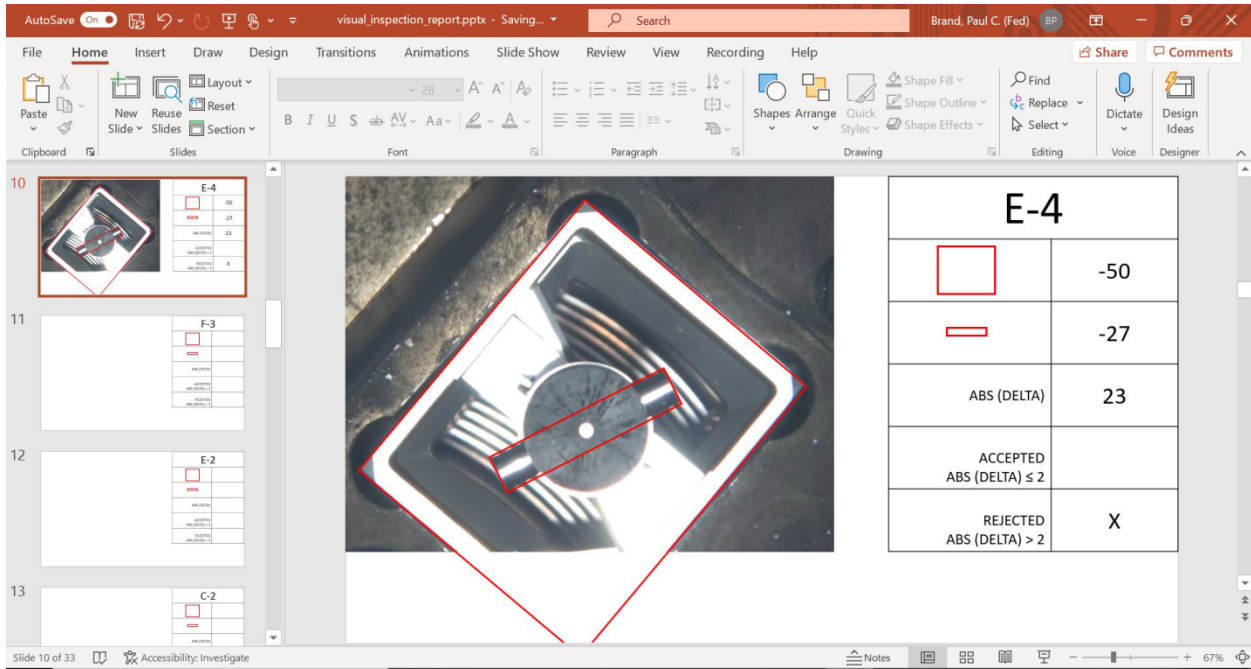
Figure 14 - "Completed Sheet for Fuel Head Visual Inspection Analysis – Rejected,"

Figure 14, "Completed Sheet for Fuel Head Visual Inspection Analysis – Rejected," in OI 6.1.9 (Revision 3) shows an example of a rejected position during the visual latch check verification as follows:

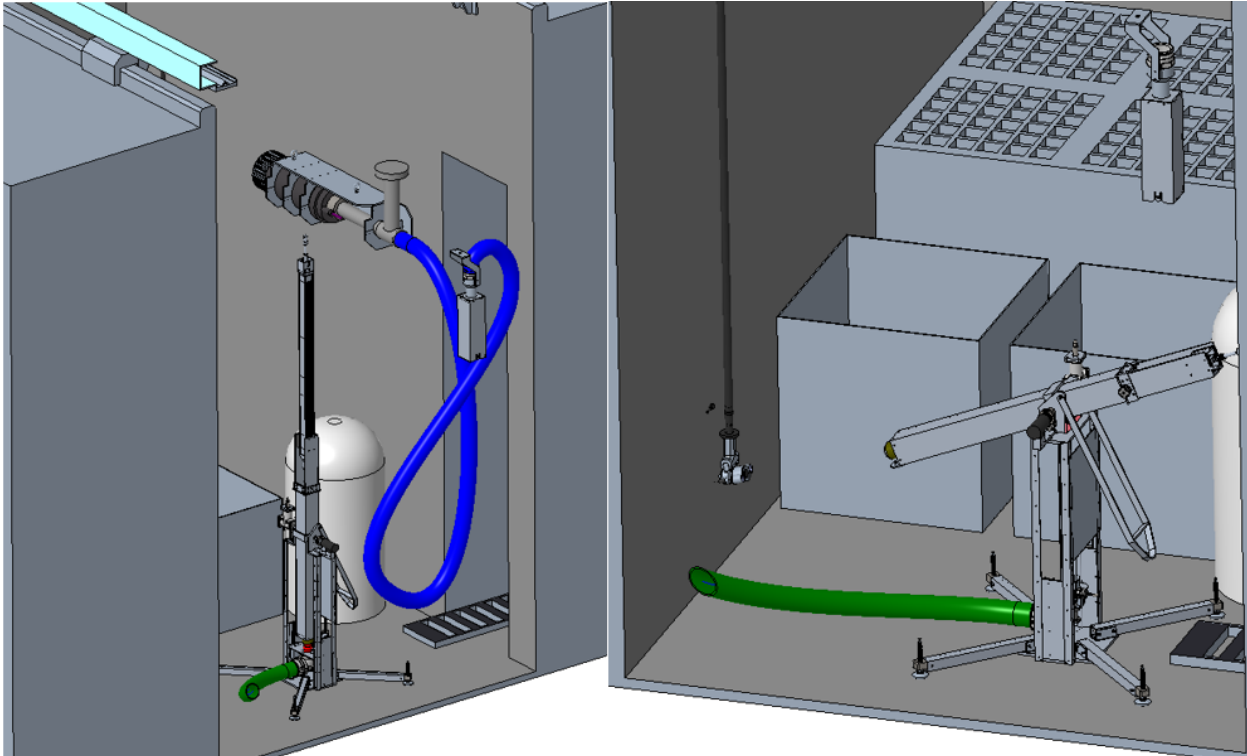
**Figure 1. Fuel Flushing and Inspection Stand.**

The audit team visited the NCNR on Wednesday, April 13, 2022, to observe the fuel examination and flushing evolutions. Framatome installed an inspection and flushing stand in the spent fuel pool. This stand was designed to allow a fuel assembly, when installed, to tilt into alignment with cameras at either end of the assembly, to permit visual inspection of the fuel plates. When upright, a fitting can be coupled to the top of the fuel assembly so that a blower nozzle can be connected to the assembly for backflow flushing. The fitting is connected to a submersible pump installed in the pool. The bottom of the assembly is connected to a canister filter to collect any flushed debris before the flushing water is returned to the pool.

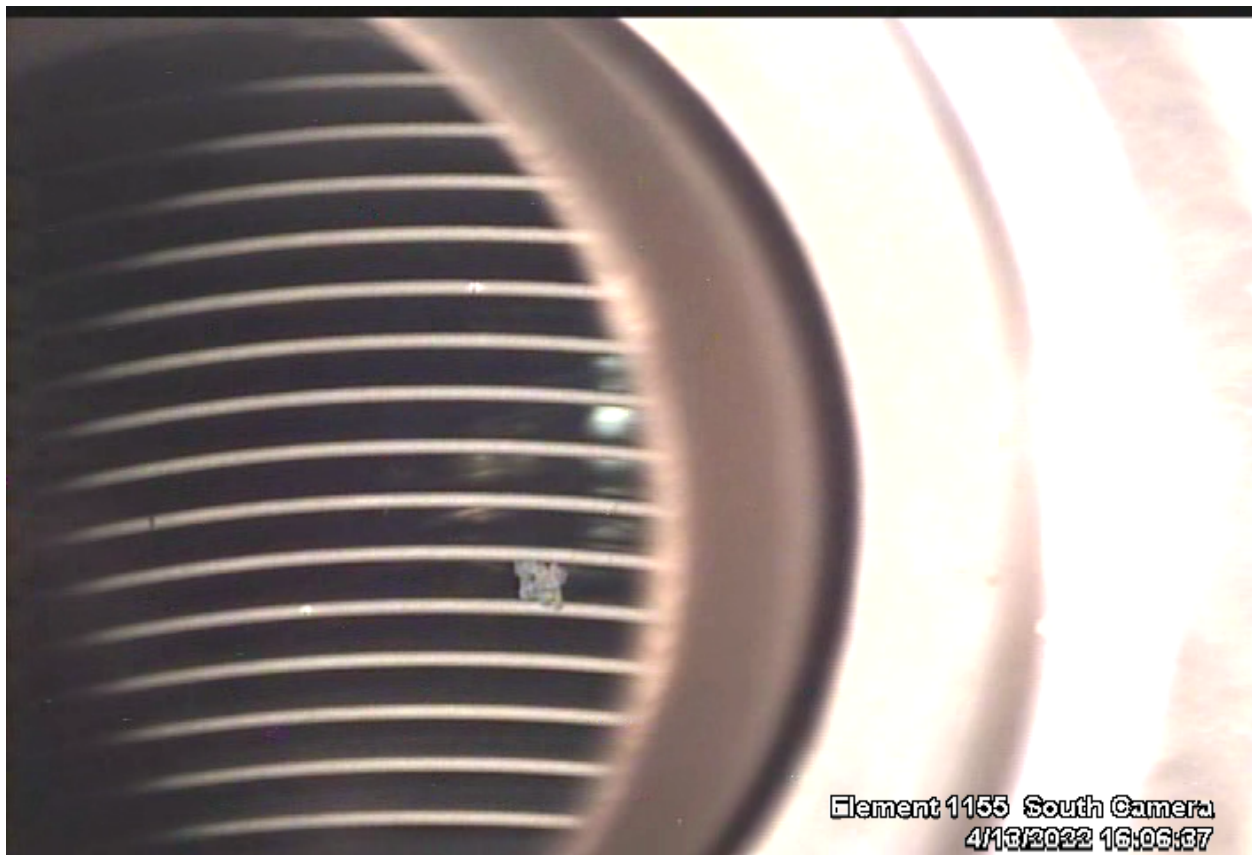
Following the completion of the flushing and inspection procedures, NIST personnel made available for NRC staff audit a preliminary disposition for the fuel. Four elements were identified as clean and, at the time, cleared for reuse. Three elements were identified as having probable fuel debris and were not cleared for reuse without further cleaning. The remaining 22 elements were determined to contain very small but visible debris. In comparison to a baseline inspection of other elements that were in the spent fuel pool but not present in the reactor, NIST personnel concluded that these 22 elements appeared somewhat similar to the condition of the other elements. Additionally, it was observed that 3 of the 22 elements with small debris had dented nozzles. Shown below is an image of Element 1155, which is believed to contain a nugget of fuel material. Also shown below is an image of Element 1157, in which superficial scratching can be seen on the element. NIST personnel indicated that, where observed, scratching did not appear to be indicative of cladding failure.

Figure 2. NIST personnel identified Element 1155 as likely containing fuel material.

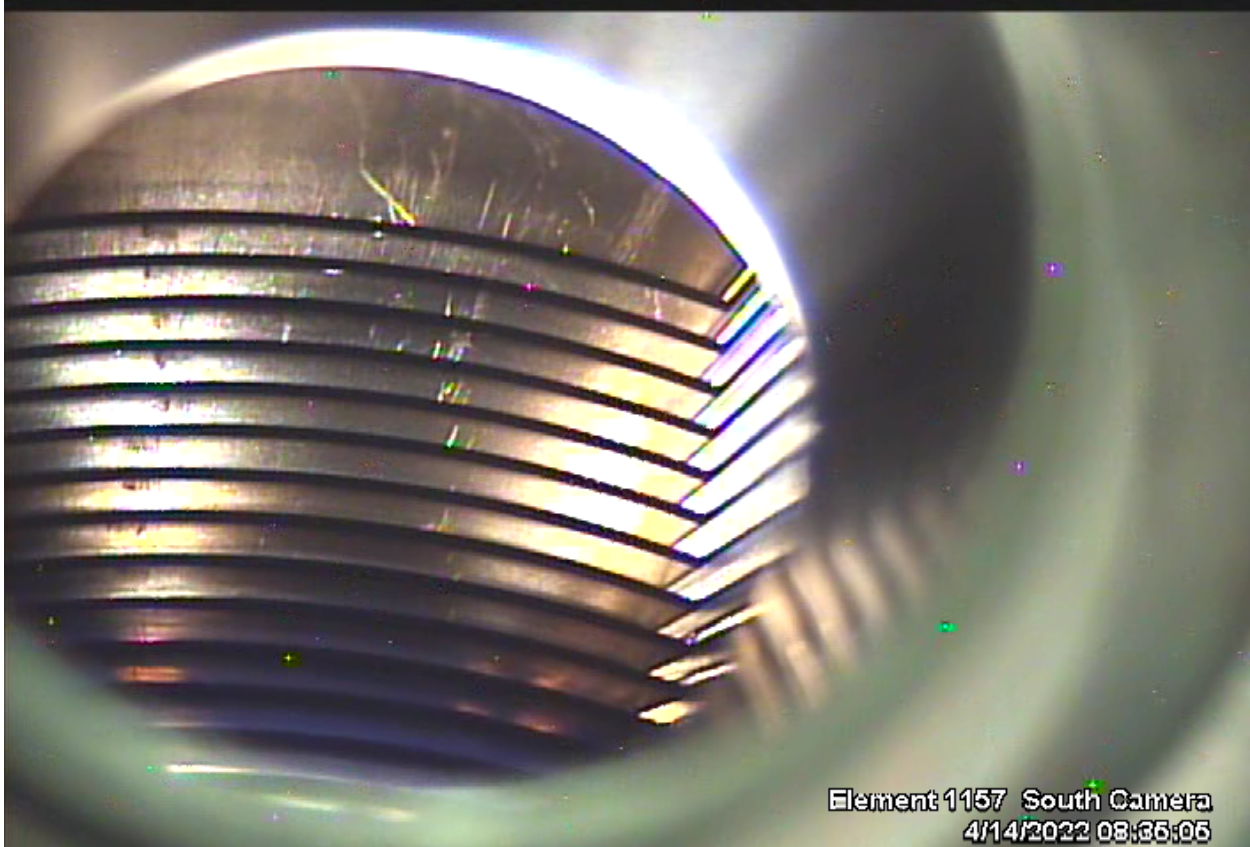
**Figure 3. Superficial (i.e., not compromising cladding integrity) scratching observed on Element 1157.**
