Subject: 10 CFR Part 21 Report – Inconsistent crimping of motor leads to ring terminal connectors and Failure to Comply. Trillium Valves USA Part 21 Evaluation I211003

LIMDOC-2022-004

**Subject: Inspection of terminal samples returned from Trillium Valve**

ATTACHMENT 3: Reportable Condition per 21.21(d)(4)

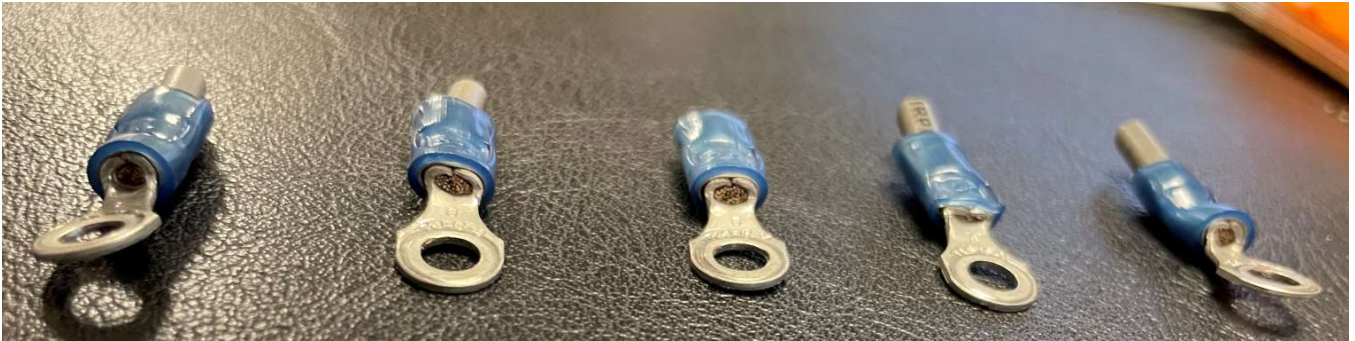
**Photo # 1: Five Terminals Removed from Actuator**

Photo # 1 provided by Trillium Valve shows five ring tongue terminal connectors removed from the actuator identified as serial #L983445. Two of these terminals were returned to Limitorque from Trillium Valve. The returned samples, designated as RS1 and RS2 are shown in photos # 2 & 3. The terminals were forwarded to the engineering special test lab for evaluation. For comparison purposes, Flowserve QA also provided the lab with three samples of terminal connectors that were installed and crimped by the Lynchburg production wiring department. These are shown in photo #4.

The three comparison samples shown in photo #5 are uniform in appearance. In contrast, the terminal connectors shown in photos #1, 2, 3, & 4 show inconsistencies in the location of the crimp and the extent of deformation of the barrel and insulator.

Limitorque's inspection has determined that the root cause of the intermittent continuity at the wire conductor to terminal connection is likely attributable to a workmanship error resulting in inconsistent crimping of the lead wire to the terminal. On sample RS2, the conductor was not fully inserted into the terminal barrel prior to crimping. On samples RS1 & RS2, the crimping tool was not positioned properly on the terminal barrel prior to the crimp. The other terminals shown in photos 1 & 2 exhibit similar inconsistencies.

Trillium Valves USA recommends the inspection of these actuators listed in Attachment 2 for the lack of continuity at the motor leads which may be impacted by inconsistent crimping of the lead wire to the ring tongue terminal.

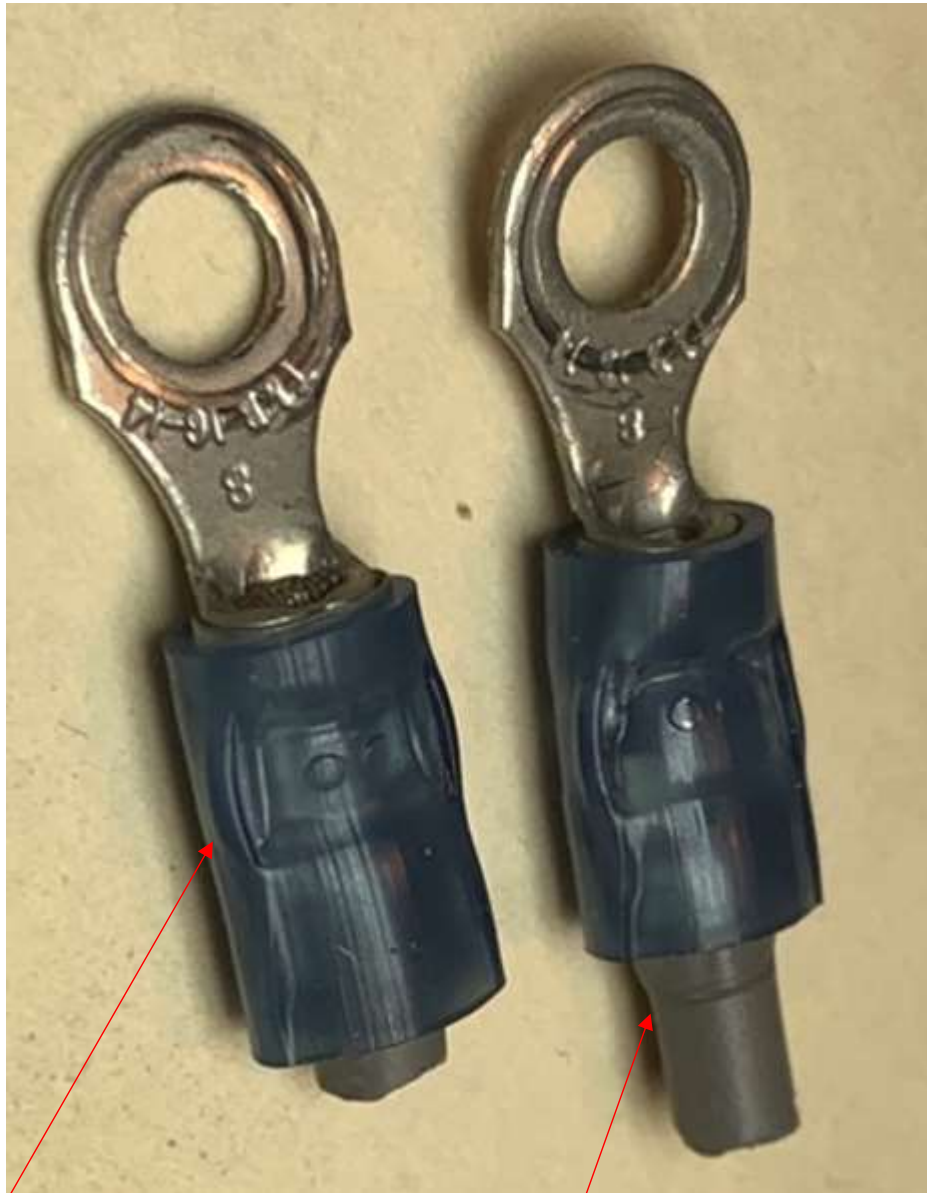
**Photo # 3: Samples Returned for Evaluation**

- Terminal RS1, identified as the terminal with the longest wire protruding, showed no continuity initially but when the end of the wire was manipulated continuity was intermittent. The wire appears to have been partially pulled out of the connector evident by the crimp impression in the wire insulation below the terminal and, also evident by the wire conductor not extending to the end of the barrel on the terminal side. Also, the wire did not appear to be firmly held when the wire was manipulated for the continuity test. The wire conductor was approximately 0.045" short of reaching the end of the terminal barrel.

- Terminal RS2, identified as the terminal with the short wire protruding, initially checked good continuity however manipulation of the wire caused continuity to drop on at least one occasion. The wire appears to be still firmly held by the crimp however there is very little wire protruding from the terminal to make this evaluation. The wire conductor was approximately flush with the end of the terminal barrel.

RS1: Secondary crimp partially on the wire insulation rather than the terminal insulator

RS2: Primary crimp not positioned correctly over the barrel of the terminal housing the conductor

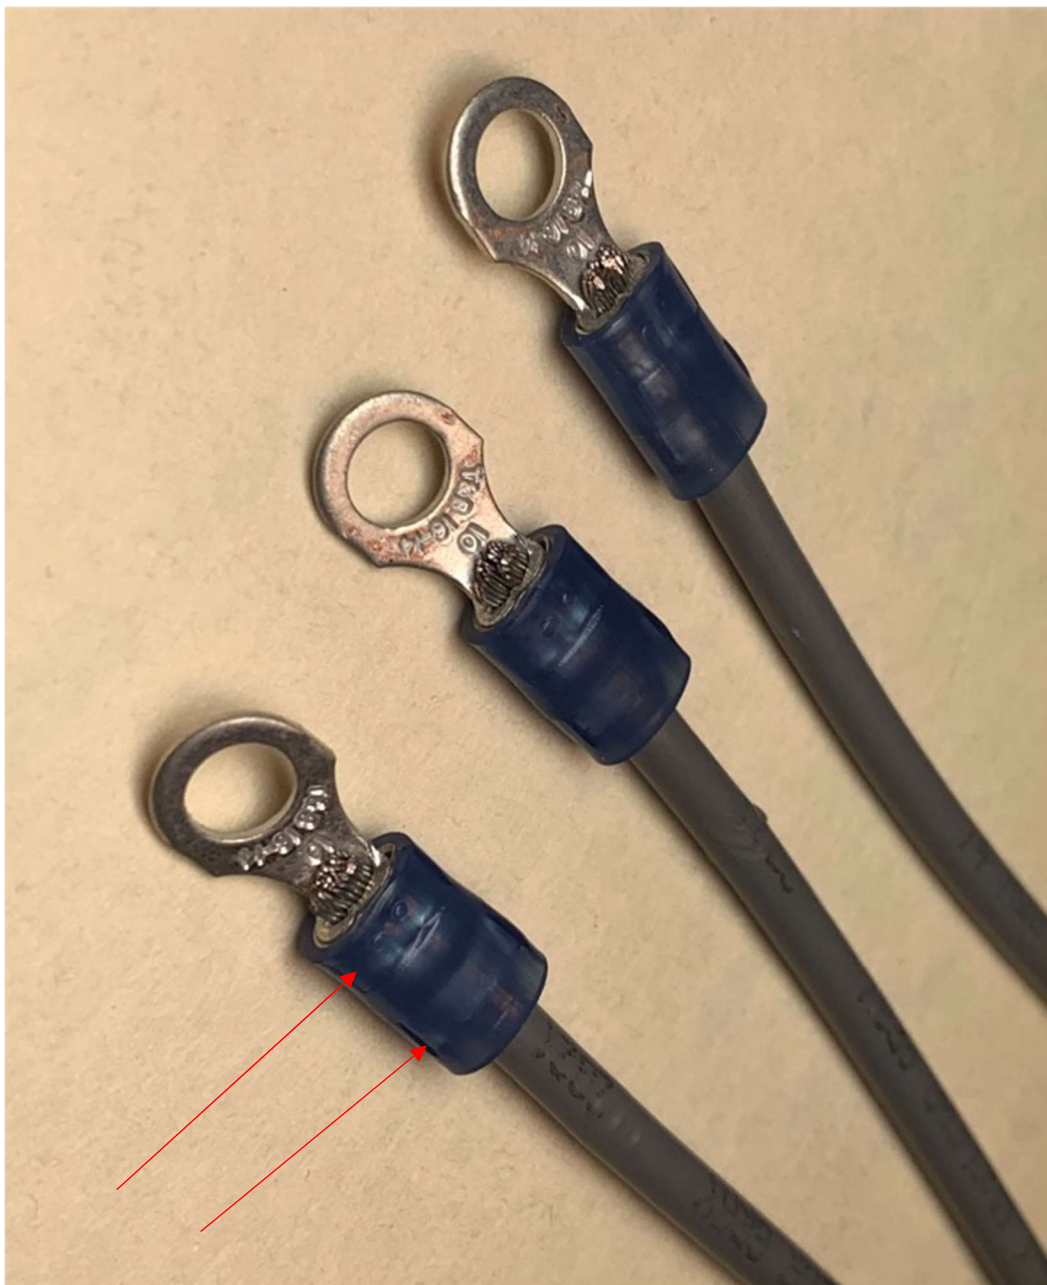
**Photo # 5: Samples Provided for Comparison**

- The terminals provided by QA for comparison have an obviously different impression from the crimp tool than the samples returned from the customer. Also, the wire extends well beyond the end of the crimp barrel on these samples. Numbering on these terminals is different than those received from the Customer. (Regarding this comment, the terminals received from the customer are T & B part # RB863 which has a hole for a #8 screw typically used on the control and power Marathon terminal strip. The samples provided by QA are a T & B part # RB873 which has hole for a #10 screw typically used on the geared limit switch and torque switch terminals. Otherwise, the terminals are identical.)

Photo # 5 comment: There are two visible compression marks from the crimping tool. One crimp mark is directly over the barrel housing the conductor while the second crimp mark is over the barrel that clamps on the insulation of the wire.

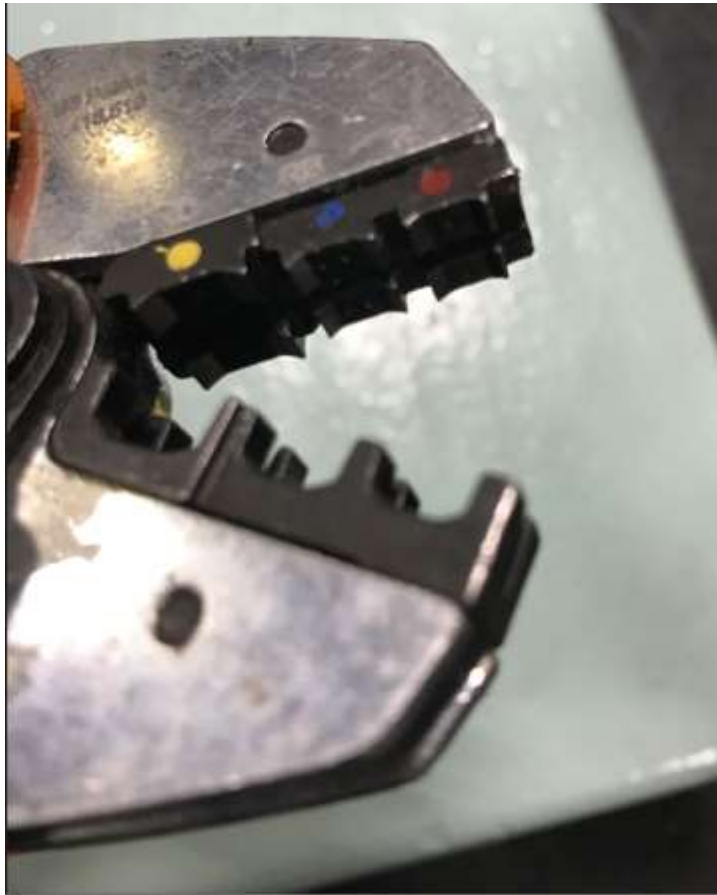
**Photo # 6: Crimping Tool**

The crimping tool used by Limitorque (reference photo # 6) has jaws that crimps the connector in two places simultaneously. The primary crimp compresses the serrated barrel (reference Figure 1 and Photo #7) onto the wire conductor. The secondary crimp compresses the funnel entry barrel onto the outer wire insulation.
