**Subject: Beaver Valley Power Station, Unit No. 1
BV-1 Docket No. 50-334, License No. DPR-66
Supplemental Response to Bulletin 2002-01, Reactor Pressure Vessel
Head Degradation and Reactor Coolant Pressure Boundary Integrity**

Attachment A
BVPS Supplemental Response to NRC Bulletin 2002-01

**The following is supplemental information regarding the condition of the
Beaver Valley Power Station (BVPS) Unit 1 reactor pressure vessel head**

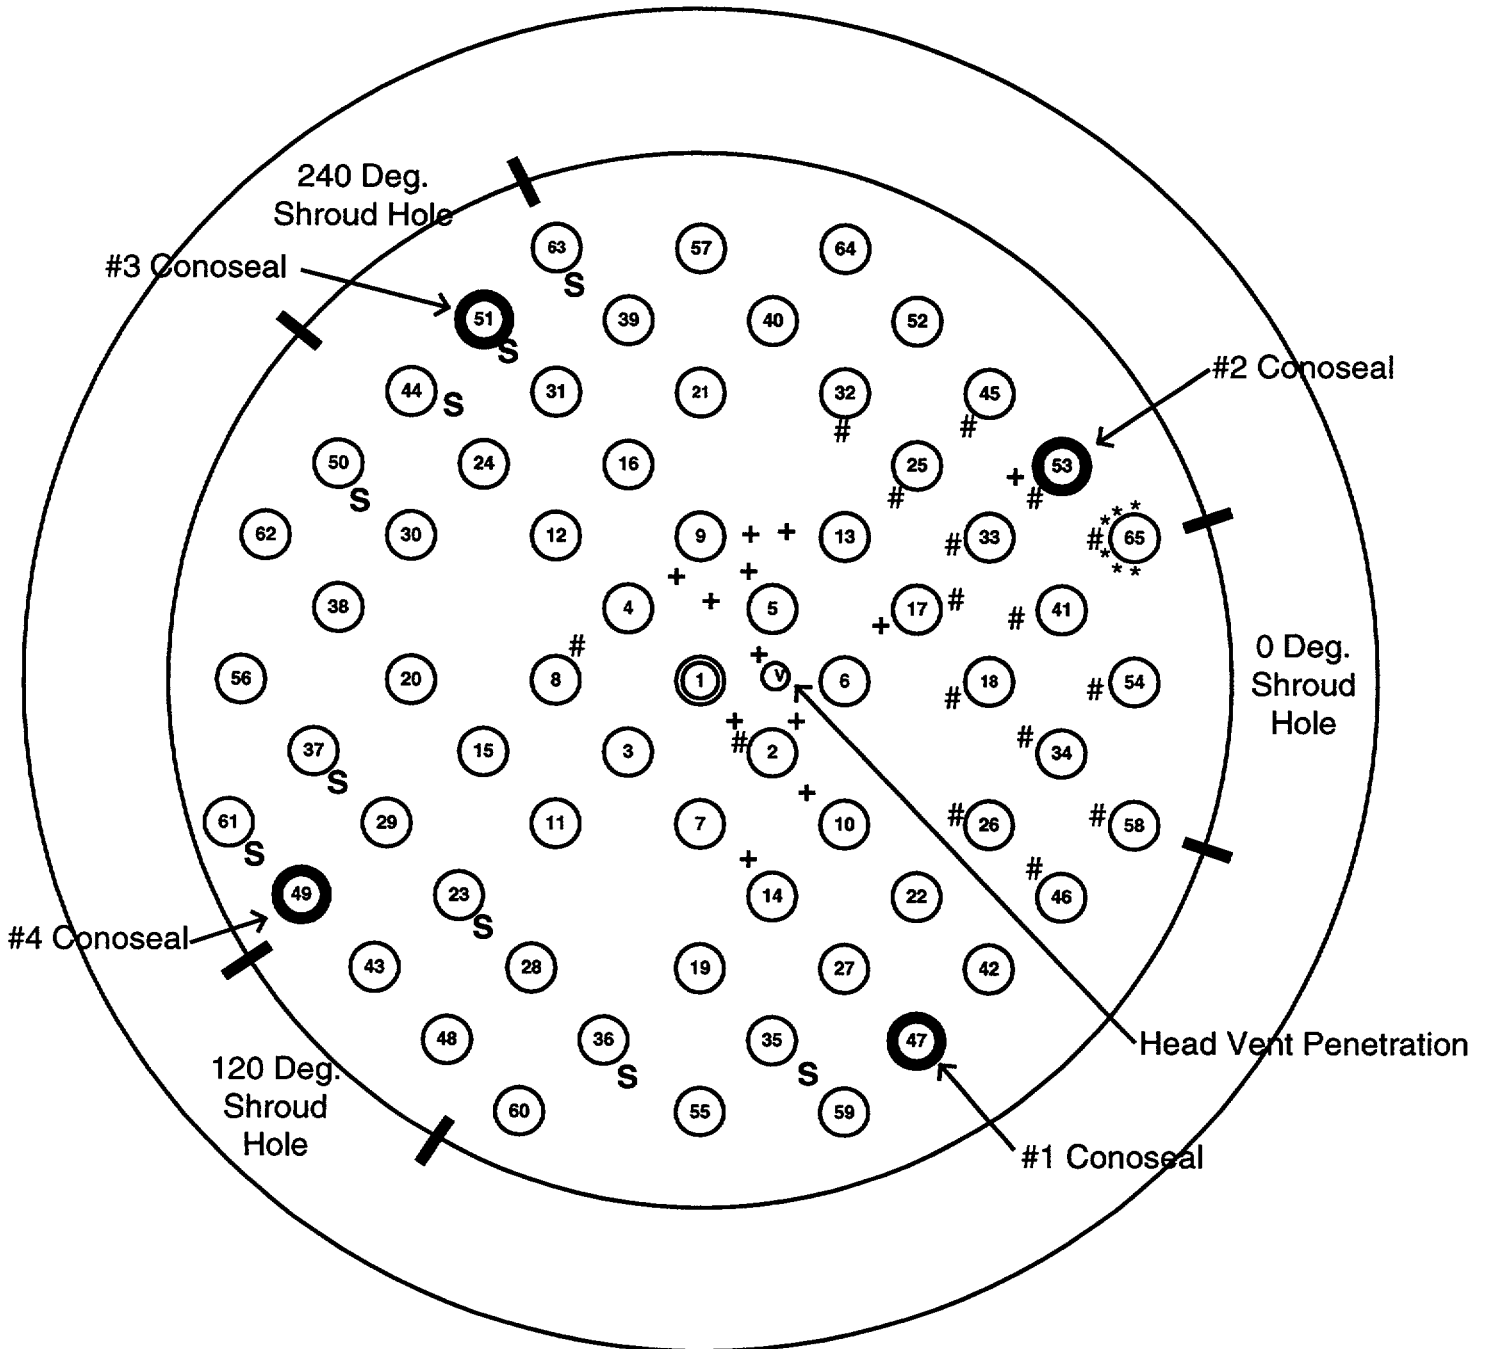
Figure 1
BV- 1 Reactor Vessel Head Map

Based on the visual examinations performed in September 2001 on the Unit 1 reactor vessel head area captured on video, a mapping of the entire head has been performed. The map (Figure 1) includes a legend to denote the various degrees of boric acid residue on the head surface, ranging from a light dusting to larger flakes and debris, as well as photos (Figures 2 through 6) to depict examples of the various conditions present. Figure 7 is provided to illustrate the mirror insulation configuration (plan view). The four conoseal joints identified in Figure 1 as penetrations #47, #53, #51, and #49 are located above the insulation and shroud.

Greater than 90% of the reactor vessel head surface within the shroud periphery has a light dusting of boric acid residue. This dusting is primarily white in color and is generally less than 1/32" in thickness, and is illustrated in Figure (2)

- + = Head surface areas with larger, loose flakes and other debris present. (Figure 3)
- # = Penetrations with loose debris in vicinity of penetration (usually "uphill"). (Figure 4)
- S = Head surface areas with pronounced white stains (Figure 5)
- * = Corrosion adjacent to Penetration # 65 (Figure 6)
