UNITED STATES
NUCLEAR REGULATORY COMMISSION
OFFICE OF NUCLEAR REACTOR REGULATION
WASHINGTON, DC 20555-0001

April 22, 1996

NRC INFORMATION NOTICE 96-23: FIRES IN EMERGENCY DIESEL GENERATOR EXCITERS
DURING OPERATION FOLLOWING UNDETECTED FUSE
BLOWING

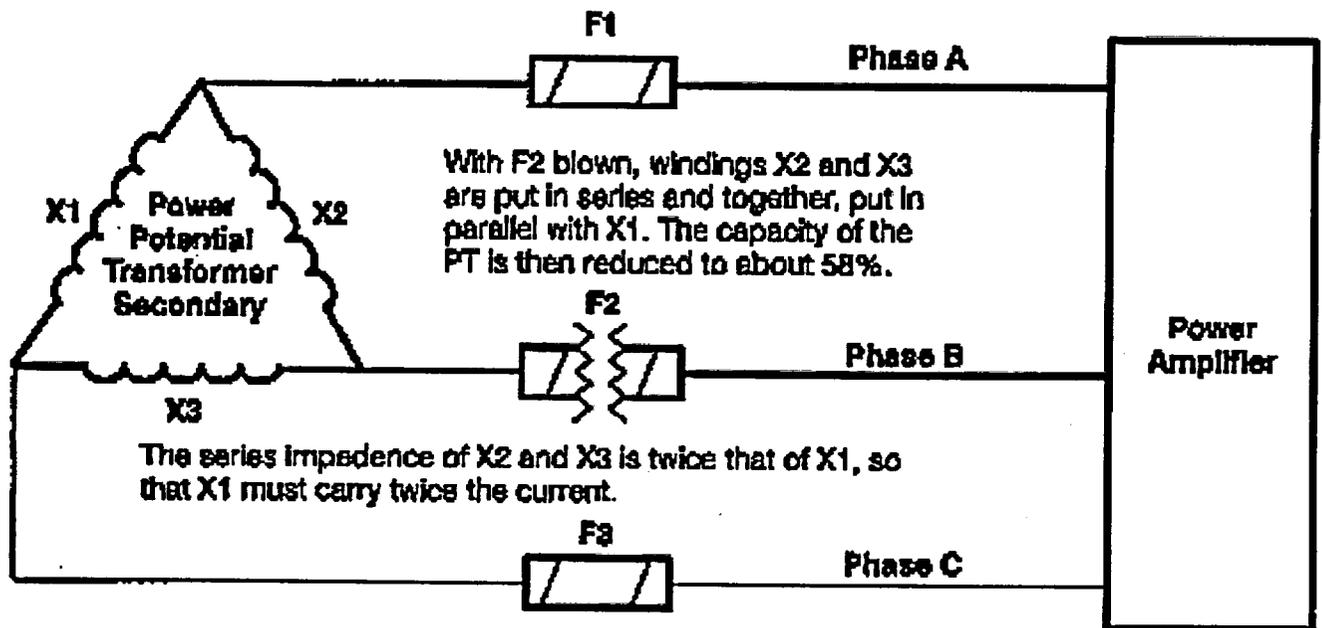
Single-phasing the secondary windings of the delta-connected potential transformers, as a result of the blown fuses, left them at about 58 percent of rated capacity with one phase winding carrying two-thirds of the total load. The other two windings were effectively put in series with each other; together they were now in parallel with the first winding, but with twice the total impedance and hence, only one-third total load. This effect is illustrated in Figure 2 of Attachment 1 to this notice. Subsequent operation with the undetected blown fuse for about 1 hour at or above full load severely overloaded the affected windings. It is expected that prolonged operation at any power level significantly above the reduced capacity of the single-phased potential transformers would eventually cause damage. However, even with the imbalanced load, total excitation current demand from the potential transformer, being within expected limits, was not sufficient to blow either or both of the other two fuses. Operation continued until the overloaded windings overheated and suffered progressive insulation breakdown, internal short circuiting of the windings, and the resultant fire.

Figure 2: Effect on Potential Transformer Secondary Windings of Single-Phasing Due to Blown Fuse

The licensee has installed blown fuse indication on the EDG exciter cabinets. Prior to the installation of the blown fuse indication, the licensee established procedures and trained operators to verify the condition of the potential transformer secondary fuses following all EDG shutdowns, particularly those in which there are indications (such as no exciter shutdown light) that the exciter was not turned off automatically. Procedures and training also covered the conditions under which the exciter shutdown pushbutton is to be actuated and under which the alternate power amplifier is to be selected to maintain operability, e.g., in case an EDG demand signal is received during the fuse verification, or in case a fuse should blow during operation with or without an attendant fault or overload condition.

In other designs, such as newer Basler equipment, underfrequency protection is often available that will independently shut down the exciter upon loss of the prime mover. The licensee has installed volts-per-hertz protection to avoid the conditions in question. However, EDG exciter systems of other designs that remain on, either through a system design flaw or malfunction, after engine mechanical shutdown may behave in a similar manner.
