UNITED STATES  
NUCLEAR REGULATORY COMMISSION  
OFFICE OF NUCLEAR REACTOR REGULATION  
WASHINGTON, D.C. 20555

September 13, 1993

NRC INFORMATION NOTICE 93-71: FIRE AT CHERNOBYL UNIT 2

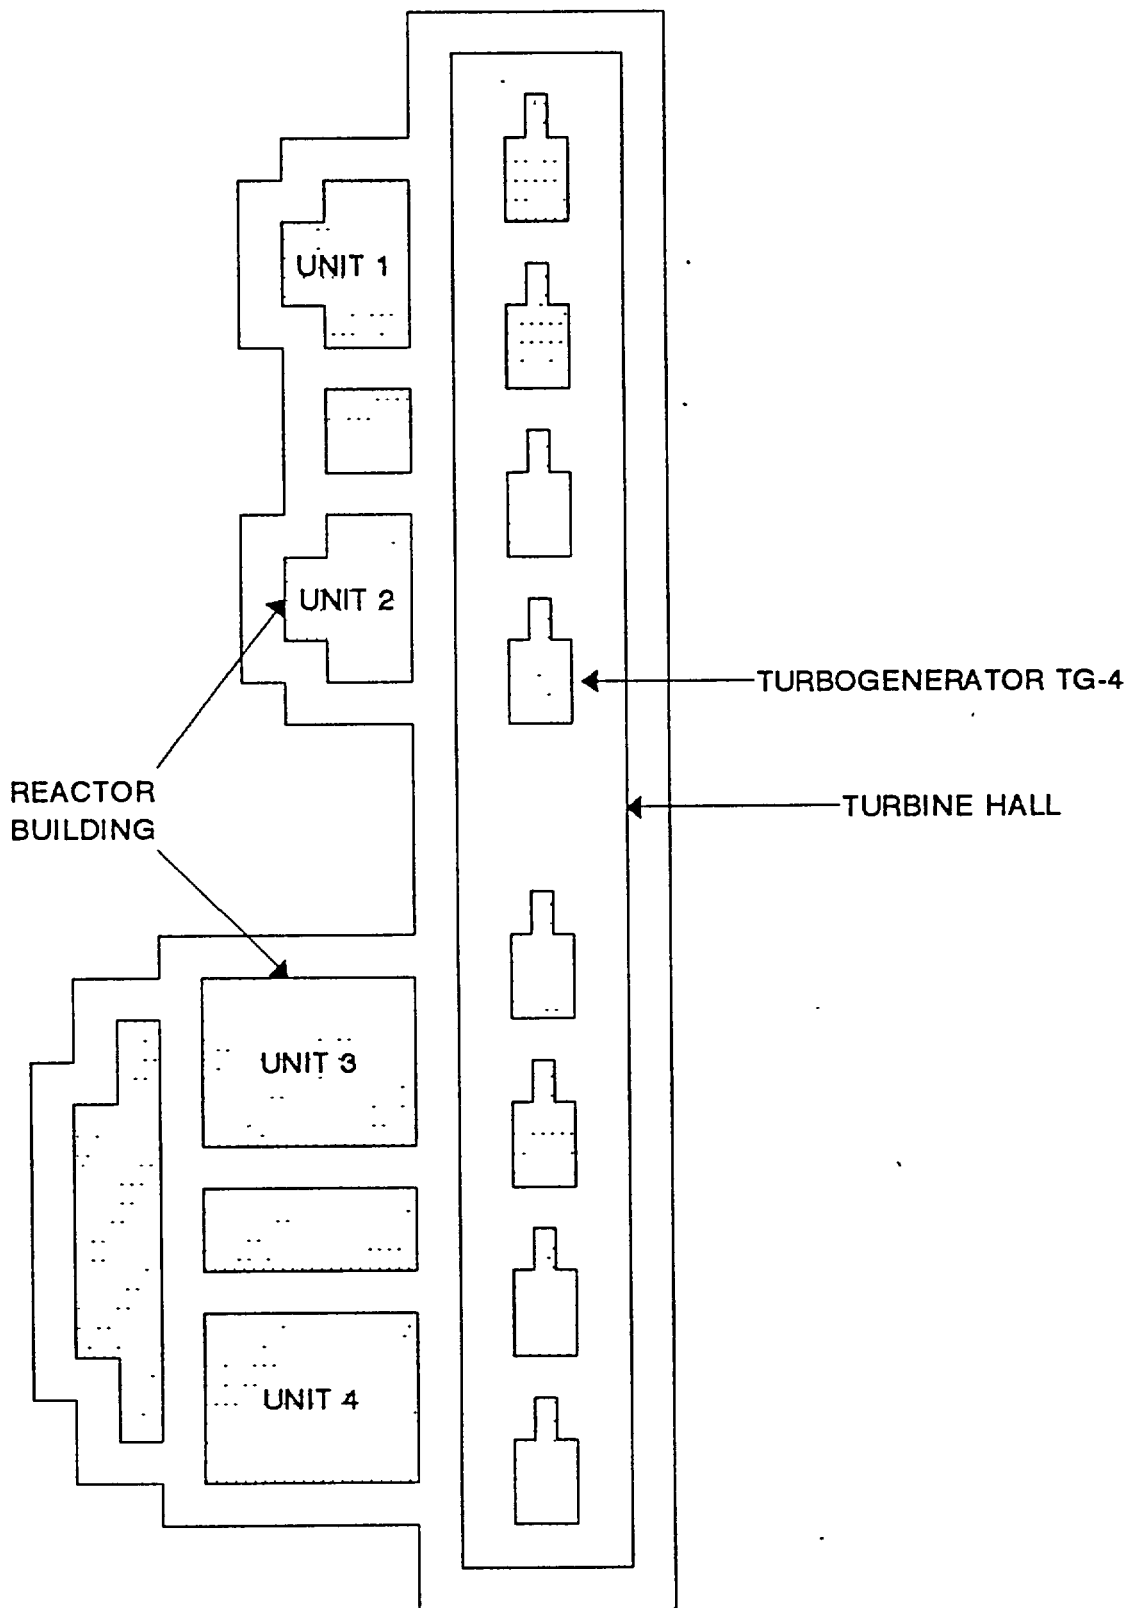
# CHERNOBYL TURBINE HALL LAYOUT

On October 11, 1991, Unit 2 of the Chernobyl Nuclear Power Station was operating at 70-percent power. Each Chernobyl unit has two twin, independent turbogenerators and all four units share a common turbine hall (see Attachment 1). In order to perform minor repairs and adjustments on turbogenerator 4 (TG-4), operators reduced Unit 2 reactor power and isolated the steam supply to TG-4. At 7:46 p.m., the operators switched off the generator excitation field and opened disconnect breakers 1, 2, and 3 in the 330 kV switchyard to electrically isolate TG-4.

Fire fighting efforts focused on containing the fire and preventing it from spreading to adjacent equipment. There was little concern for the turbine hall roof catching fire because the asphalt coating on the roof had been removed after the 1986 accident at Chernobyl Unit 4. However, the local ventilation systems, which were the only method available for heat and smoke removal, were unable to cope with the smoke and heat generated by the fire. The fire brigade was concerned for the structural integrity of the roof because the roof supports had no heat retardant coating and because sprinkler systems in the turbine hall were not designed to cool the structural supports. The fire brigade attempted to cool the supports by spraying them with water from below but were unsuccessful because the plant fire pumps could not provide adequate flow to the area sprinkler systems and the local fire-fighting efforts at the same time. The metal trusses of the roof structure reached a temperature greater than 900°C [1650°F] and collapsed at 8:35 p.m.

A 50 meter by 50 meter [165 feet by 165 feet] section of the roof collapsed onto the turbine deck and also onto an adjacent pit that contained the main feedwater pumps, the auxiliary feedwater pumps and their associated control cabinets. Damage to the pump systems and a fire in one control cabinet disrupted makeup water flow to the reactor cooling system. The operators cut the electrical power to the pump motors and the control cabinets to remove them as a potential ignition source. Because of the significant amount of damage, the operators believed that the main feedwater and auxiliary feedwater pumps could not be readily restored. Therefore, the operators added water to the reactor primary coolant circuit by opening the steam relief valves to reduce pressure and aligning a low-pressure nonsafety-grade condensate pump to the auxiliary feedwater system piping. This arrangement made controlling the steam separator drum water levels difficult but allowed the operators to provide core cooling throughout the event. The fire was extinguished by 11:30 p.m.
