**Bottom Mounted Instrument  
Penetration Tube Condition Update**

6/5/03

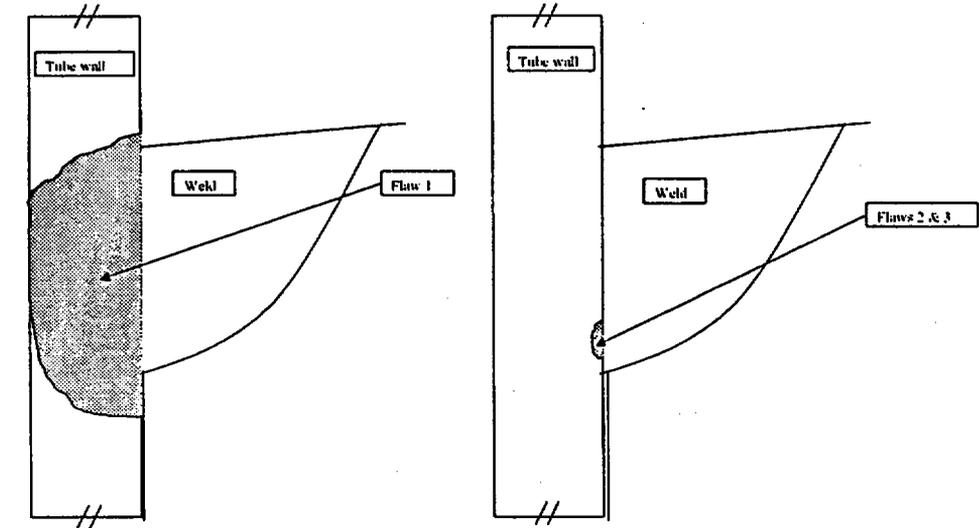
# Penetration #1

- Penetration #1
  - Three axial indications, one leak path
  - No crack-like indications on J-Groove weld
  - Visual grinding marks in side of tube
- Penetration #46
  - Two axial indications, one leak path
  - No crack-like indications on J-Groove weld

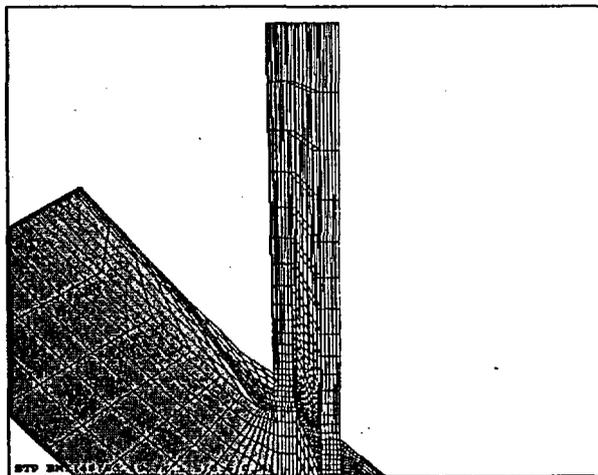
## Analysis Shows Minimal Displacement During Welding

Coldworking is not a significant contributing factor
