SEQUOYAH NUCLEAR PLANT (SQN) UNIT 2, NRC BULLETIN 2003-02,
"LEAKAGE FROM REACTOR PRESSURE VESSEL LOWER HEAD
PENETRATIONS AND REACTOR COOLANT PRESSURE BOUNDARY
INTEGRITY," (TAC No. MC0564) AND NRC ORDER EA-03-009 -
INTERIM INSPECTION REQUIREMENTS FOR REACTOR PRESSURE VESSEL
HEADS AT PRESSURIZED WATER REACTORS

Reactor Pressure Vessel (RPV)
Lower Head Examination Results
(Excerpts from Report No. BOP-2448)

REACTOR PRESSURE VESSEL LOWER HEAD

REMOTE VISUAL (VT-2) BIM PENETRATION EXAMINATION

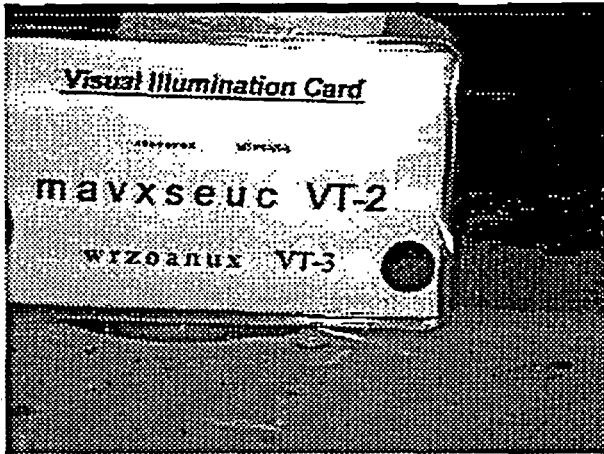
Figure 1
Resolution check @ 14"

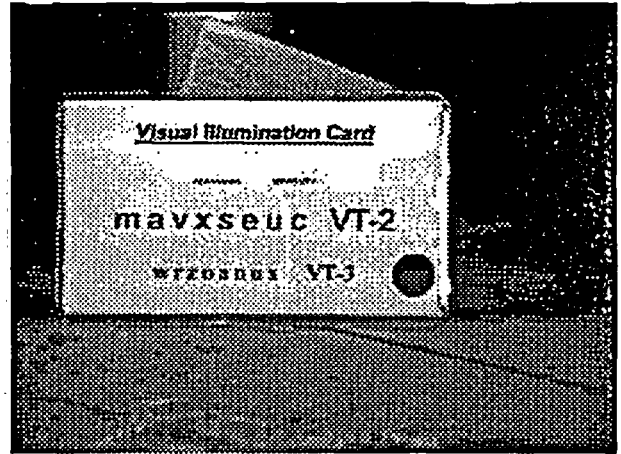
Figure 2
Resolution check @ 38"

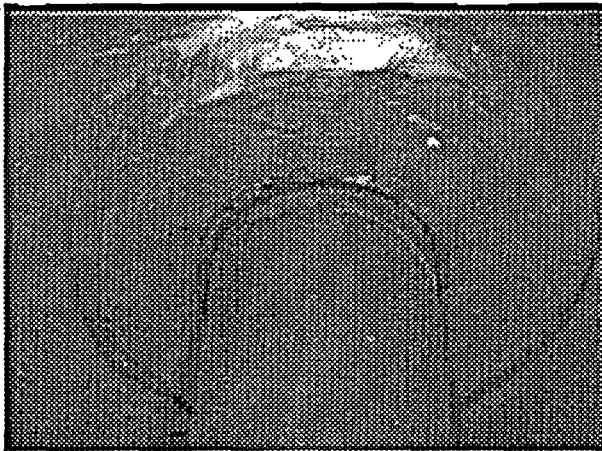
The overall condition of the bare head surface was very clean, with minimal coating degradation. The surface of the head and the instrumentation tubing exhibited markings consistent with construction activities. Ref: Section 3: Figure No's: 3 through 12

Figure 3 – BMI No. 25
General Condition

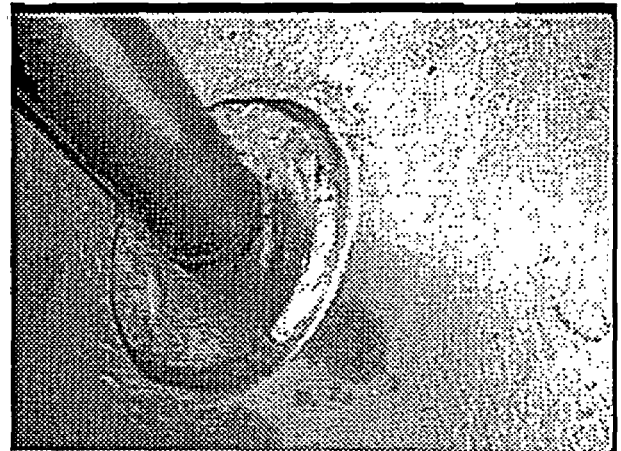
Figure 4 – BMI 26
General Condition

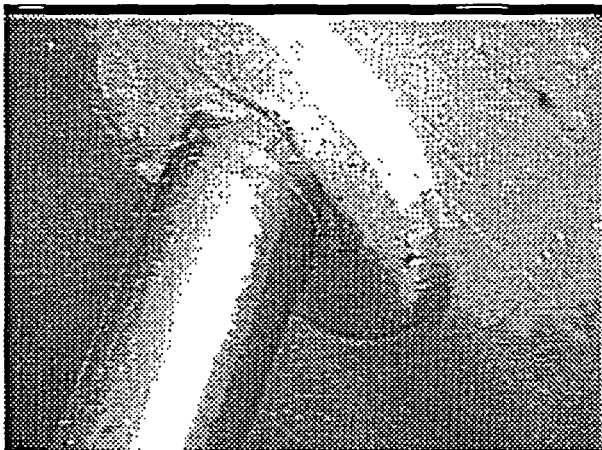
Figure 5 – BMI 26
General Condition

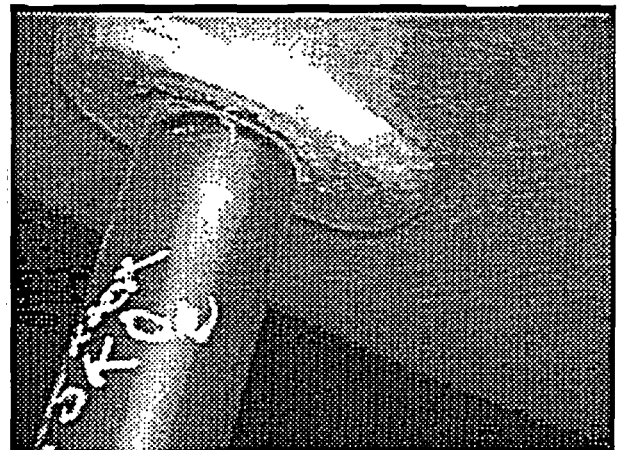
Figure 6 – BMI 33
General Condition

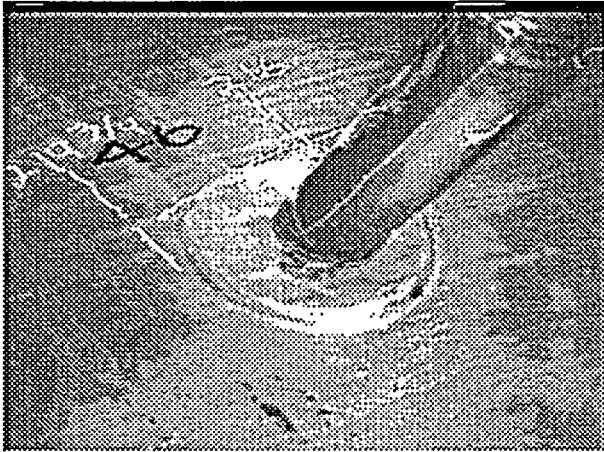
Figure 7 – BMI 46
General Condition

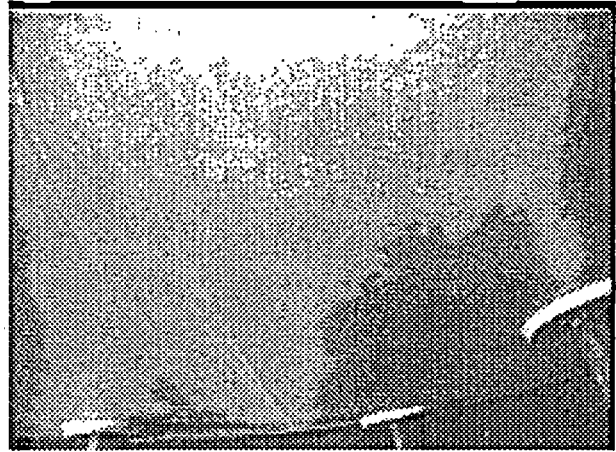
Figure 8
General Lower Head Surface Condition

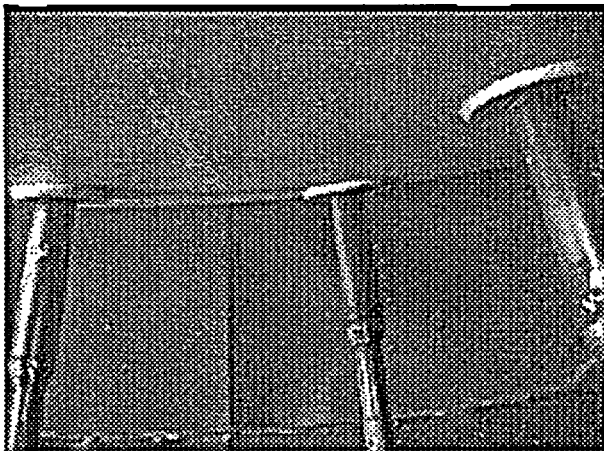
Figure 9
General Lower Head Surface Condition

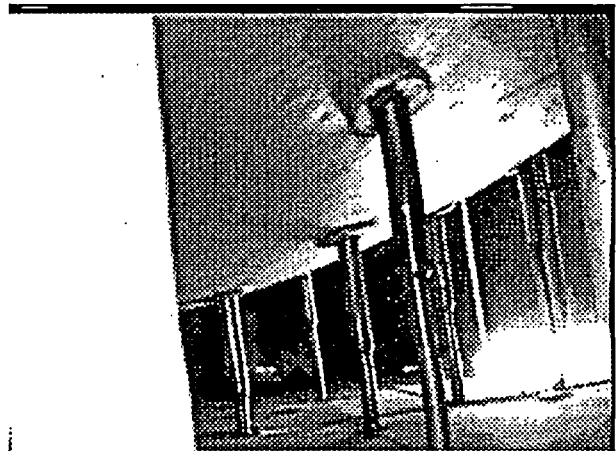
Figure 10
General Lower Head Surface Condition

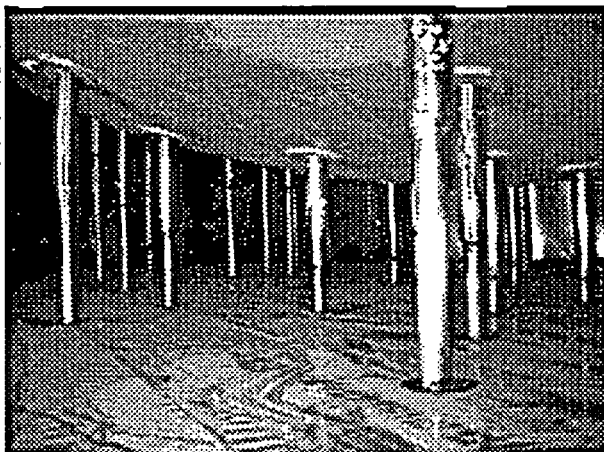
Figure 11
General Lower Head Surface Condition

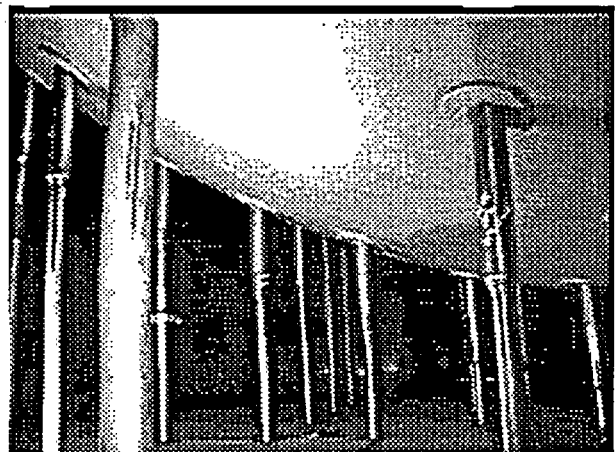
Figure 12
General Lower Head Surface Condition

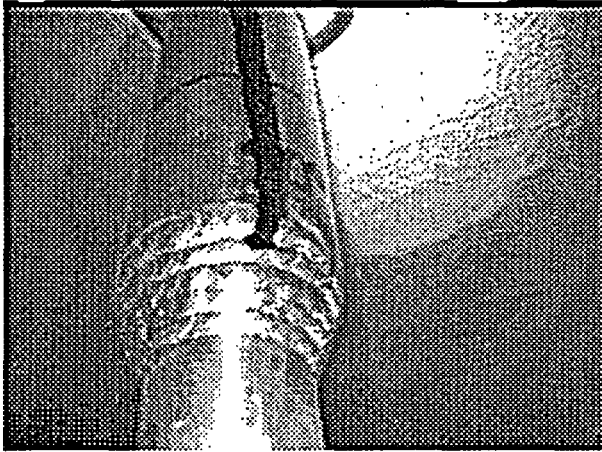
A dark stain was observed on 25 instrument tubes that originated approximately 1"-2" below the penetration (reference Section 3, Figure No's: 13-16). This condition was reported to site Engineering for evaluation and PER No. 03-016523-000 was generated to document the condition.

Figure 13 – BMI 23
General View of Black Coating/Stain

Discussions with site personnel involved in the construction phase of SQN have led to the determination that the substance described as dark and "tar-like" is most likely residue from flagging tape (non-adhesive) used for identification purposes. The flagging was not removed prior to startup and has consequently melted and adhered to the surface of the guide tubes.

Stress corrosion cracking of the BMI's is not believed to be an issue due to the residual material from the flagging material based on the above evaluation. In order to further substantiate this determination, a liquid penetrant examination using the fluorescent water washable method (N-PT-7) has been performed on three guide tubes (#26, #30, and #46). No recordable indications were identified during the non-destructive examination. Final disposition of this issue is documented in PER 03-16523.

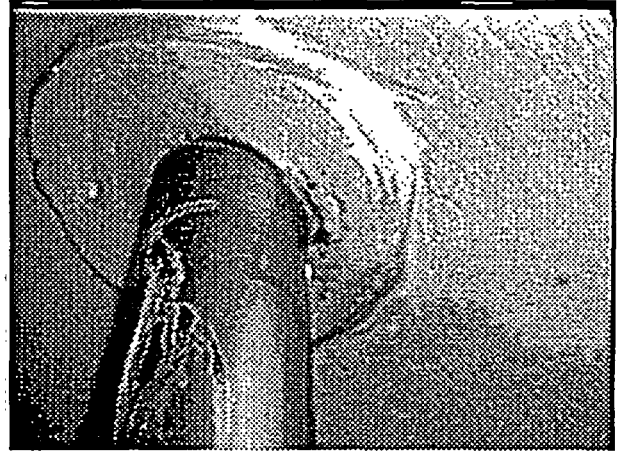
Figure 14 – BMI 24
General View of Black Coating/Stain

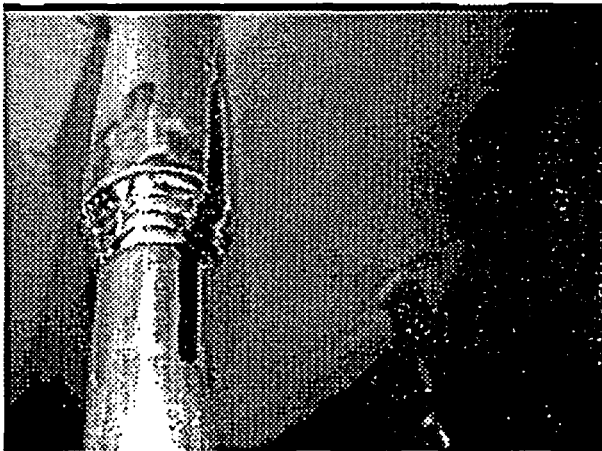
Figure 15 – BMI 24
General View of Black Coating/Stain

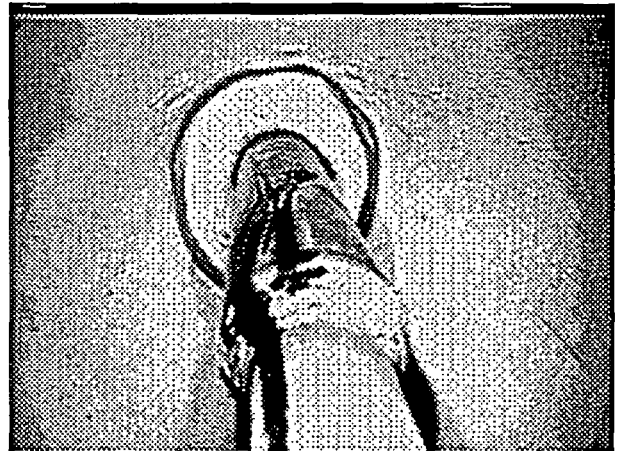
Figure 16 – BMI 25
General View of Black Coating/Stain
