7. FENOC/Davis-Besse Response to CRDM Cracking and Boric Acid Corrosion Issues

7.1 Davis-Besse Actions and Responses to Key US NRC and Industry Initiatives

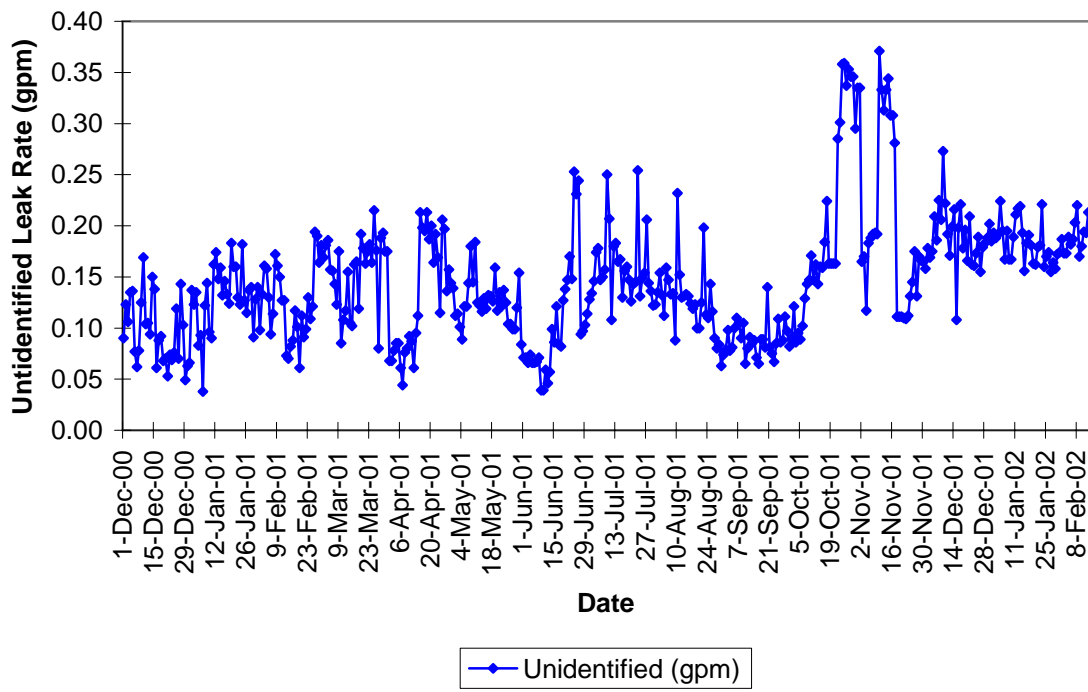
Figure 7.1 Daily average unidentified leak rate for Davis-Besse Cycle 13.⁶⁷

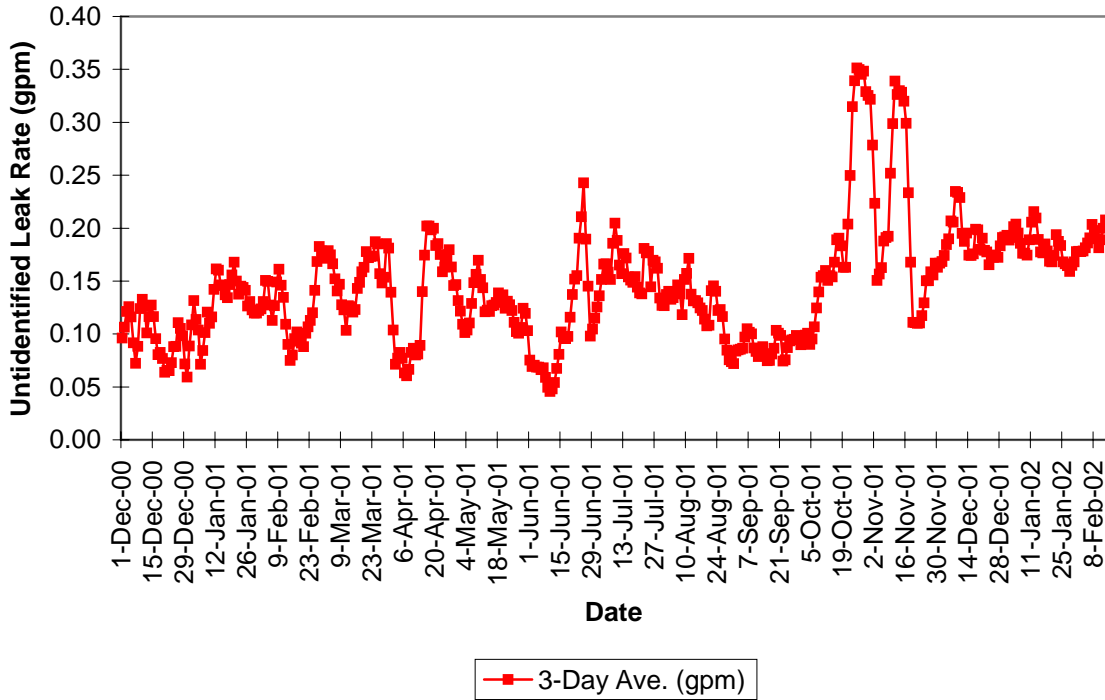
Figure 7.2 Three-day average unidentified leak rate for Davis-Besse Cycle 13.⁶⁷

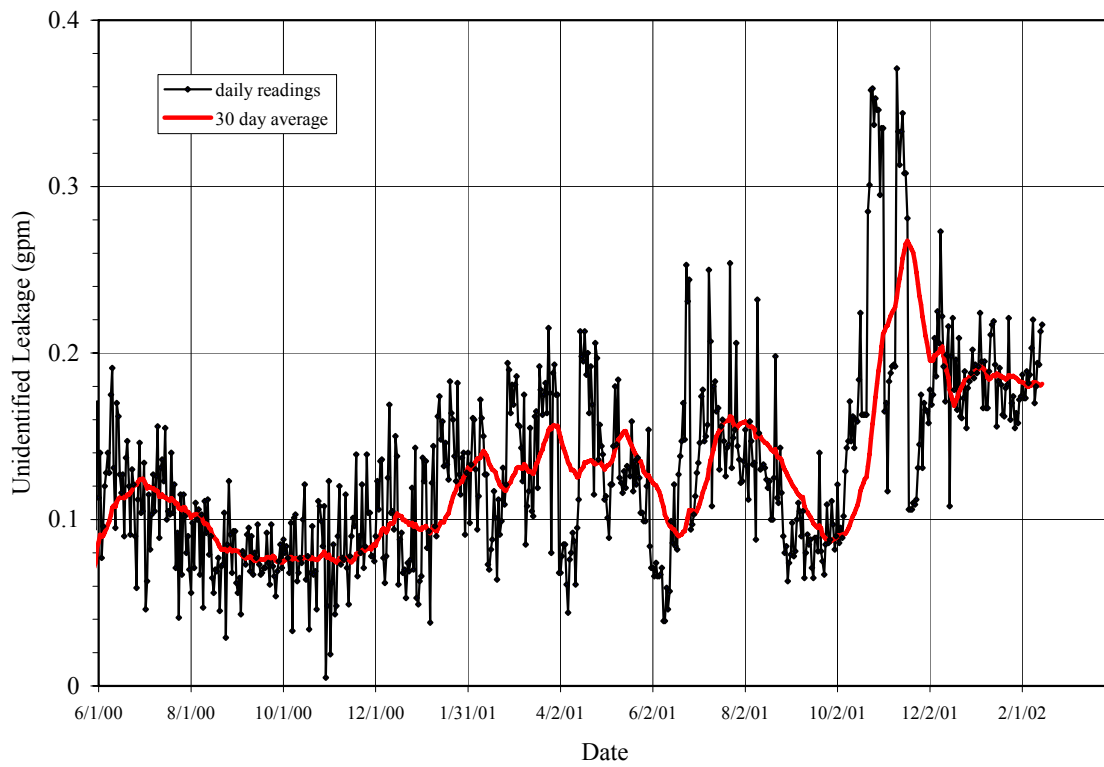
Figure 7.3 Thirty-day average unidentified leak rate for Davis-Besse Cycle 13.⁶⁸

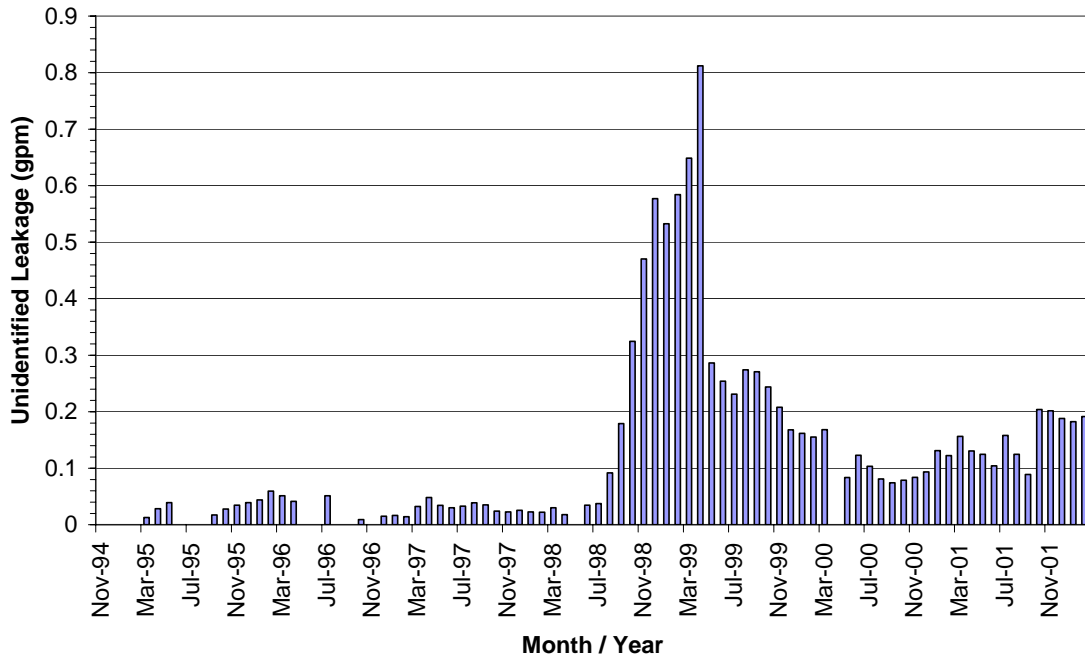
unidentified leak rates, as shown in Figure 7.4 for Cycles 10-13,⁶⁹ further reduces the ability to evaluate shorter term fluctuations in the unidentified leak rate.

Figure 7.4 Monthly average unidentified leak rate for Davis-Besse Cycles 10 through 13.⁶⁹

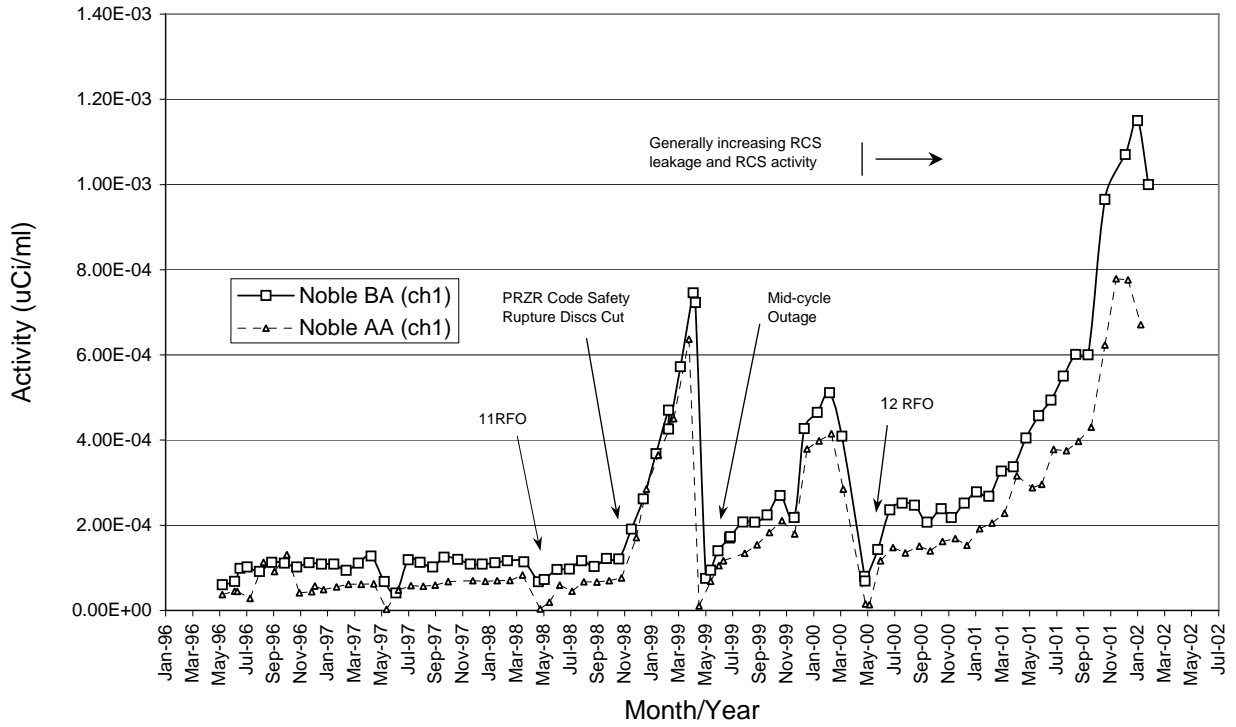
Figure 7.6 Noble gas activity for Cycles 10-13 for radiation monitors RE 4597AA and RE 4597BA.⁷¹

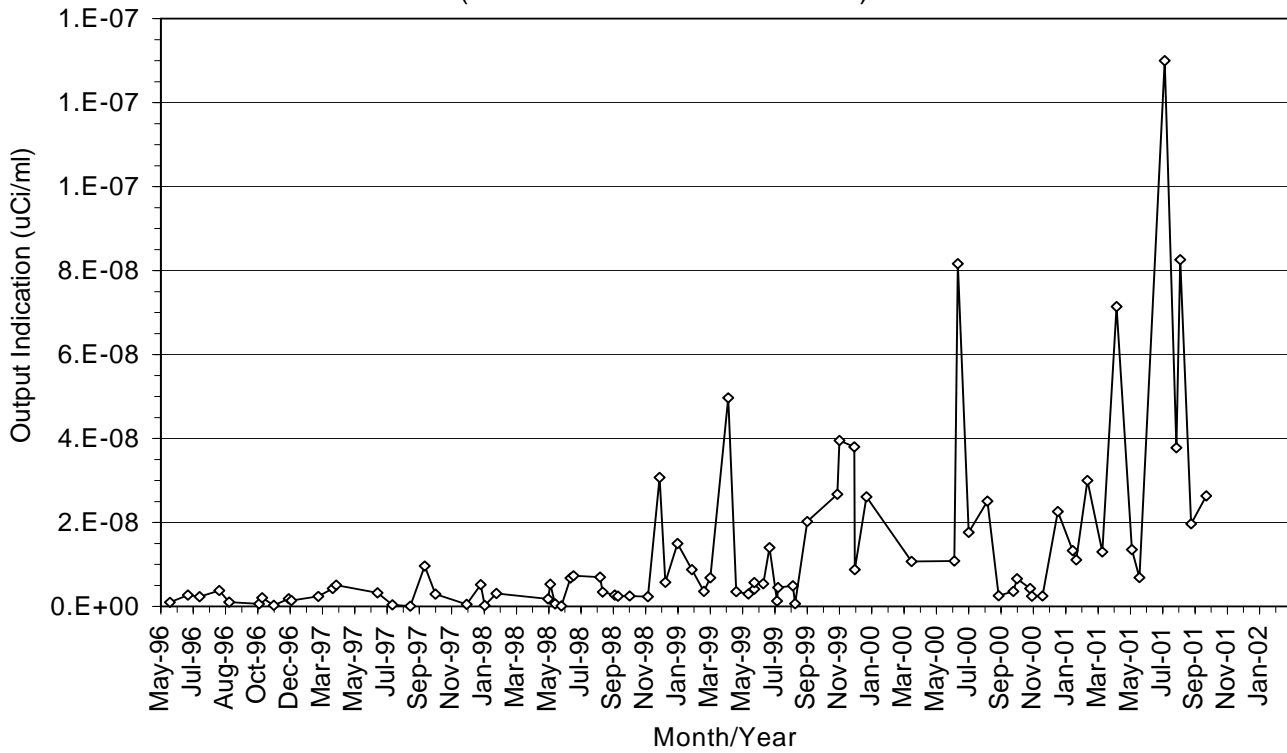
Figure 7.7 Iodine activity for Cycles 10-13 for radiation monitors RE 4597AA and RE 4597BA.⁷³

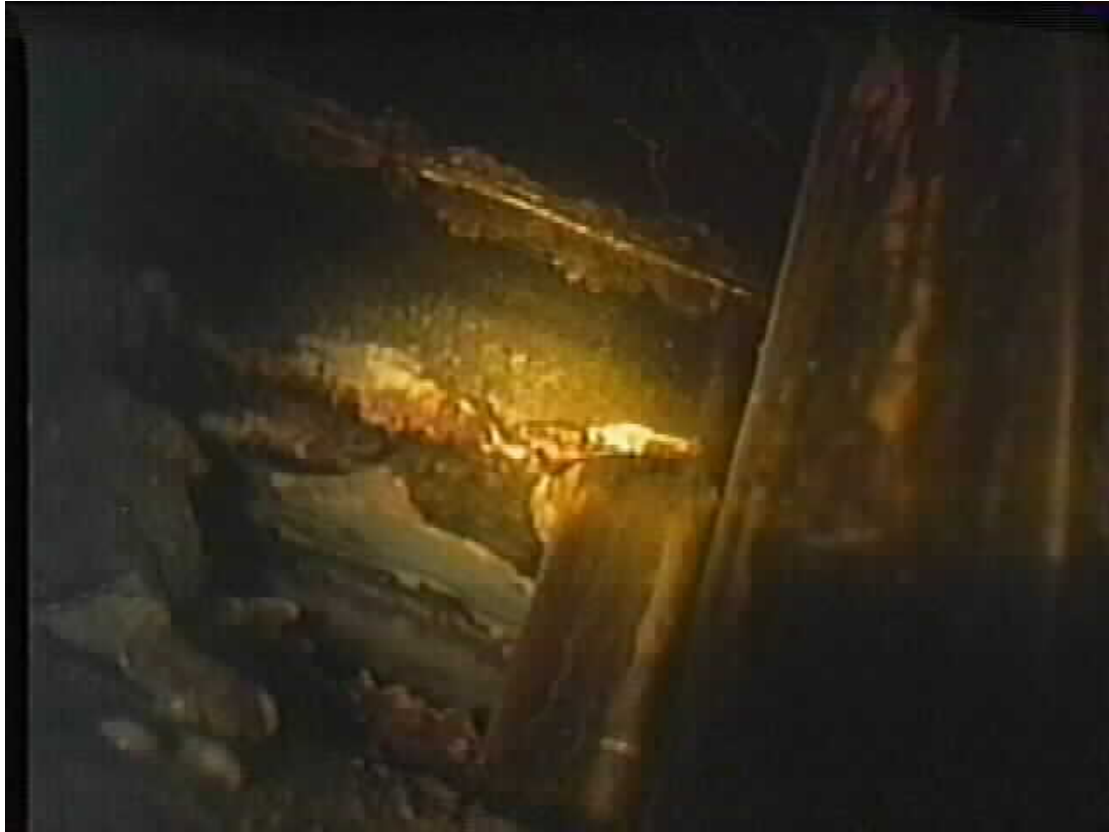
Figure 7.8 Flange Leakage Showing Boric Acid Deposits Leaking Through the Mirror Insulation at 8RFO.⁸¹

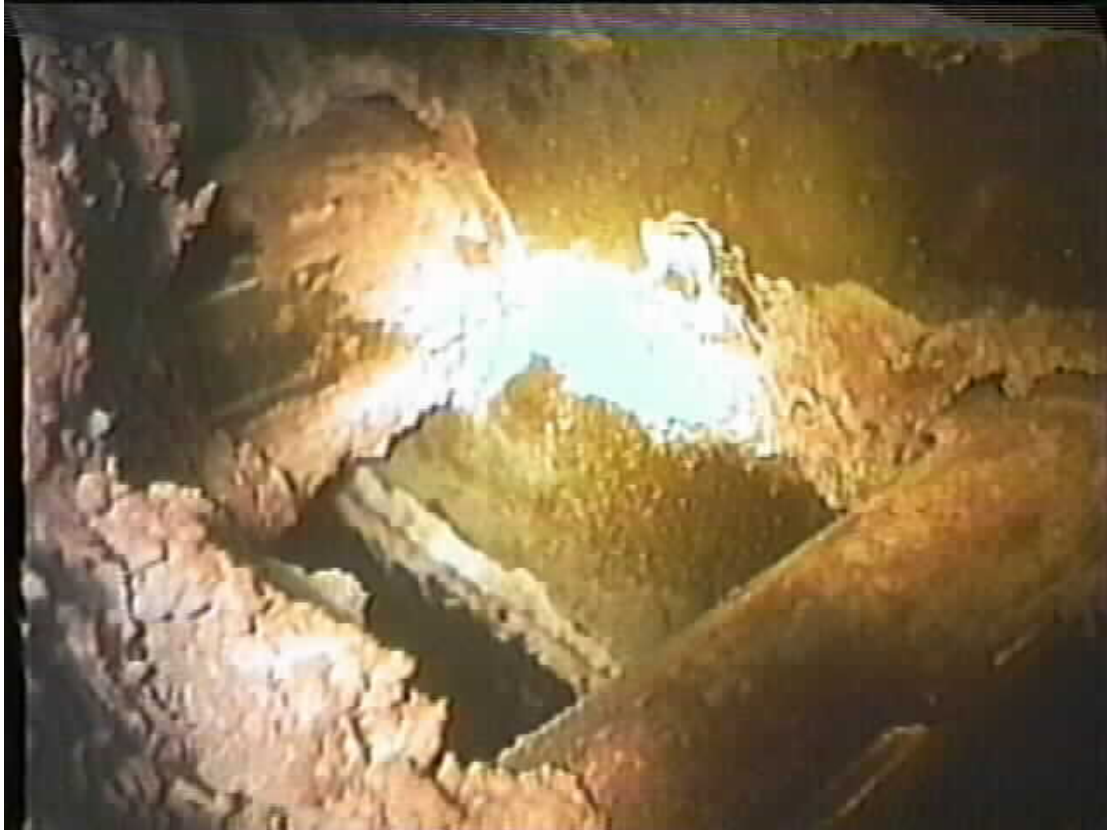
Figure 7.9 Flange Leakage Showing Boric Acid Deposits On Side of Nozzles and Stalactites from Gaps in Insulation (8RFO).⁸¹

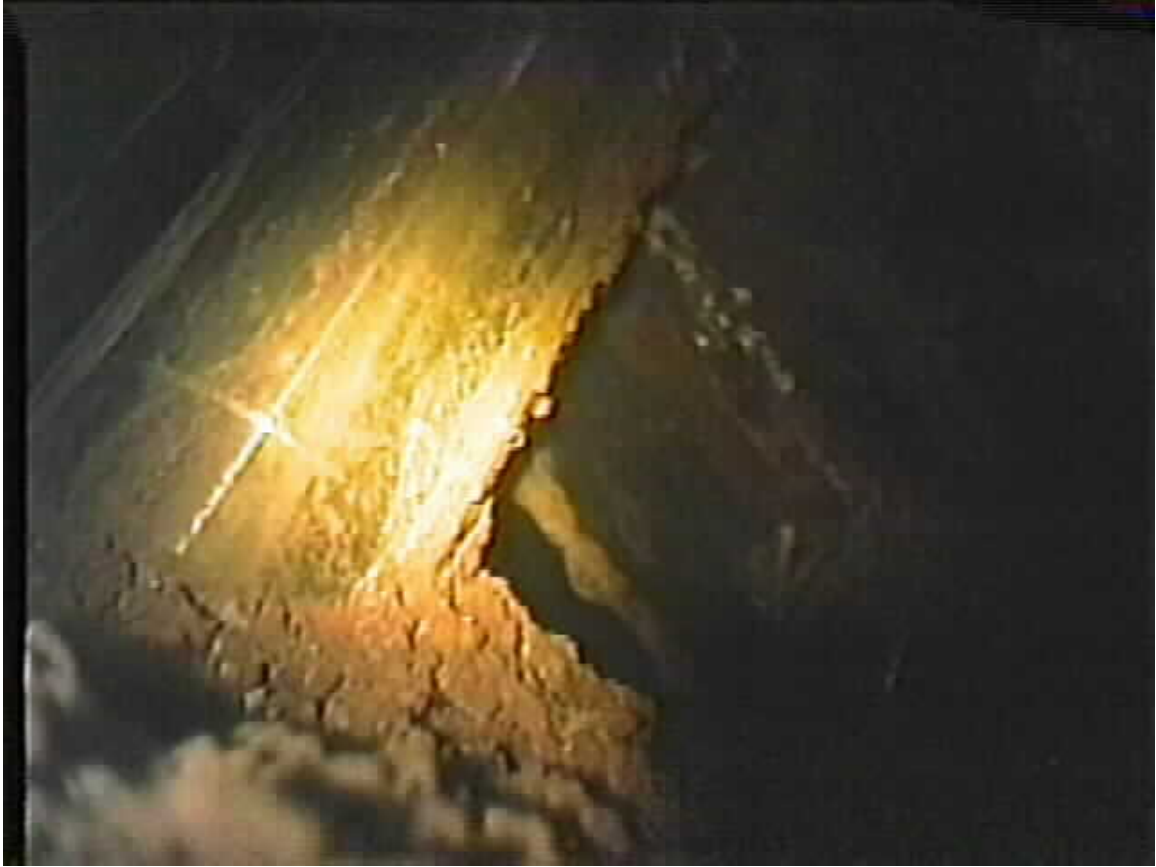
Figure 7.10 Reddish Brown Boron Deposits Crusted on Side of Nozzle (8RFO)⁸²

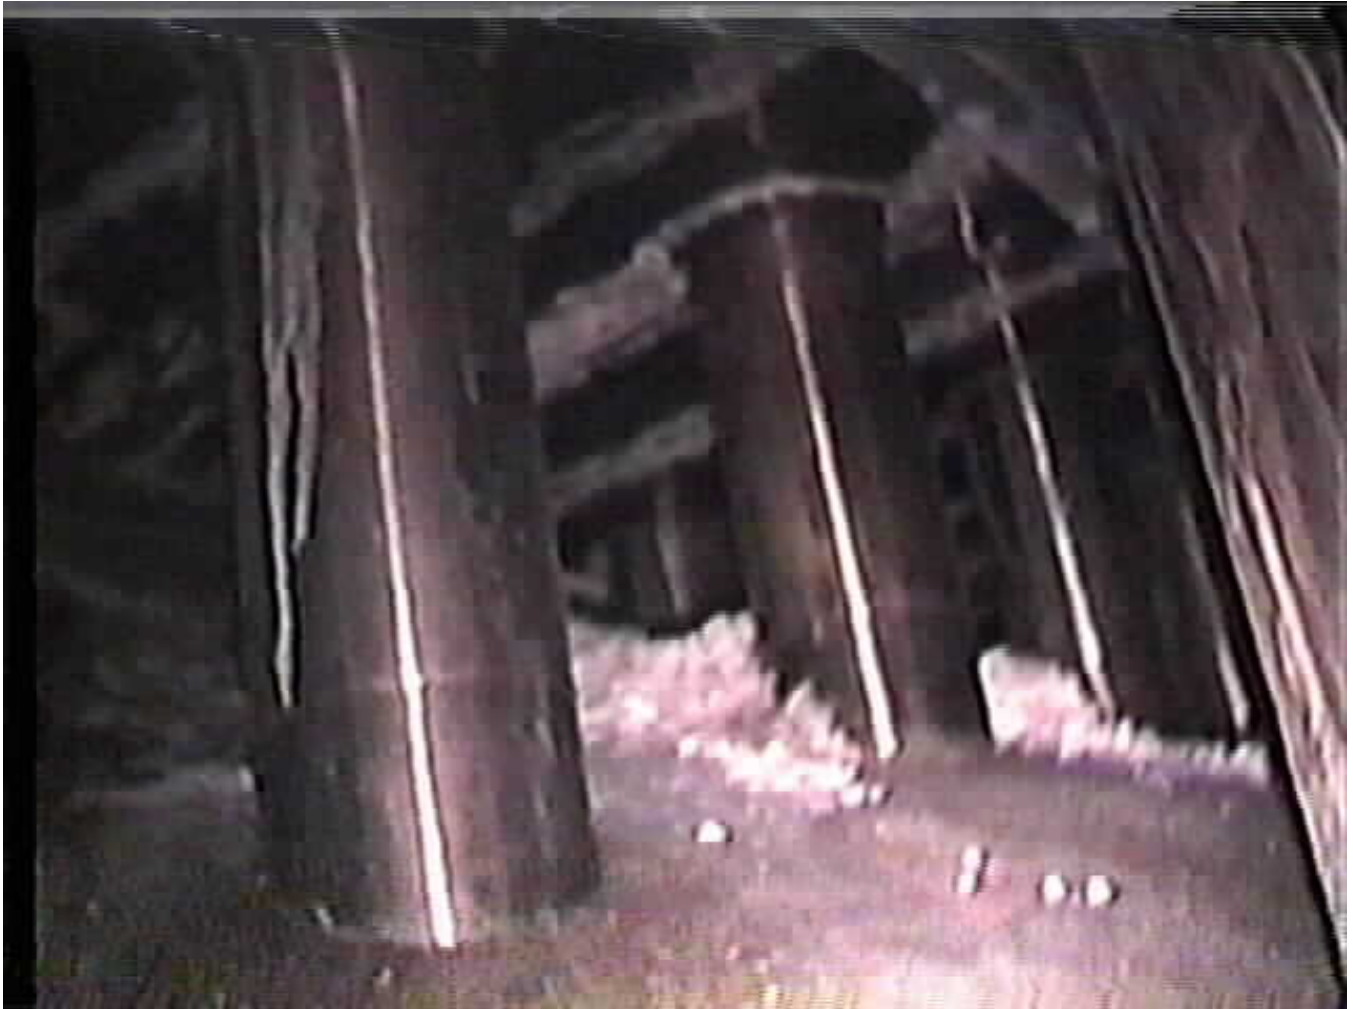
Figure 7.11 Boric Acid Deposits Behind the CRDM Nozzles on the North Side of the Reactor Pressure Vessel Head at 10RFO.⁸⁶

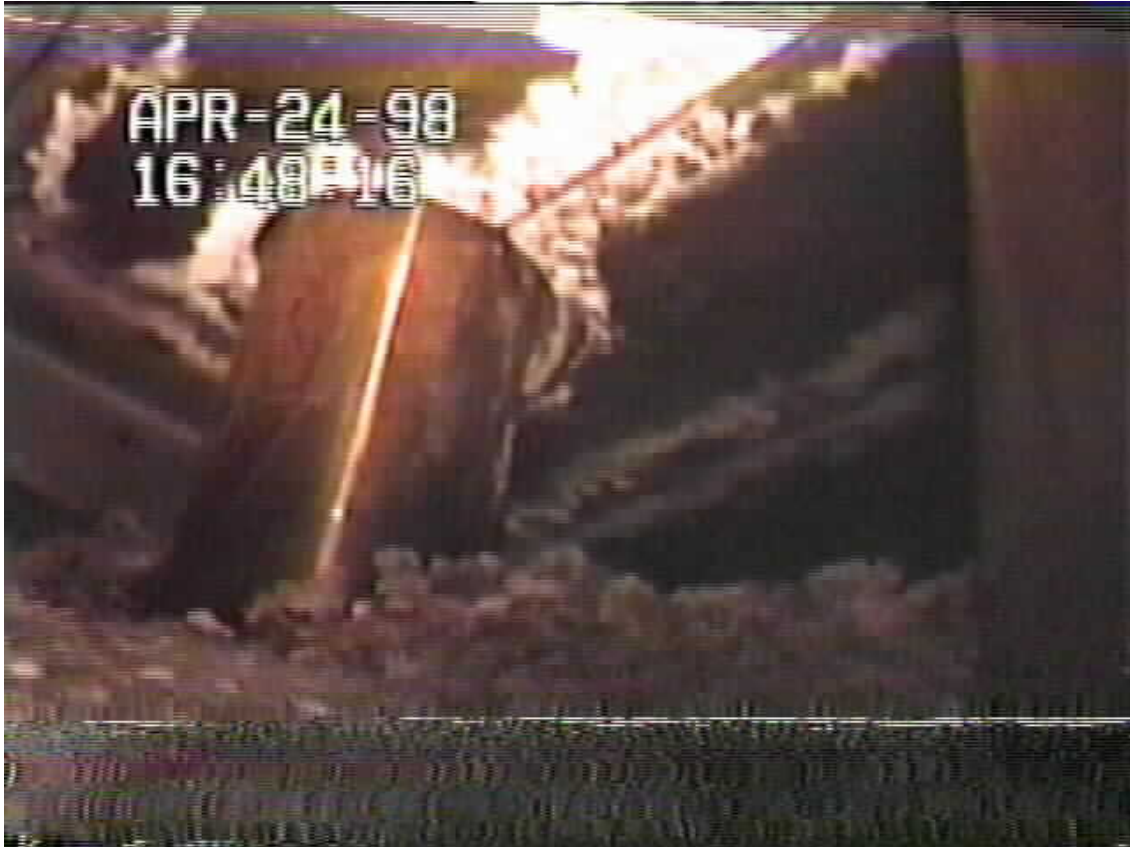
Figure 7.12 Boron Piled on Reactor Pressure Vessel Head Under the Mirror Insulation Near Nozzle 31 (11RFO).⁸⁹

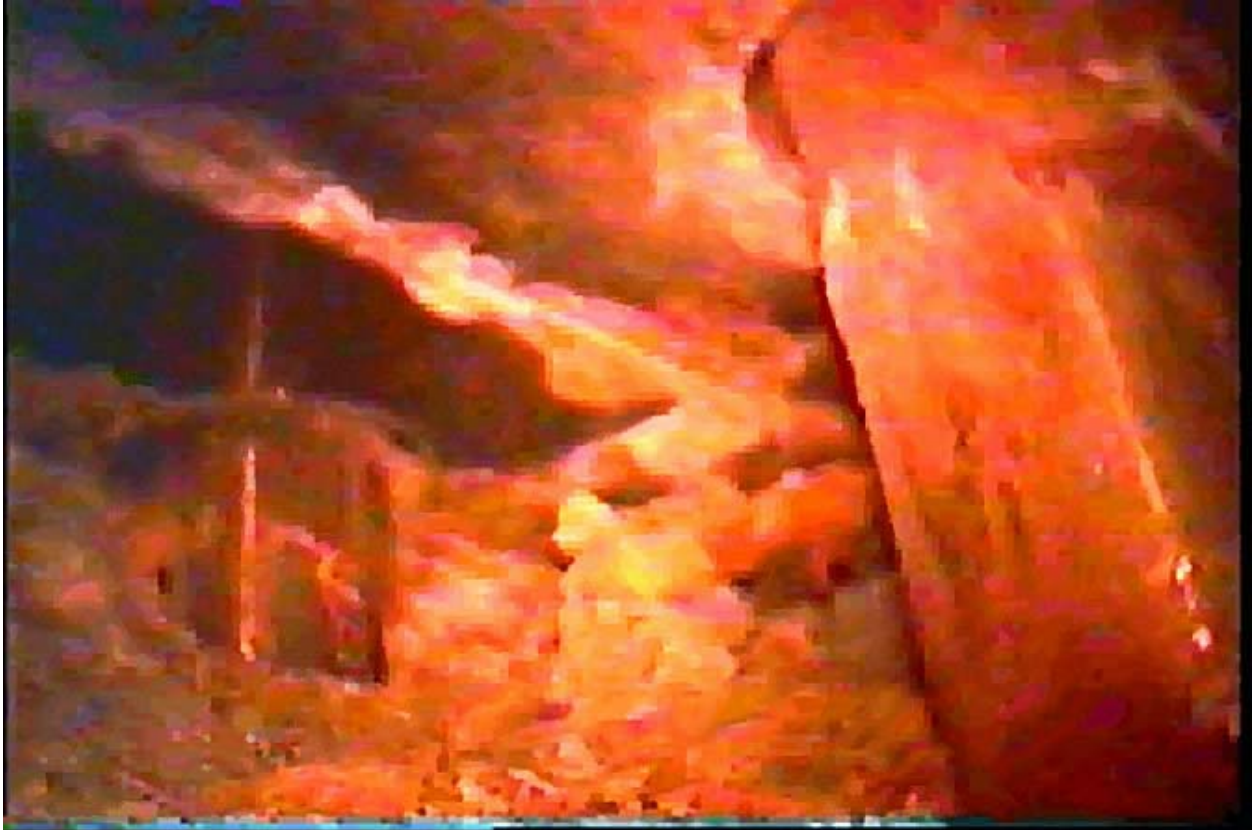
Figure 7.13 Boron Piled Up to the Mirror Insulation Near the Center of the RPV Head (12RFO).⁹⁹

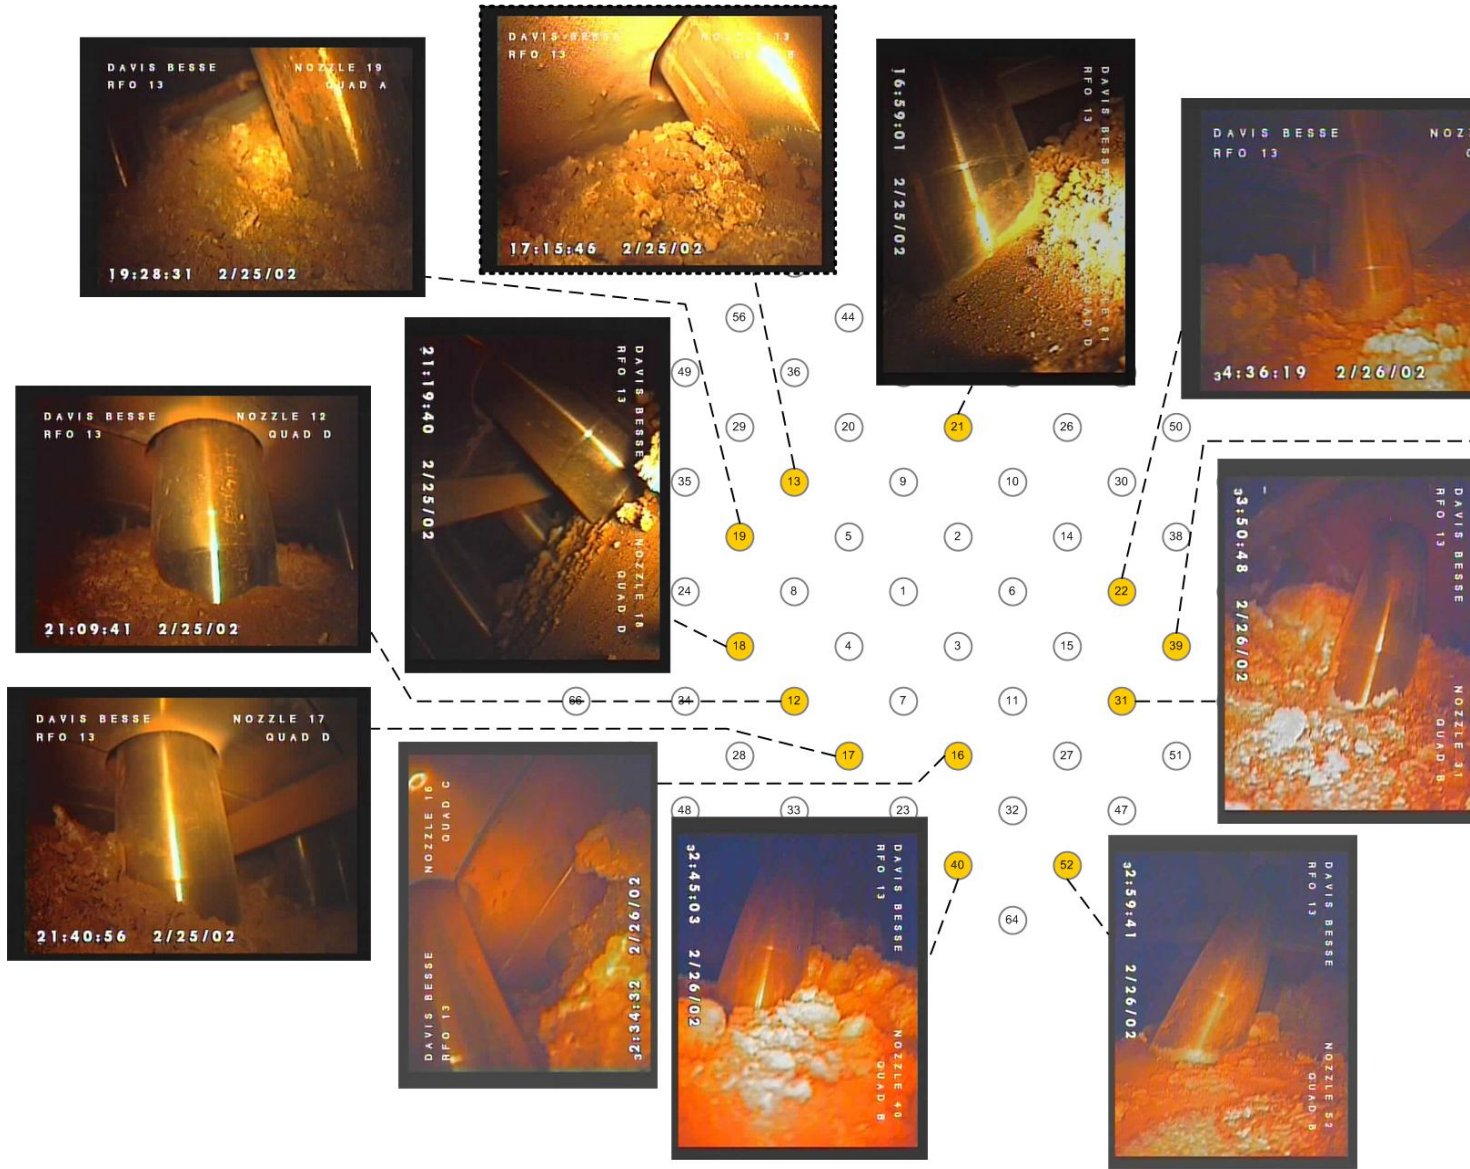
Figure 7.14 Boric Acid Deposits on RPV Head at 13 RFO. Note this is Figure 24 from the Root Cause Report.¹⁰⁴

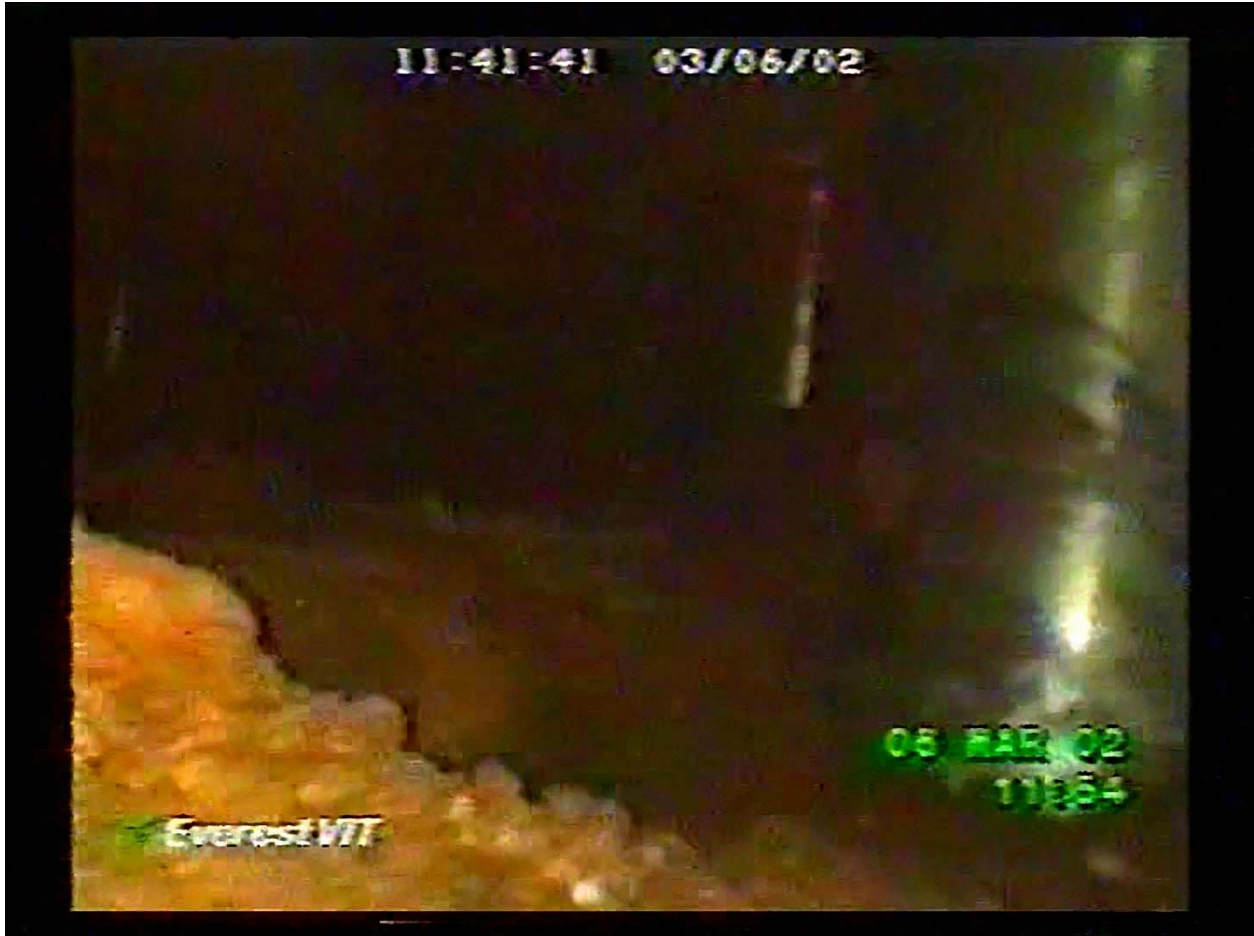
Figure 7.16 Corrosion Product/Boric Acid Deposits Adjacent to Nozzle 3 (270 Degree Side) after Hydrolasing.¹⁰⁶
