10. The Unique Nature of the Davis-Besse Nozzle 3 Crack and the RPV Head Wastage Cavity

10.1 Wastage Cavities at Nozzles 3 and 2

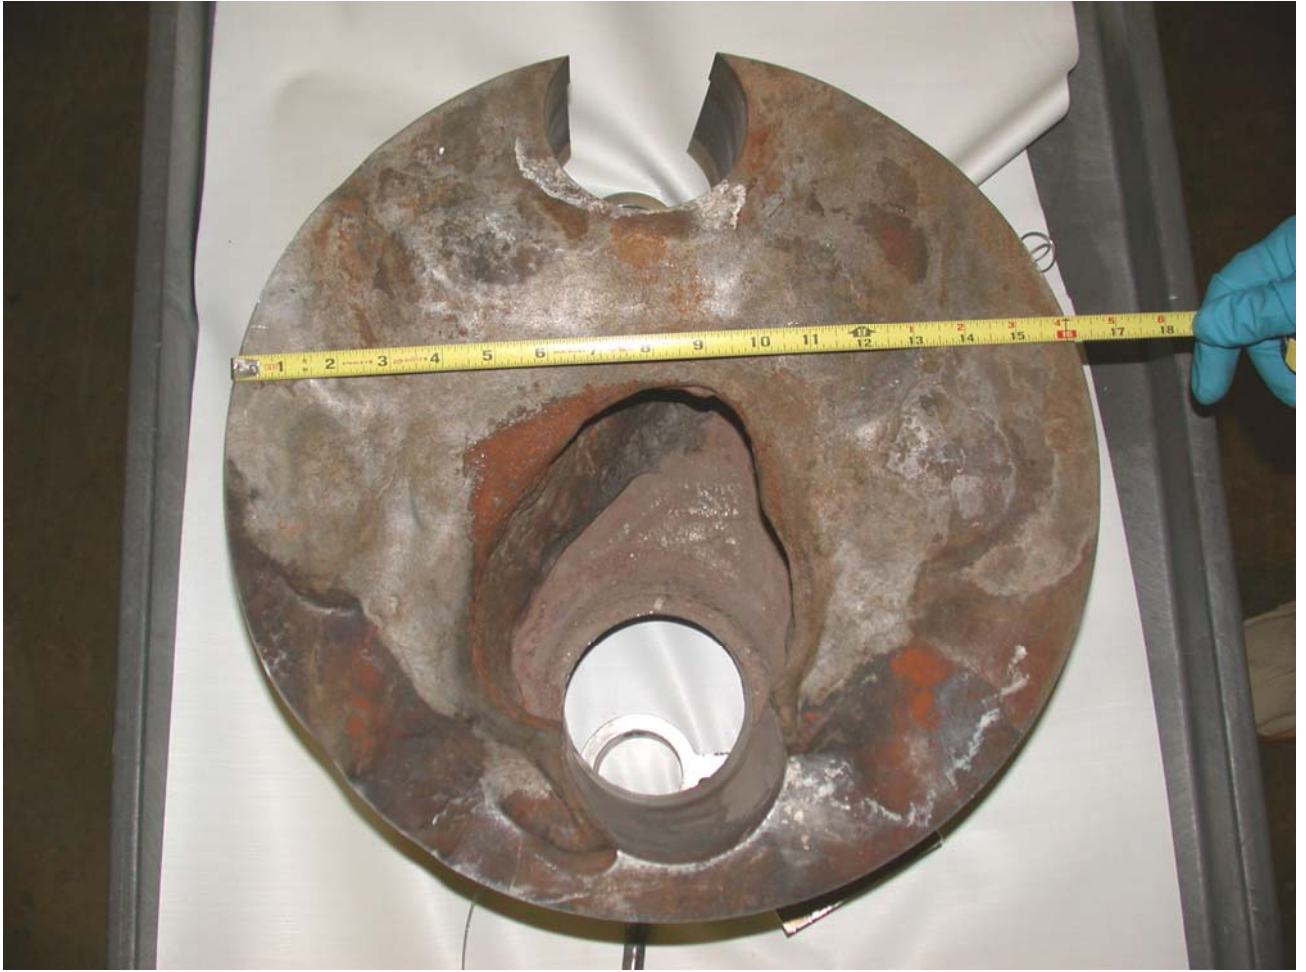
- The cavity extends down to the upper surface of the stainless steel cladding, exposing both the cladding and the J-groove weld.
- The cavity extends approximately 8 inches towards nozzle 11, is a maximum of approximately 4 inches in lateral dimension, and extends back to approximately the 90° and 270° points on the nozzle bore.
- The total volume of alloy steel removed was approximately 195 cubic inches.

- The cavity morphology is indicative of a combination of processes, including mechanical removal by impingement of high velocity fluid, flow assisted corrosion, and boric acid corrosion.

- The corrosion process is clearly more dominant in the upper region of the cavity. There is clear evidence of mechanical removal and/or flow-assisted corrosion in the lower region, where the wastage cavity is clearly undercut. This lower undercut region is indicative of a more rapid metal removal process than at the mid-elevation point of the cavity.

Figure 10.1 Top view of wastage cavity.

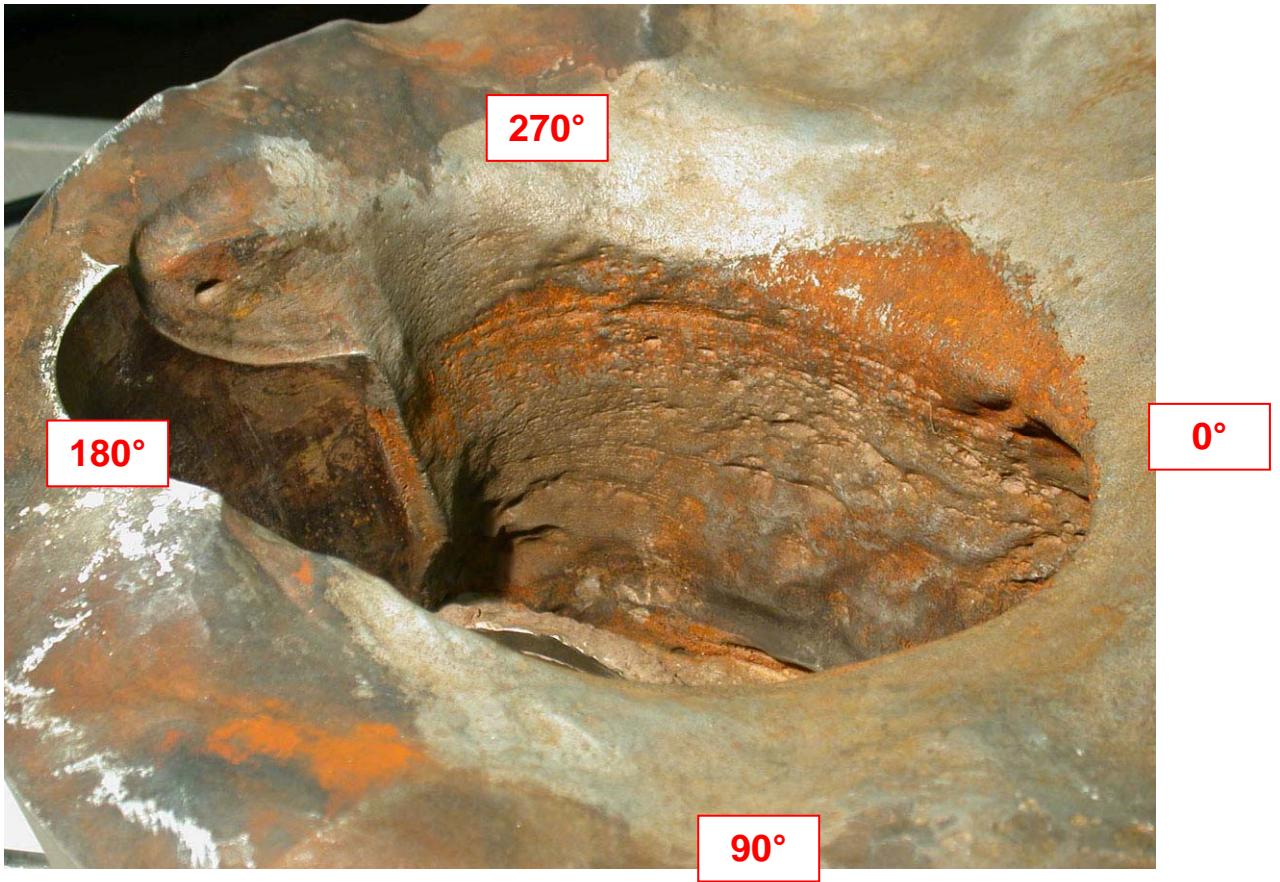
Figure 10.2 View of cavity looking toward 270°

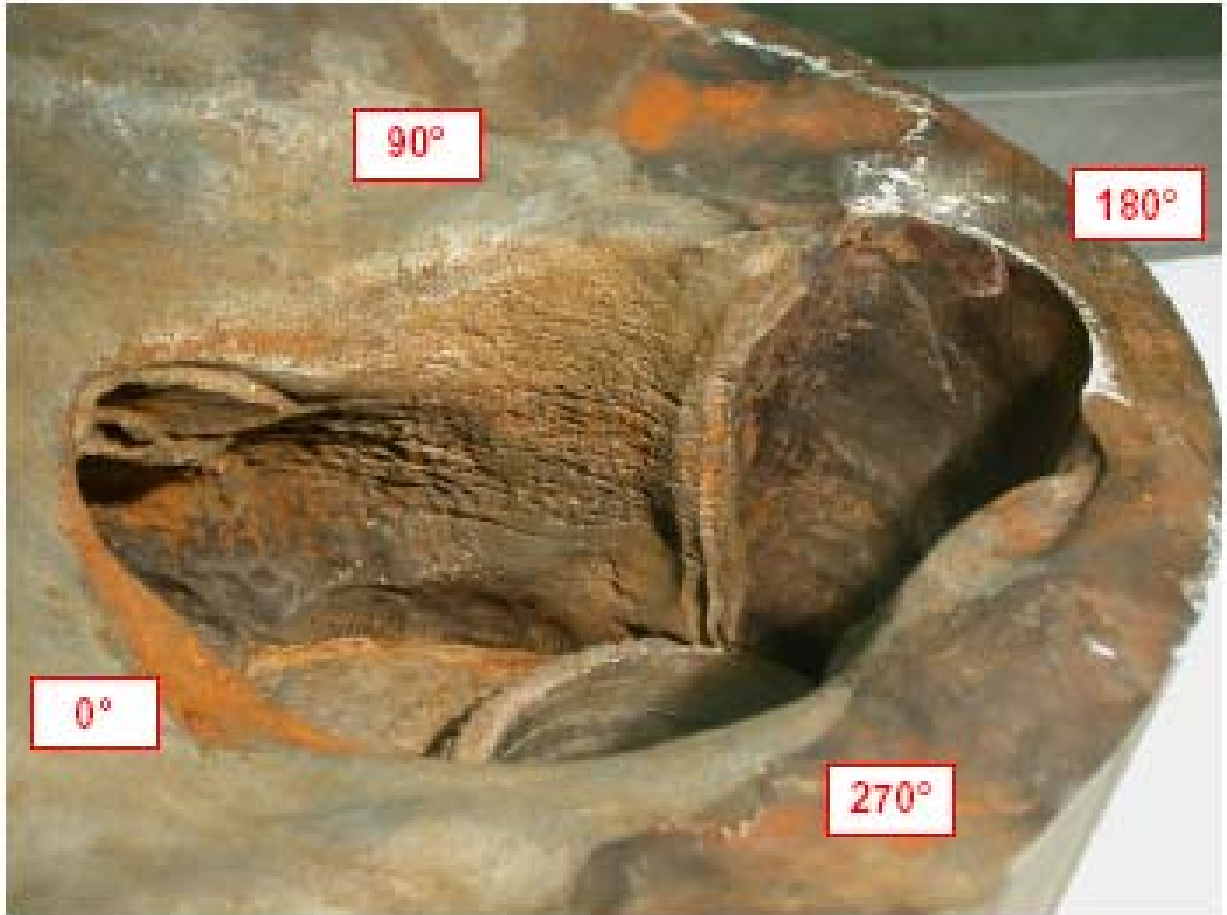
Figure 10.3 View of cavity looking toward 90°

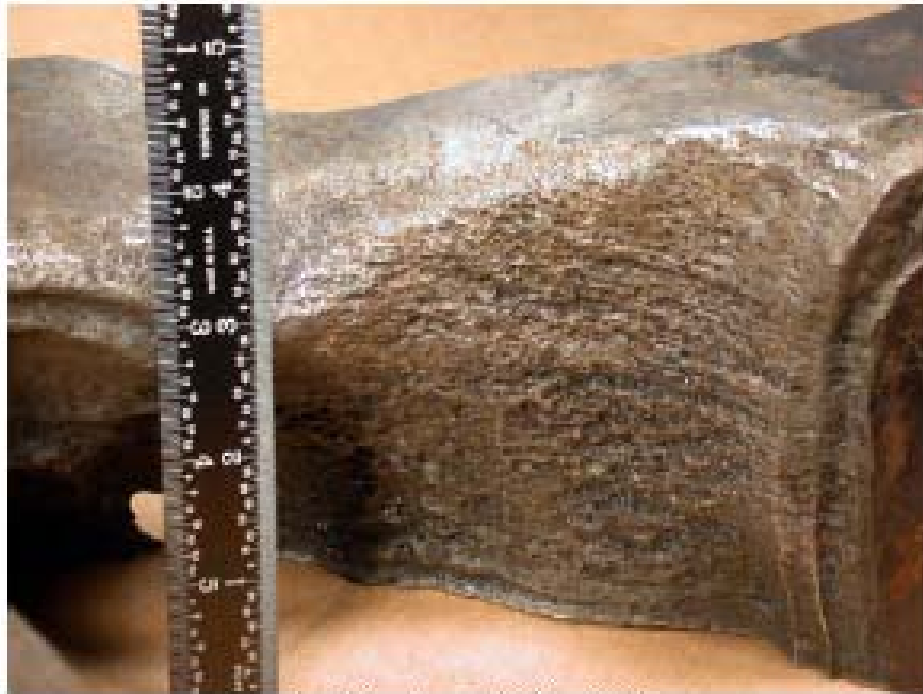
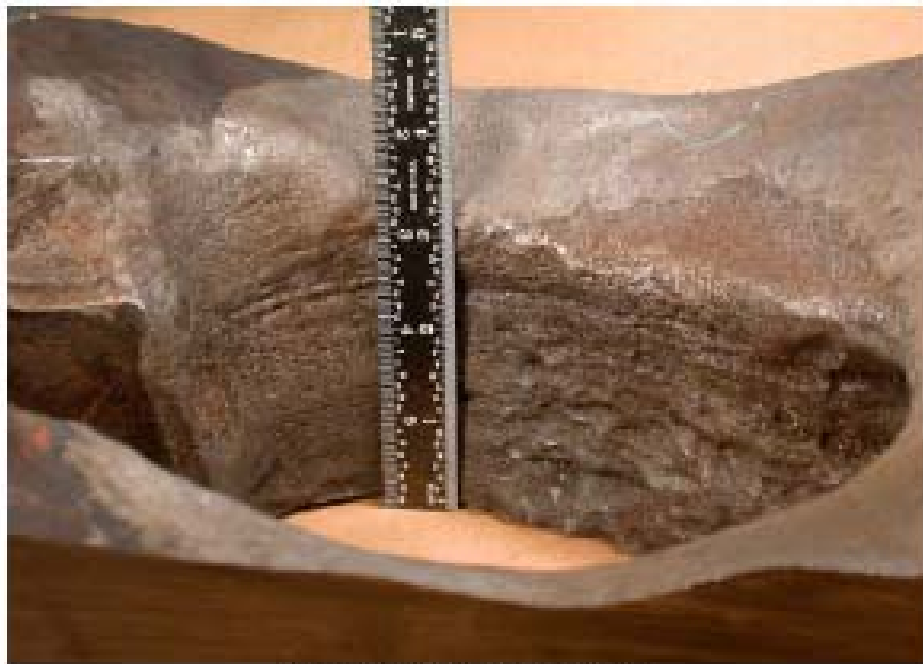
Figure 10.4 Low magnification photographs of cavity sidewalls

- General corrosion of the upper RPV head surface around the cavity is evident to a depth of 1 to 1.5 inches. This can be seen in the view of the top section of the cavity (Figure 10.4) and more clearly shown in the dental mold impressions (Figure 10.5).

Looking toward 90° ~0.7X

Looking toward 270° ~0.5X

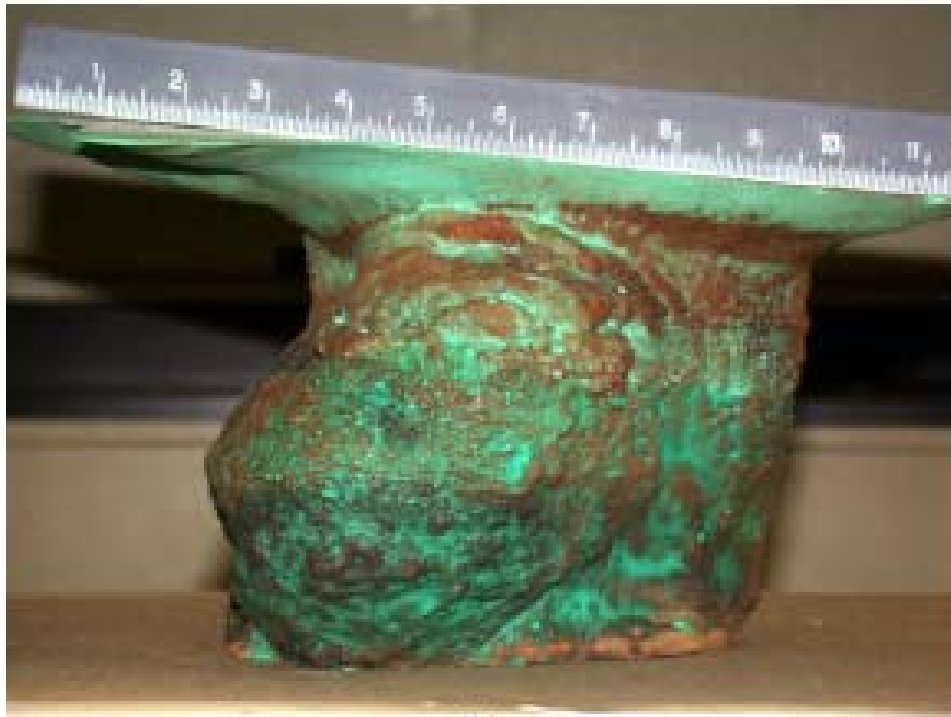
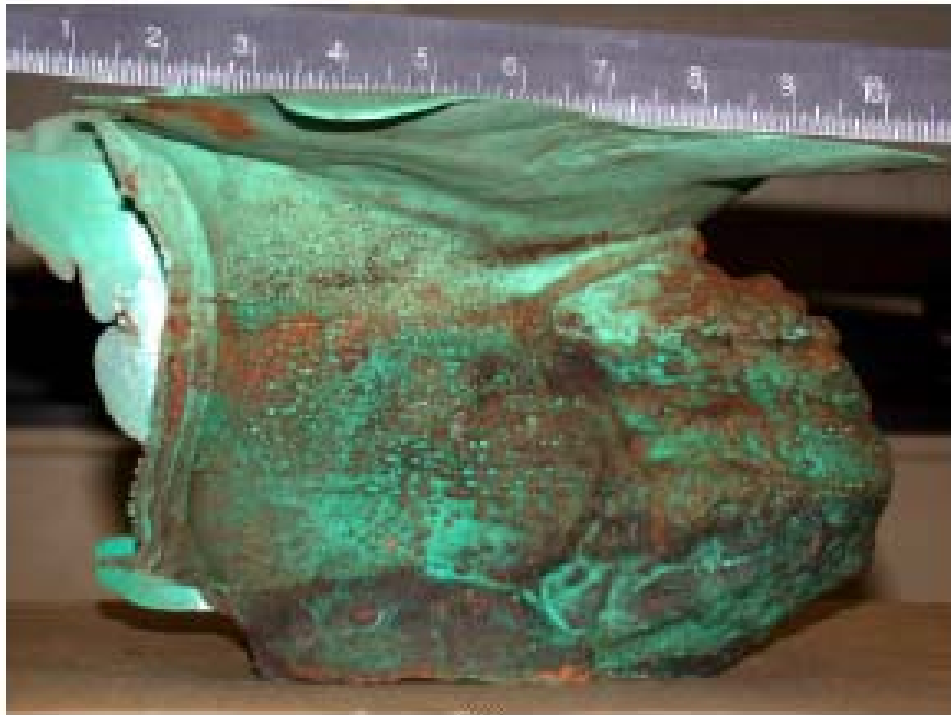
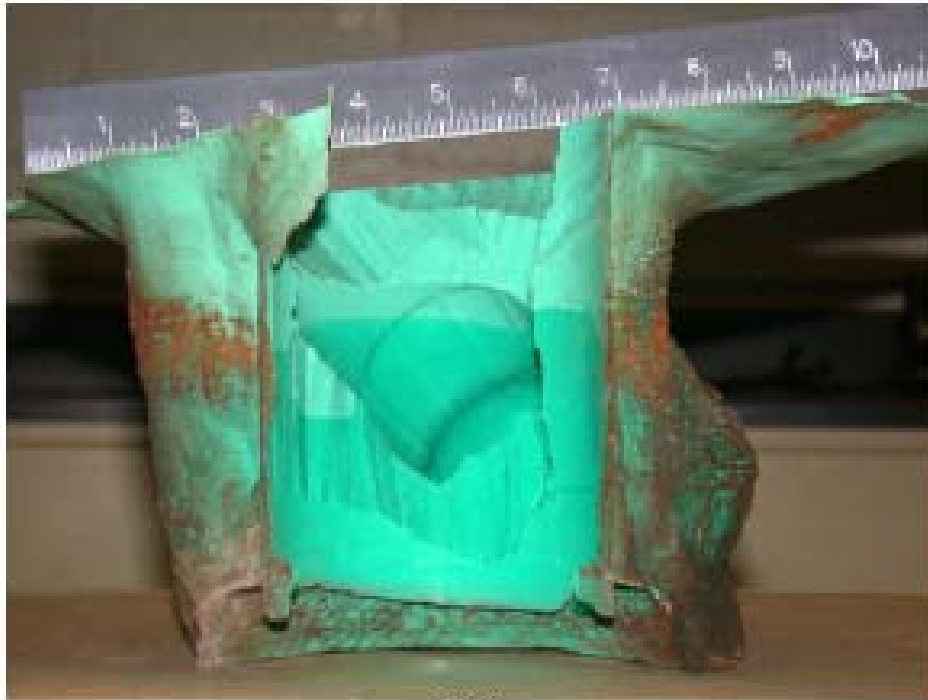
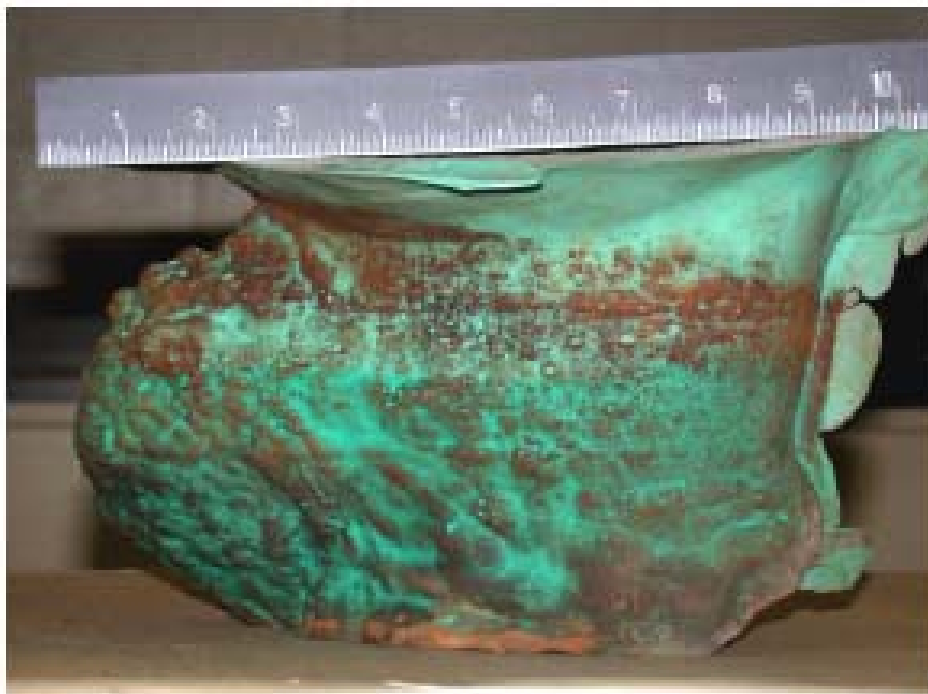
Figure 10.5(a) Photographs of cavity dental mold

Figure 10.5(b) Photographs of cavity dental mold

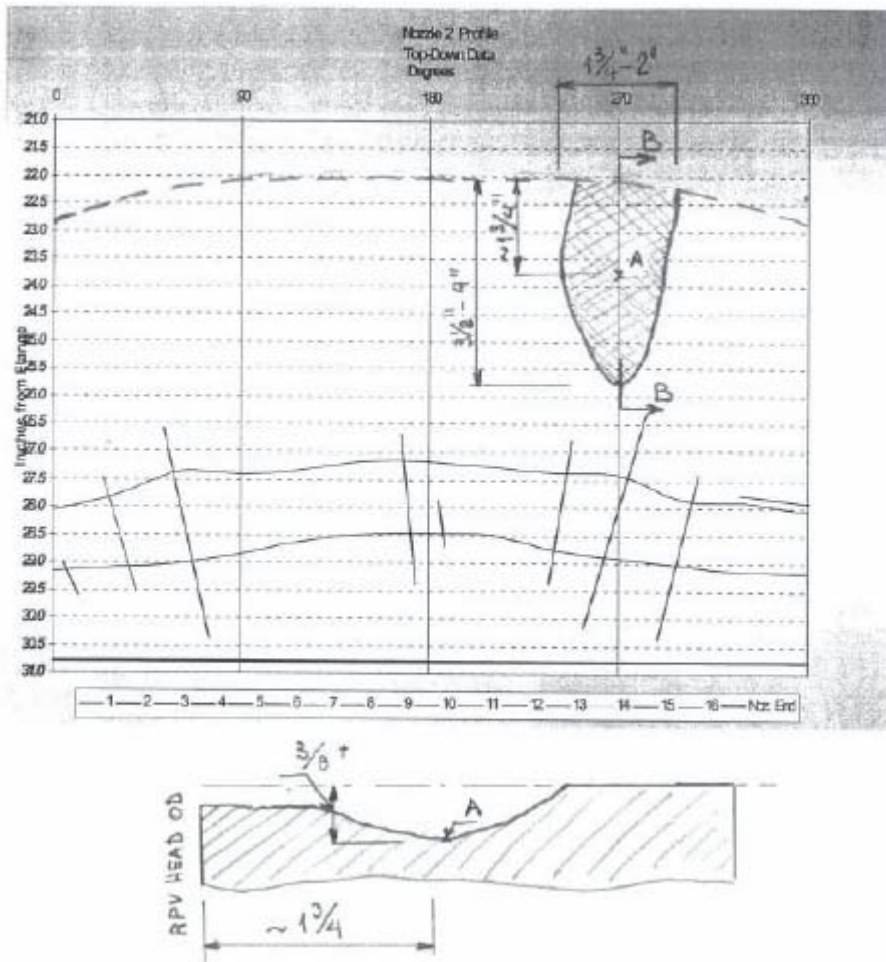
- The wastage cavity was located above three of the through wall axial cracks in Nozzle 2, in the upper half of the nozzle bore, centered on the 270° location.
- The wastage area was located 180° away from the two longest axial cracks in Nozzle 2, which were either side of the 90° location.

- Enlargement of the annulus clearance at the upper surface of the RPV head was observed at approximately the 90° location.
- None of the axial cracks extended up into the wastage cavity.
- The wastage area extended approximately 3 ½ to 4 inches down from the upper surface of the RPV head and was 50° (1 ¾ inches) in circumferential extent.
- The maximum penetration of the cavity into the RPV head was approximately 3/8 inch in the radial direction away from the nozzle OD, and this maximum point was approximately 1 ¾ inches below the upper surface of the RPV head. This indicates that whatever processes of mechanical removal, corrosion, or flow-assisted corrosion were active; the cavity was growing at its maximum rate sub-surface.

Figure 10-6 Wastage Cavity at CRDM Nozzle 2

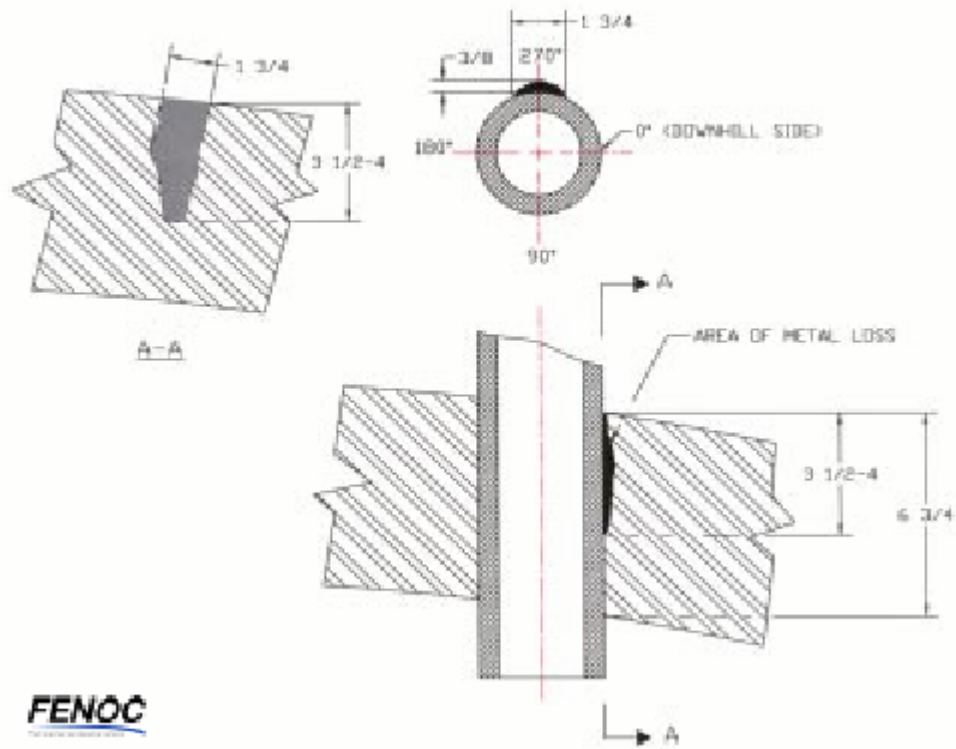
Figure 10-7 Wastage Cavity at CRDM Nozzle 2

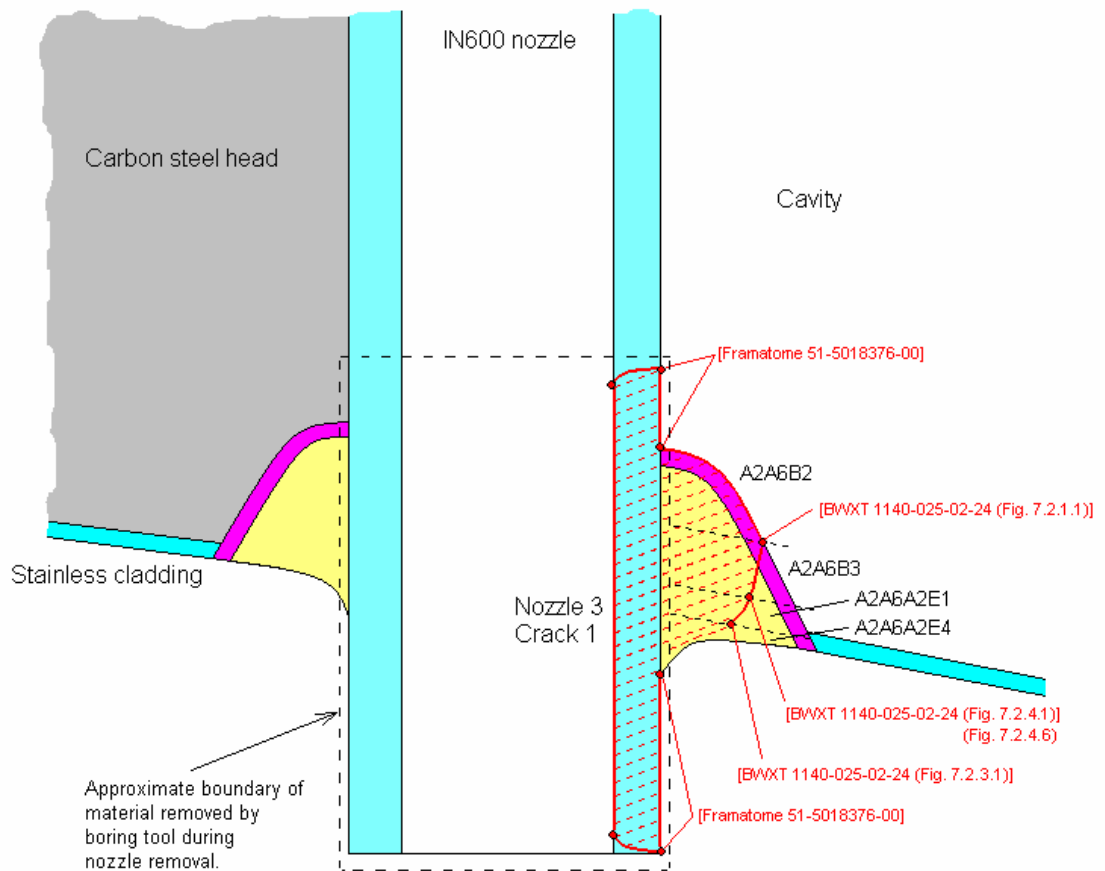
However, careful metallurgical examination of the portion of the J-groove weld that remained after the RPV head section containing the cavity was removed from the RPV head, together with the UT data, allowed us to build up a composite picture of the large nozzle and weld crack at CRDM Nozzle 3 that is shown in Figure 10.8 (See Section 8.4.2).

Figure 10.8 Schematic of final size and shape of Crack 1 in Davis-Besse CRDM Nozzle 3 (from Section 8, Figure 8-10)

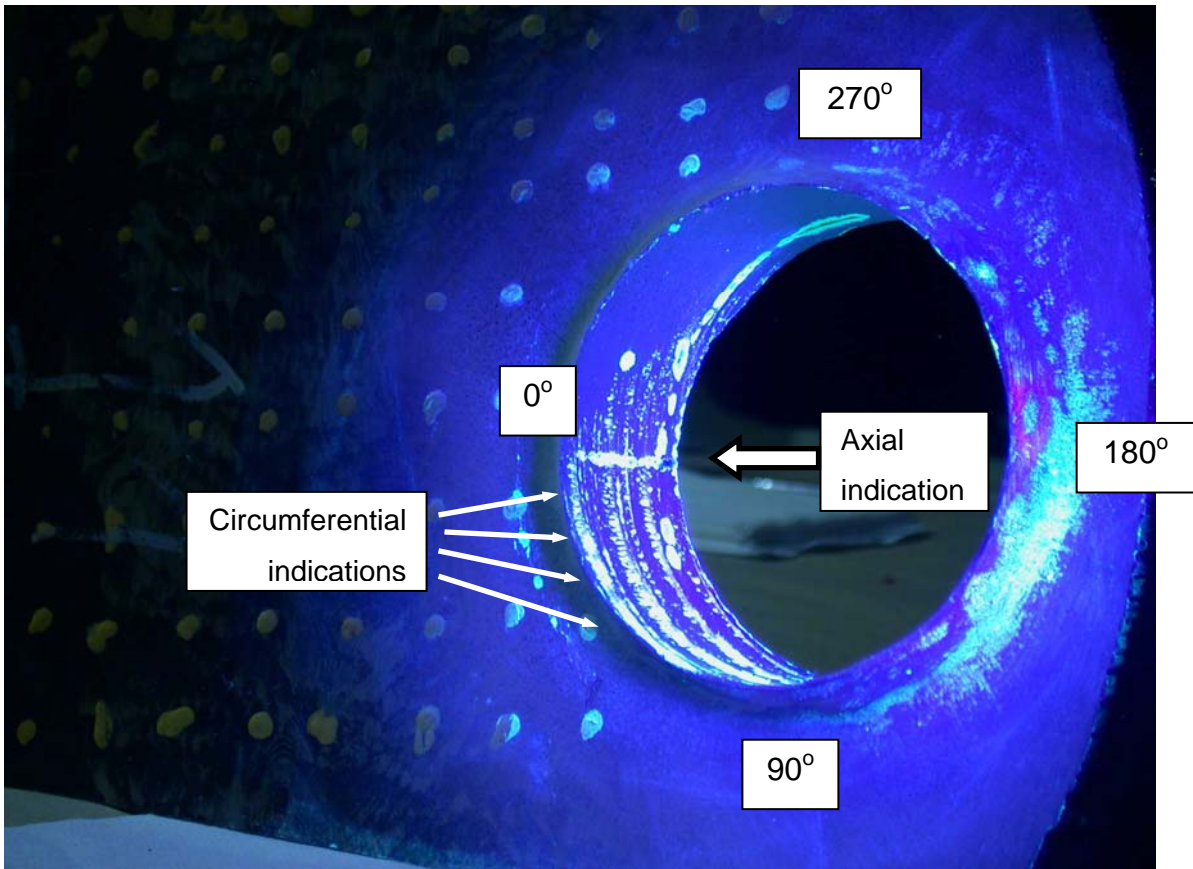
- A large axial through-wall crack (Crack 1) at the 3° location at the top of the J-groove weld extended from almost the bottom of Nozzle 3 to 1.23 inches above the weld on the OD.
- This axial nozzle crack appears to have extended into and almost completely across the J-groove weld at Nozzle 3.
- The metallurgical examination of this weld crack showed that it was quite wide and extended approximately 0.75 inches across the weld in the radial direction at the 10° location (Figures 10.9 through 10.14).
- The weld crack was in line with the upward bulge and crack in the stainless steel cladding at the bottom of the wastage cavity. The bulge in the cladding may have contributed to opening of the weld crack.

Figure 10.9 PT results for nozzle 3 J-groove weld bore and cladding underside. The J-groove weld contained an axial indication near 10° on the bore ID and circumferential indications on the RCS side from ~20° to ~45°.

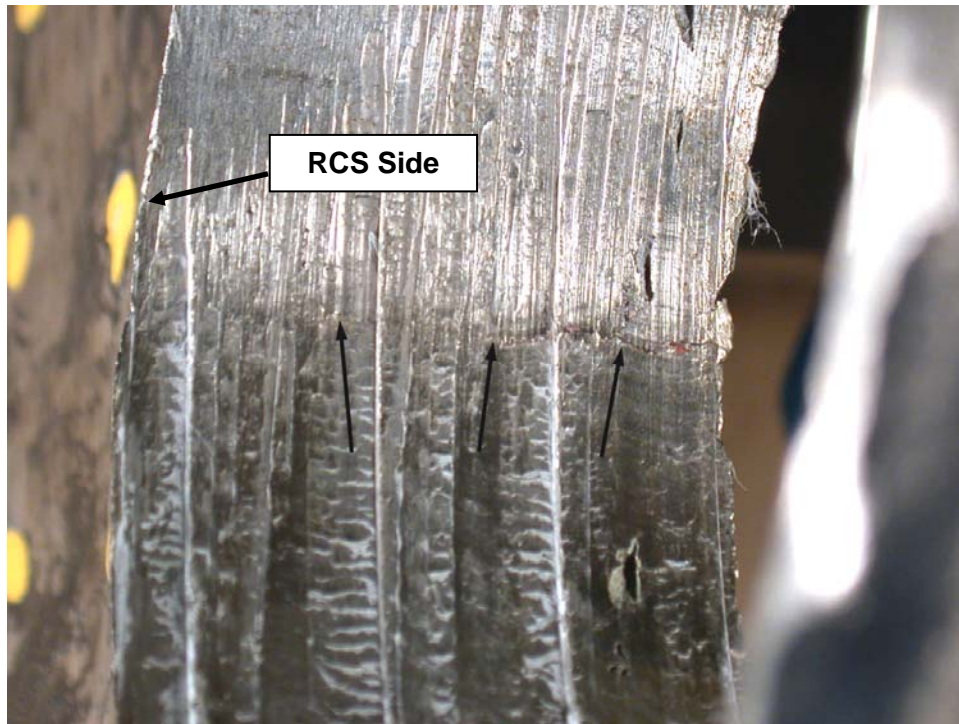
Looking at J-groove weld bore near 10°. ~1.2X

Figure 10.10 Photograph showing the remaining portion of the axial crack near 10° in the CRDM Nozzle 3 J-groove weld. This is the portion remaining after the machining was completed for nozzle repair.

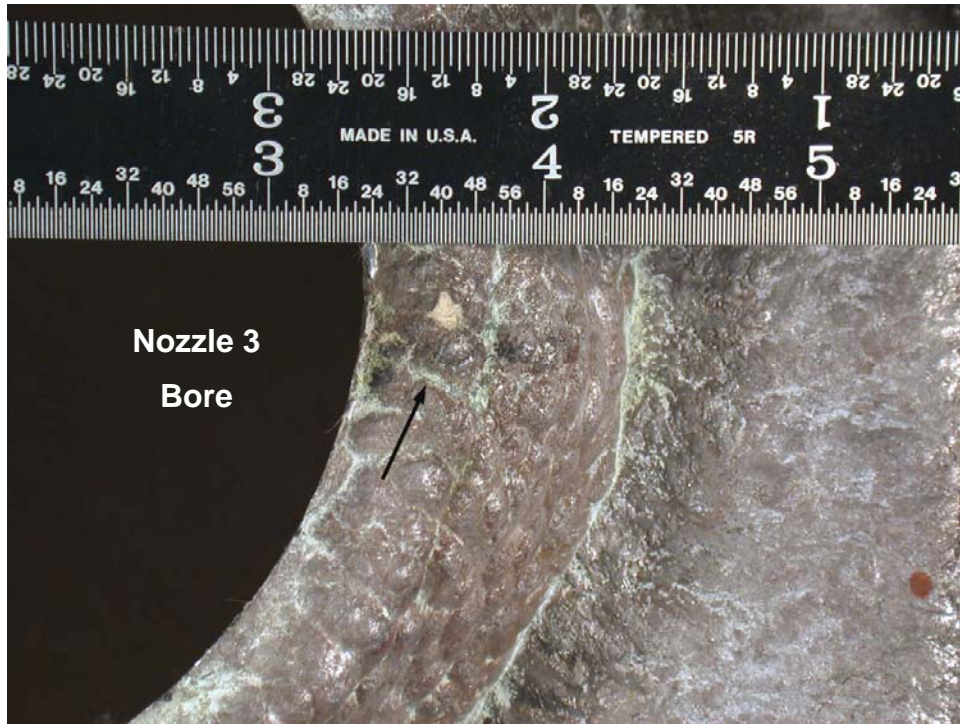
Top view of J-groove weld crack near 10°. ~1.4X

Figure 10.11 Photograph showing axial crack in CRDM nozzle 3 J-groove weld near 10°.

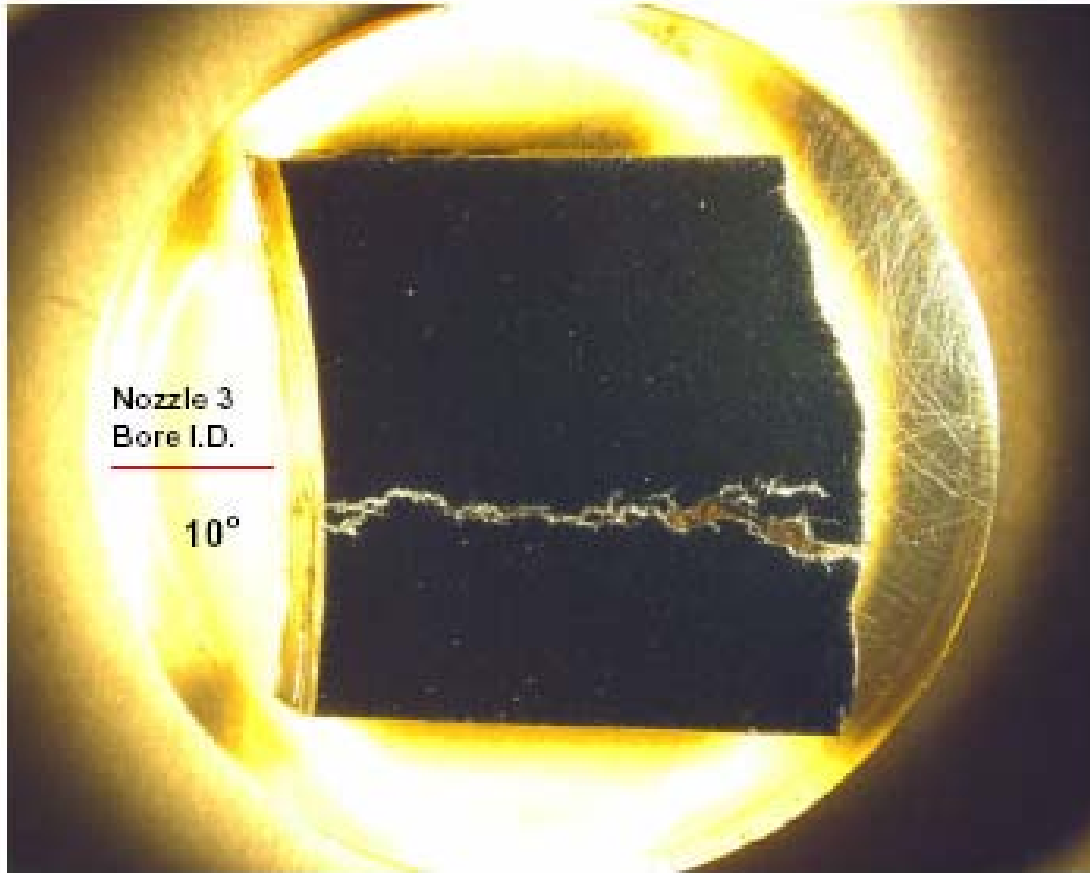
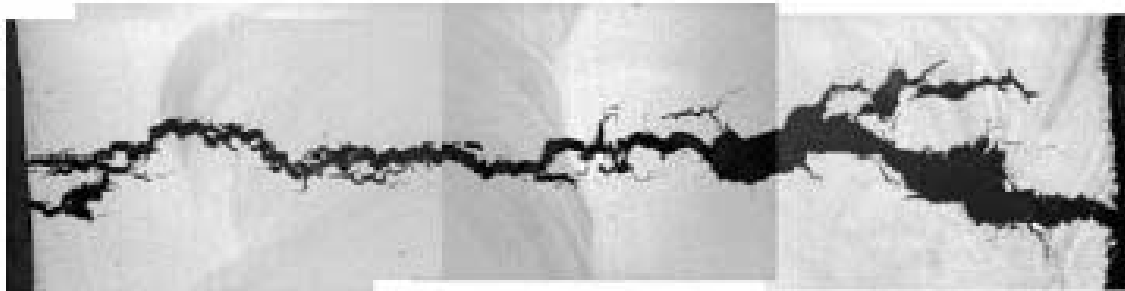
Figure 10.14 Macro photograph of metallographic mount sample A2A6B2 (see Figures 5.4 and 5.5 for the sample orientation). The axial cracking at $\sim 10^\circ$ is through the J-groove weld, in contrast to the cracking near 180° , which was partially through the weld. A slightly higher magnification micrograph is also provided
