UNITED STATES
NUCLEAR REGULATORY COMMISSION
OFFICE OF NUCLEAR REACTOR REGULATION
WASHINGTON, DC 20555-0001

NRC INFORMATION NOTICE 2008-07: CRACKING INDICATIONS IN THERMALLY
TREATED ALLOY 600 STEAM GENERATOR
TUBES

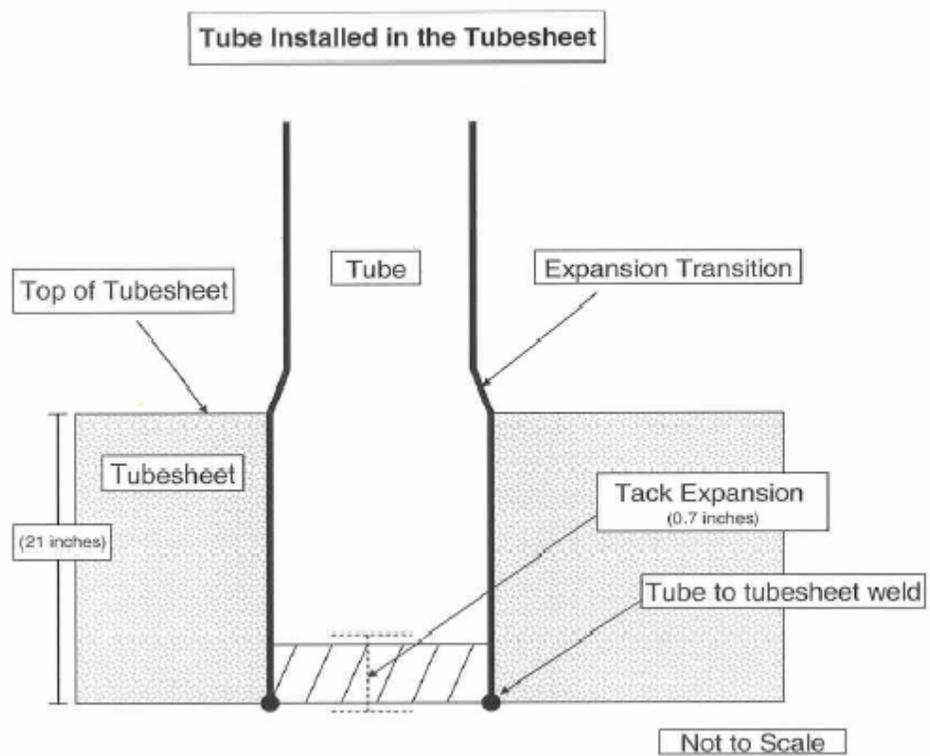
Figure 1

Vogtle, Unit 1, has four Westinghouse Model F recirculating steam generators. Each steam generator has approximately 5600 tubes fabricated from thermally treated Alloy 600. During fabrication of the steam generators, the lower portions of the tubes were inserted and hydraulically expanded into a thick plate called a tubesheet. The tubesheet is approximately 533.4 mm (21 inches) thick and has two holes for each tube (one hole on the hot-leg side of the steam generator and one hole on the cold-leg side). The tubes were hydraulically expanded for the full depth of the tubesheet. The transition from the expanded portion of the tube within the tubesheet to the unexpanded portion of the tube at the top of the tubesheet is referred to as the expansion transition region of the tube. The tubes are welded to the tubesheet at their lower ends (See Enclosure, Figure 1).
