**UNITED STATES  
NUCLEAR REGULATORY COMMISSION**  
REGION II  
SAM NUNN ATLANTA FEDERAL CENTER  
61 FORSYTH STREET, SW, SUITE 23T85  
ATLANTA, GEORGIA 30303-8931

March 19, 2010

**SUBJECT: NRC AUGMENTED INSPECTION TEAM REPORT NO. 70-143/2009-011**

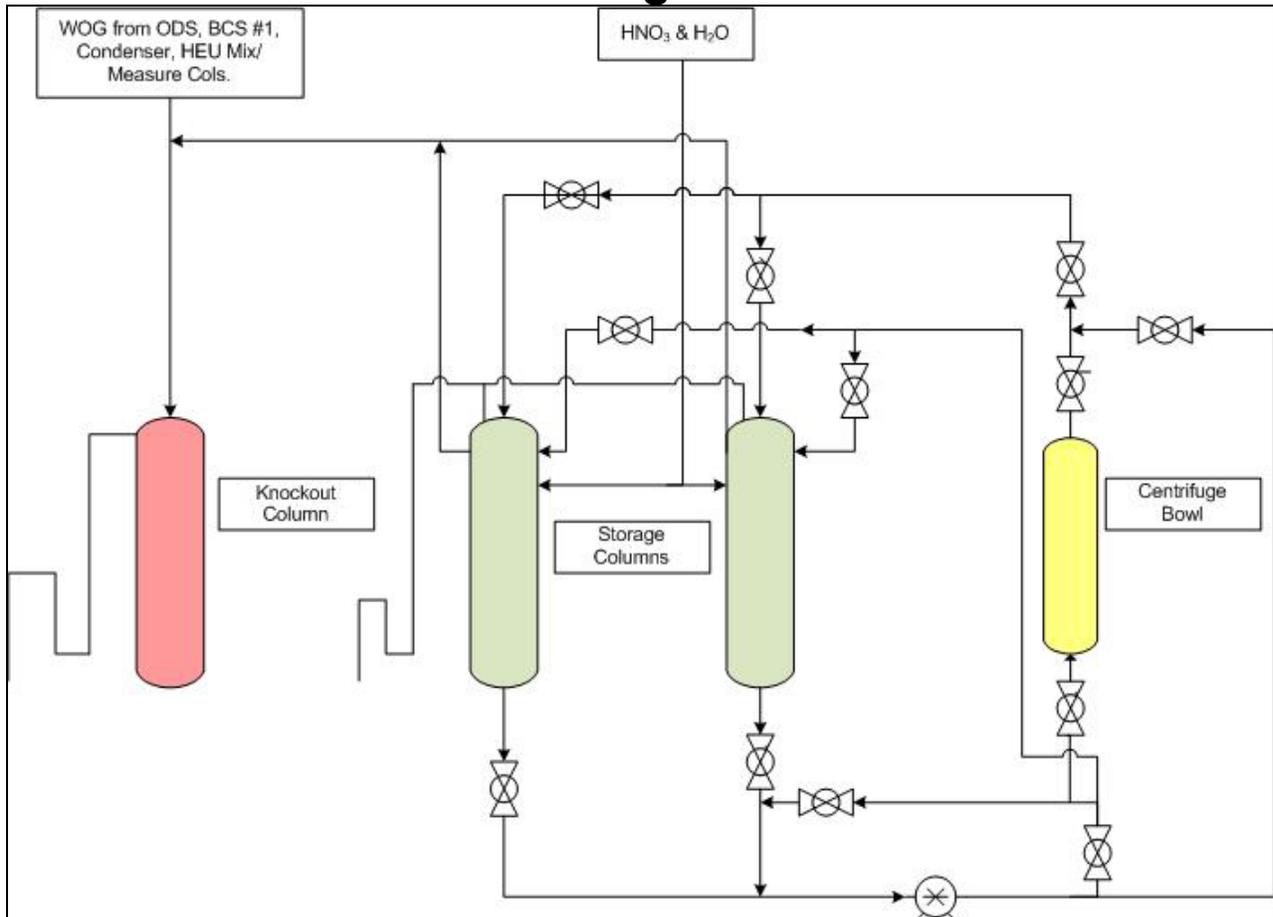
### **Bowl Cleaning Station #2**

This chemical process is exothermic and has historically produced nitrogen oxide compounds (NO<sub>x</sub>) which are normally captured and processed by the wet off-gas (WOG) system. Safety Controls designated as IROFS include a NO<sub>x</sub> detection system with sensors at the employee working level and at the ceiling close to the knock out column's siphon break which is a potential release point for these gases.

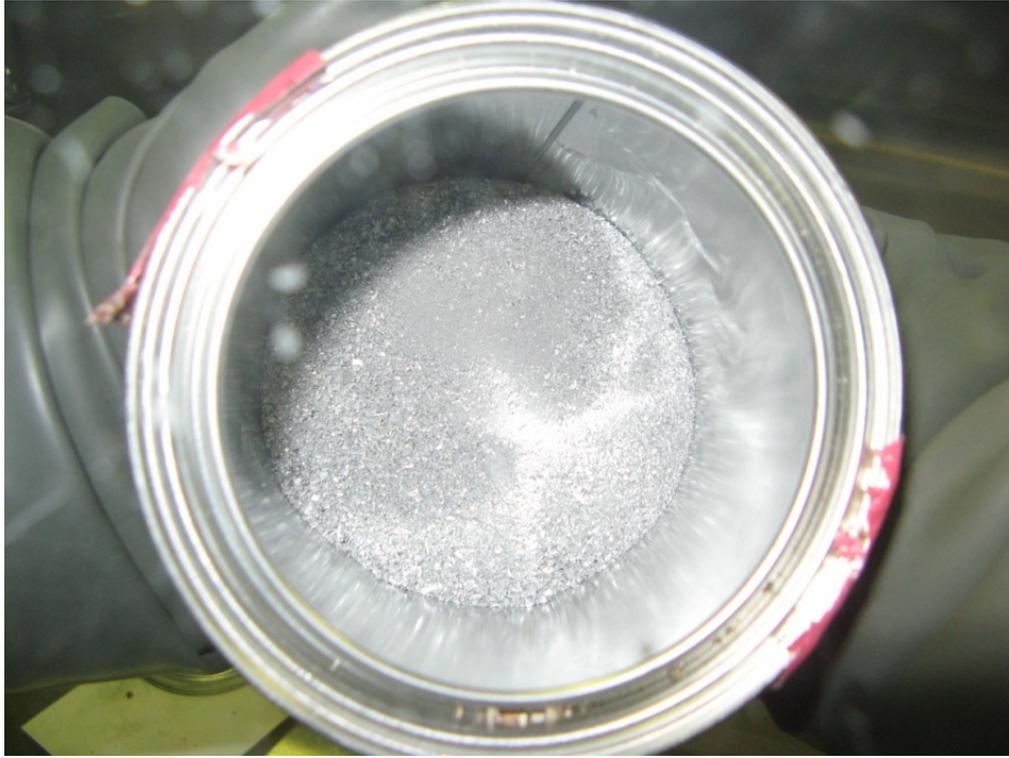
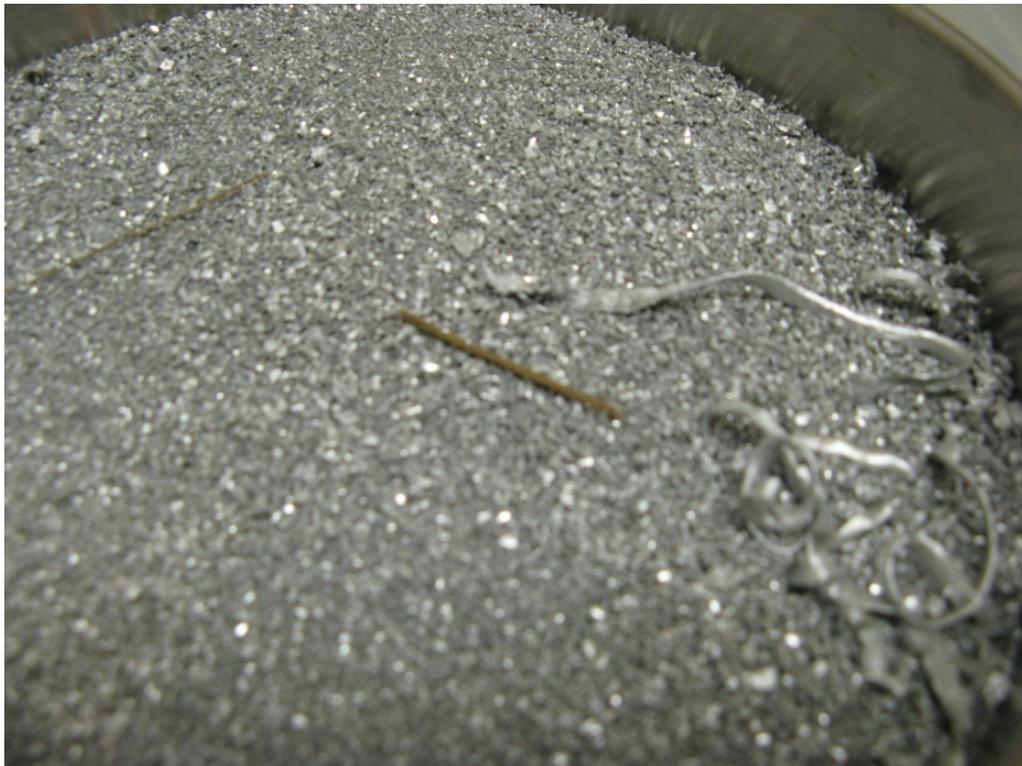
## Representative Picture of UAL Alloy Fines

On October 12, 2009, NFS finalized its procedures for chemical processing of UAI fines scrap material in the centrifuge BCS. A representative picture of this material is included as Attachment 3. The NFS laboratory had analyzed a sample of fines to determine the procedure modifications that were necessary to process this material. The decision was made to process the fines in the BCS using nitric acid because laboratory testing indicated that dissolving the fines with caustic in the normal dissolver column was not recommended due to the potential for a vigorous reaction. The nitric acid dissolution of the first batch of material (performed in BCS 2) did not proceed according to expectations.
