Subject: 10CFR21 Reporting of Defects and Non-Compliance  
Thomas & Betts Printed Circuit Board P/N 41-01-251512

## 10CFR21 REPORTING OF DEFECTS AND NON-COMPLIANCE

COMPONENT: Thomas & Betts Printed Circuit Board P/N 41-01-251512

SYSTEM: Cyberex 20 kVA Model AC Power Supply

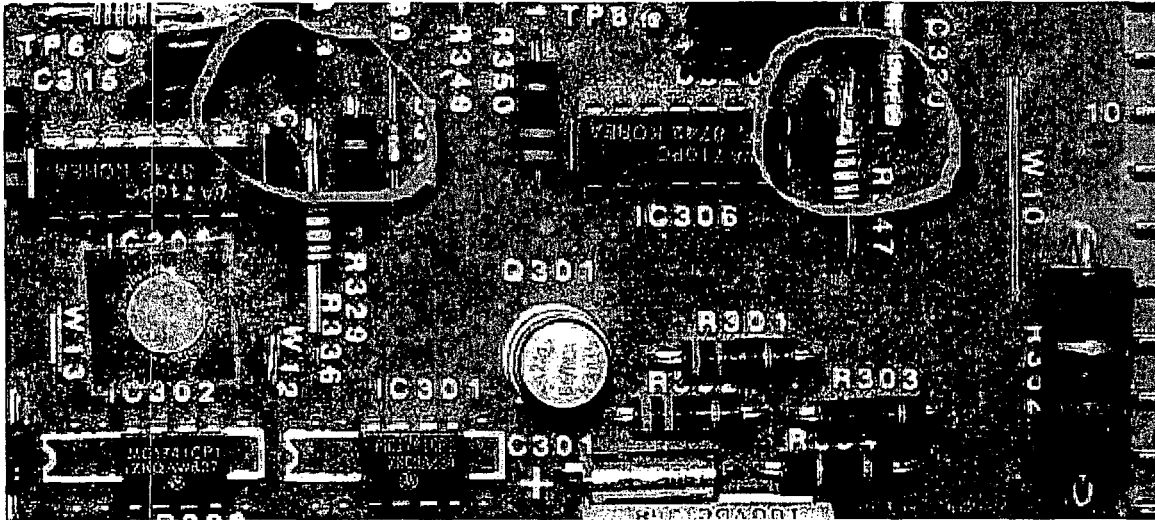
Figure 2, Correct location of resistor leads

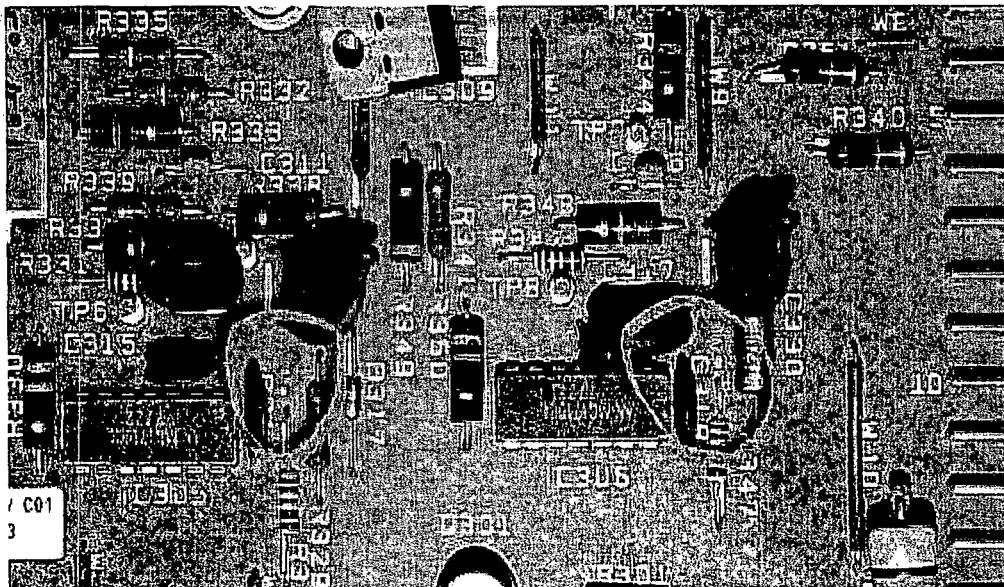
*The Inverter THD specification is < 5% and RMS voltage regulation is +/- 2%.  
The test results are within these parameters though the THD appears to be temperature sensitive and requires adjustment with any change in ambient temp. However, placement of resistors R336 and R347 in the "short" holes, as found on the 3 boards returned from the site, alters the operation of IC305 and IC306.*

*Consequently the circuits cannot function as designed. We believe the temperature sensitivity is a result of the incorrect resistors and are awaiting results of further testing from the site to confirm our suspicions.*

Figure 3, Incorrect location of the resistor leads

Pending any inspection (see Attachment 1 for instructions) performed by PSEG on field population, any defective units found will be reworked to original specifications and dedicated accordingly.

1. See figure 1 below for a picture of the Cyberex logic power supply board, p/n: 41-01-251512.
2. Inspect the board for the correct location of the resistor leads as shown in figure 2.
3. If resistor lead is installed as shown in figure 3 then notify UCI and an RMA will be issued for the repair.
