Date: 9/29/10

Subject: 10 CFR Part 21 report of potential issues with certain Regulator Model 77N-40

Attachment A

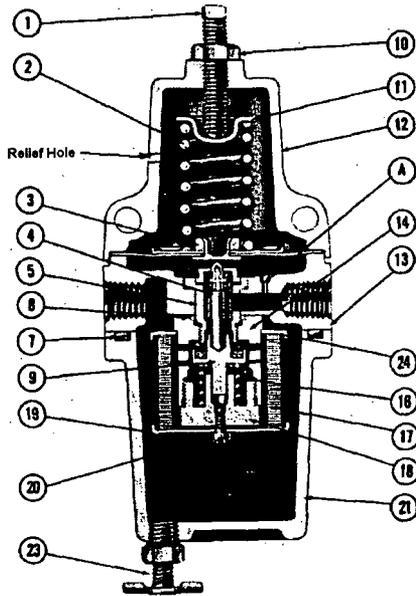
Figure 1

It was discovered during the evaluation process that the O-ring (#8 Figure 1) which isolates the pressure chambers can become damaged during the assembly process. A review of internal procedures found that the O-ring in question was assembled in the inverted position not visible to the technician during the process. Therefore the O-Ring had the potential to be damaged by the threads of the mating part.

It was also found that the supplier of the component referred to as the "Body" (#13 Figure 1) had not properly de-burred the bore that contained the sealing surface of the O-Ring on some components. The resulting sharp edge can be another source of potential damage to the O-ring.

- Inspection was added to the Body bore edge in our dedication plan.
- Inspection was added to the Relief Valve seat in our dedication plan.
- Procedures and instructions were updated to ensure that the O-Ring was assembled such that the technician can visibly see the components and ensure the O-Ring is not damaged during the assembly process.
- We reviewed the use of the "coining" technique and eliminated the practice from the current process. The technician is now instructed to assemble and test the Regulator without coining. If the Regulator does not pass the required testing the Regulator will be disassembled and the relief valve components replaced until an acceptable combination passes test.
- The existing inventory was reworked to the corrective actions above.

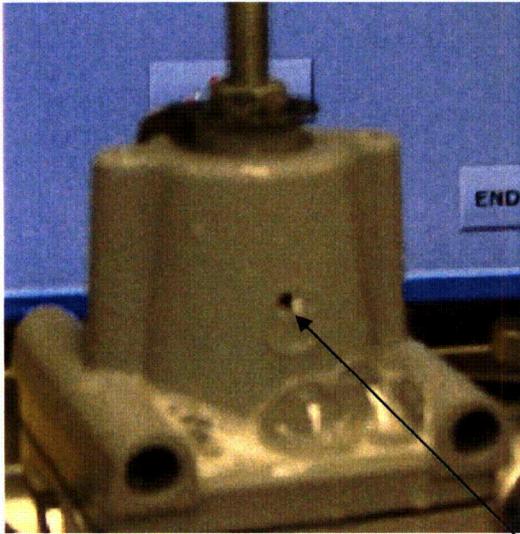
Figure 3
Acceptable

Apply leak detection fluid to the Relief hole as shown. Acceptable bubble size is shown in Figure 4. The acceptable leak rate of the bubbles is 1 to 3 per second. Unacceptable bubble size is shown in Figure 5 or bubbles that form at a rate of more than 5 or more per second.
