FM Notification Report Serial Number 10-06

Fairbanks Morse Engine
10CFR 21.21 (d)(3)(ii) Notification

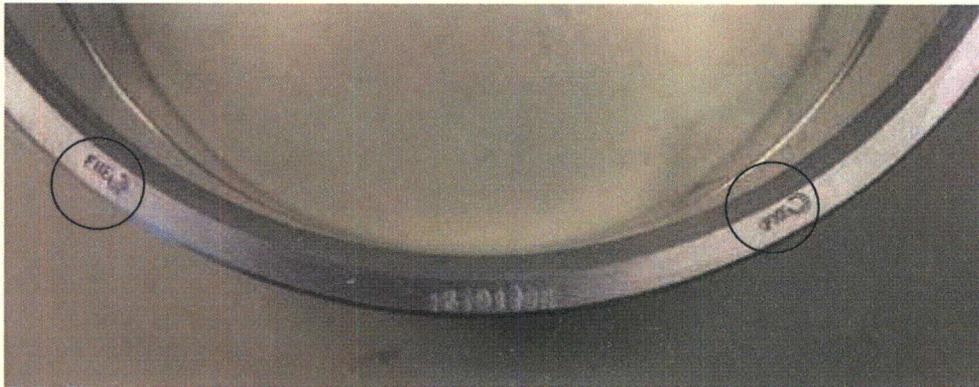
All bearings that are suspect for linear indications are stamped with two FM swirl logos as shown in the photo. Linear indications have only occurred on bearings machined from the latest permanent mold castings which are identified with two FM swirl logos as shown:

All aluminum OP bearings stamped with a double FME logo, as listed in the previous table, are suspect for having linear indications and should be returned to FME for inspection.

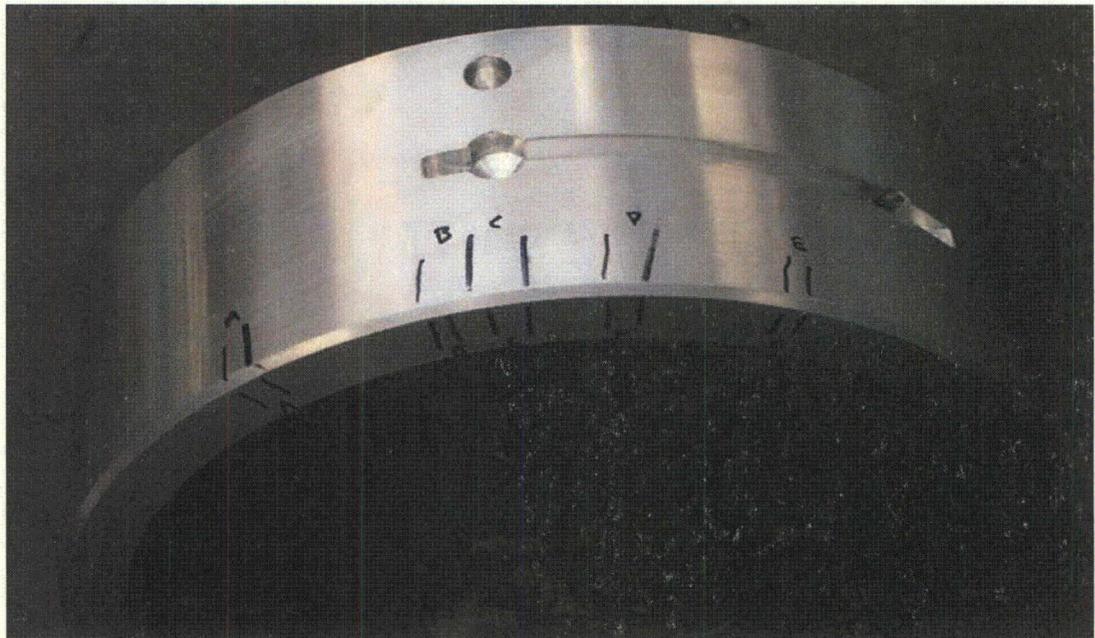
Linear indications (hot tears) were observed on one main bearing by the FM production inspector. The indications were only on one edge of the bearing. The indications went across the entire edge and extended about 1 inch deep into the bearing, being visible on the outside diameter and the inside diameter for about 1 inch. Subsequent 100% liquid penetrant inspection (PT) of all finished bearings in stock has found linear indications on 13 of 454 bearings (3% reject rate) made from permanent mold castings.

The following photo shows the location of the linear indications marked along one edge of the bearing:

The root cause of the problem occurs during the casting of the aluminum material in the permanent mold. The linear indications occur only on one edge of the casting, which has been identified as the bottom of the casting. During the cooling and solidification of the molten material poured into the permanent mold tool, the material shrinks and must be continuously replenished with molten material from the top of the casting. If the top of the casting solidifies before the bottom, there is no additional molten material available from the top to feed the bottom as it cools and shrinks, resulting in tears (hot tears) to the material on the bottom of the casting. It is suspected these hot tears are occurring due to improper cooling of the mold tool core. Because there are no cooling passages within the solid mold tool core, the core becomes progressively hotter throughout the production run until the core reaches a temperature hot enough to cause the hot tears.

As additional permanent corrective action, the FM supplier is adding air cooling passages to the permanent mold tool cores prior to any additional castings being poured. Core cooling creates directional solidification of the casting, from the inside to the outside and from the bottom to the top. Future production runs of bearings from new castings will be stamped with an FM lot number that traces to the supplier casting heat number and allows tracking the effectiveness of the corrective actions.

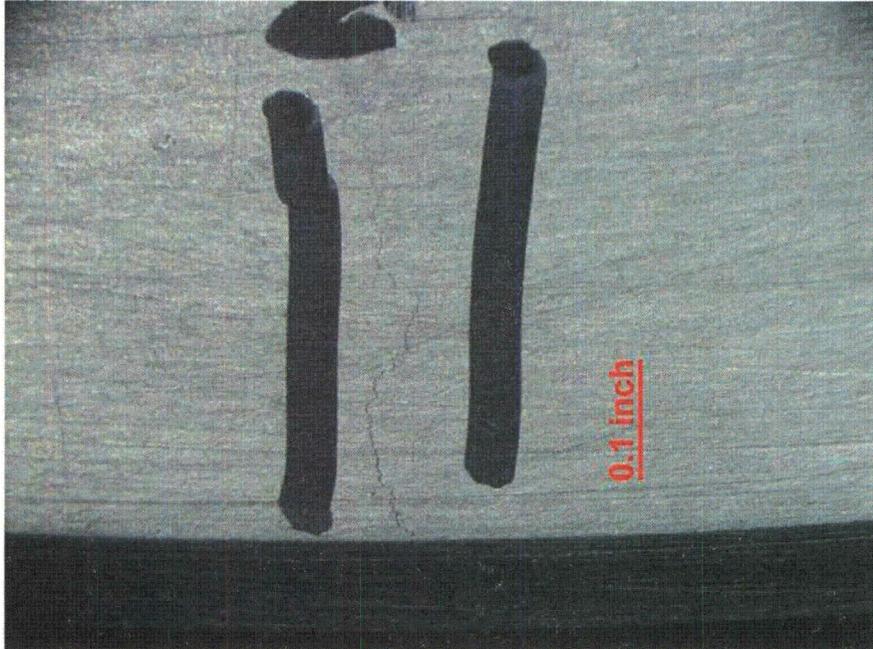
The following photomicrograph at 7X magnification shows a visually apparent linear indication:

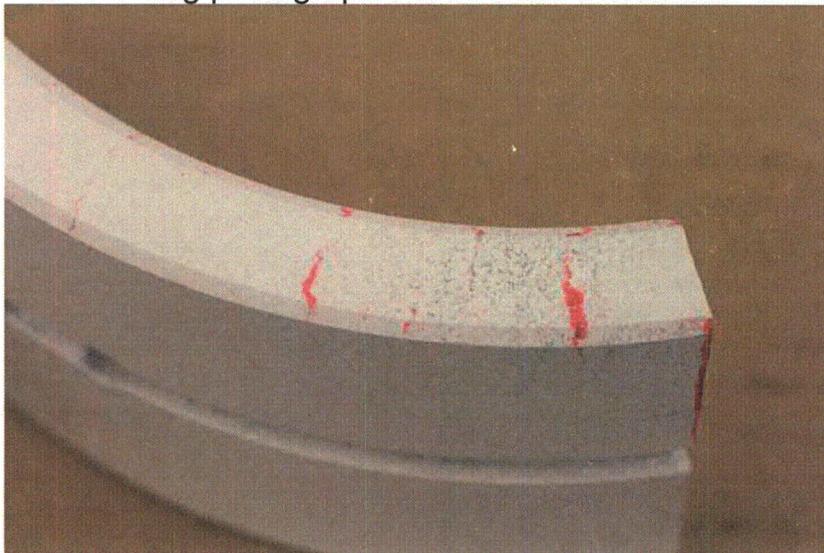
The following photograph shows linear indications observed by PT:
