Subject: 10CFR21 Reporting of Defects and Non-Compliance -
Engine Systems, Inc. Report No. 10CFR21-0098, Rev. 2

Amot Thermostatic Valve Element
P/N: 9760X

Report No. 10CFR21-0098

10CFR21 REPORTING OF DEFECTS AND NON-COMPLIANCE

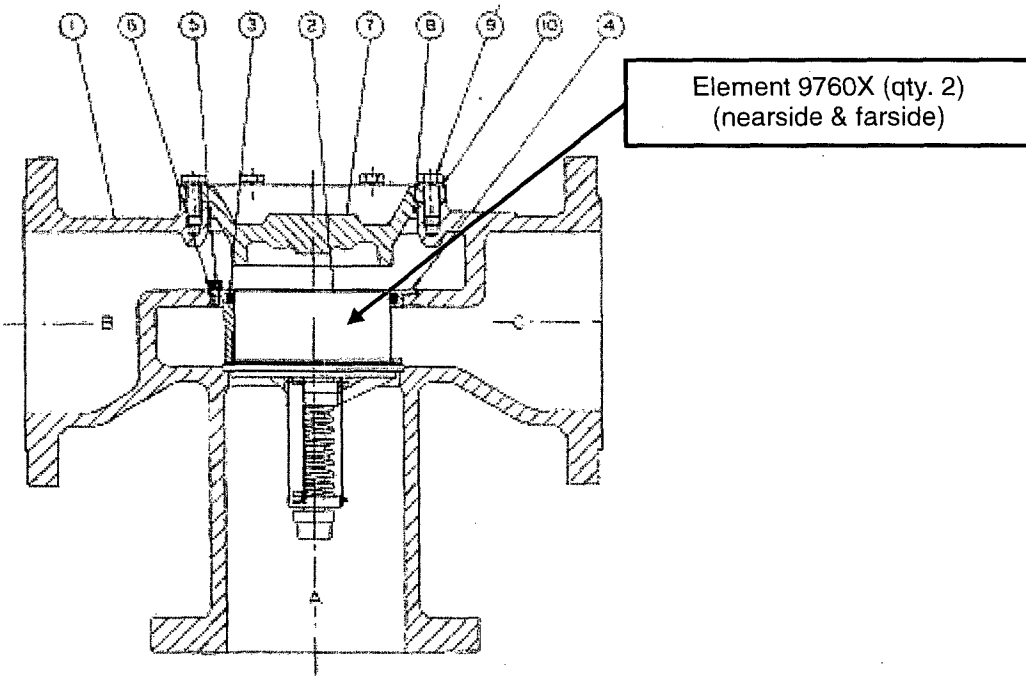
FIGURE 1: AMOT THERMOSTATIC VALVE

Each valve uses 2 thermostatic elements, Amot type 9760X (Figure 1). The elements investigated for the Palo Verde and STP applications have a nominal temperature setting of 160°F and therefore the element part number is 9760X-160.

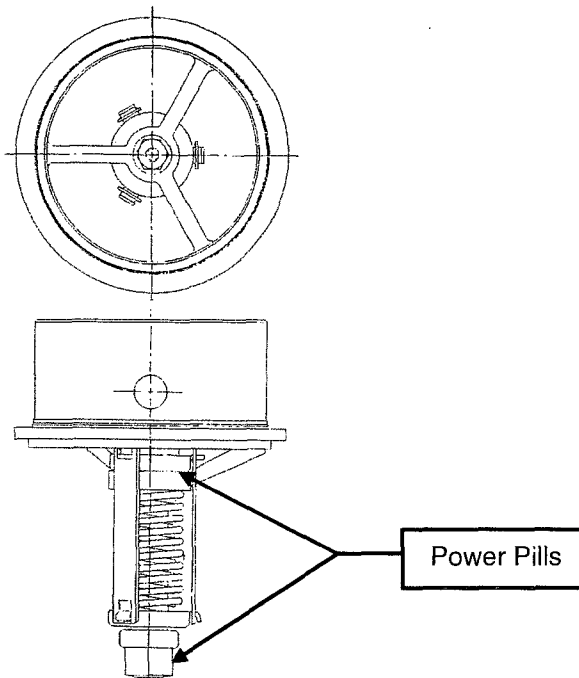
FIGURE 2: VALVE ELEMENT 9760X

The 9760X element contains two power pills (Figure 2). The power pills contain a temperature sensitive wax that expands with increasing temperature and provides the motive force to lift the element off of its seat.
