Part 21 (PAR)

Event # 48851

PART 21 - SERIES 24 CSR RELAYS WITH OVERSIZED CAM DRIVE COMPONENTS

Subject: 10 CFR Part21 Reporting of Defects and Noncompliance
Electroswitch Report # 10CFR21-032513 Rev. 0

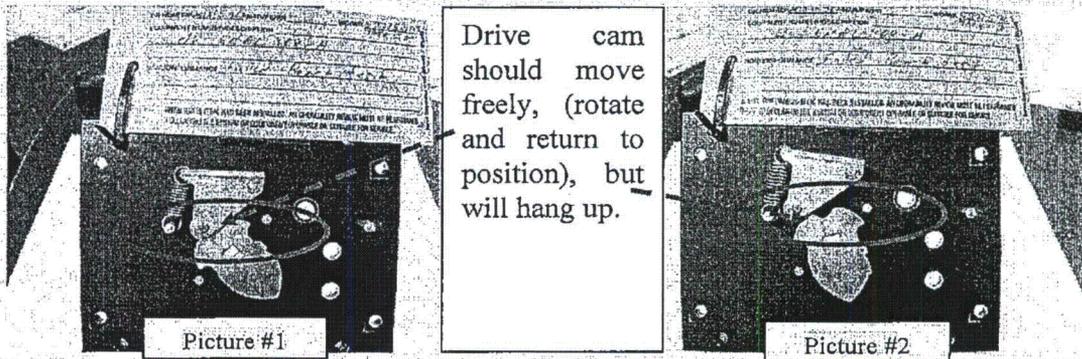
“Relay SN108-I65410 failed a bench test with the following characteristics: Contact 11/13 initially closed when relay was de-energized; opened when energized but would not close again when de-energized. Another relay failed in a similar manner. The two relays were quarantined by Waterford 3 and will be sent back to Electroswitch under a Return Material Authorization (RMA).”

1. Immediate disposition once switch was returned on RA #4850:
 - a. Initial evaluation: Performed bench test to see if problem could be replicated. Results: Switches did initially close when relay was de-energized, open when energized and close when de-energized. Because the results did not replicate failure mode at customer, engineering was brought into evaluation.
 - b. Engineering evaluation: Performed bench test again. Results: Failure mode could be replicated when switch was kept energized for a short period of time (10 seconds).
 - c. Based upon the results, Engineering had recommended the drive cam portion of the drive assembly be checked for movement. Refer to picture #1 and #2 on page 2 of report.

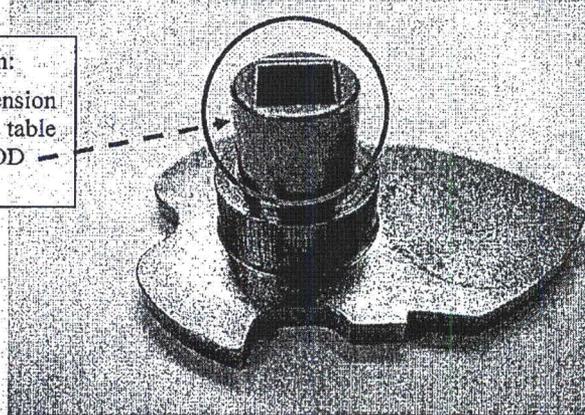
Drive cam:
.4385 dimension
referenced in table
below is the OD

- d. Measured the three components which make up the drive cam assembly.

Component	Dimension specification	Actual dimension
Drive cam (after plating)	.4385 +.0000/-.0005	.4388 .4392
Drive cam (before plating)	.4380 +.0000/-.0005	.4381 .4385
Nylon bushing	.4385 +.001/-.000	.4390
Mounting plate	.5000 +.0000/-.0005	.5000

The root cause has been determined to be oversized OD dimension on the drive cam. This tight fit in the nylon bushing and mounting plate did not allow the drive cam to close when de-energized.

It was found, during the evaluation, that the drive cam drawing was not clear with respect to the OD dimension being such before or after plating.

1. Engineering will be revising the drive cam drawing (see table below):
 - a. The OD specification on the drive cam will be revised.
 - b. The plating specification on the drive cam will be revised.
 - i. The plating specification changed from .0004 max to .0003 max.

Component	Original dimension specification	Revised dimension specification
Drive cam (after plating)	.4385 +.0000/-.0005	.4386 max
Drive cam (before plating)	.4380 +.0000/-.0005	.4380 +.0000/-.0002
Nylon bushing	.4385 +.001/-.000	Same
Mounting plate	.5000 +.0000/-.0005	Same

- c. With these changes, the stack up tolerance, which may have caused a restriction in movement, will be eliminated.
2. Test procedure will be revised to keep switch energized for 10 seconds
