### **Leak-Chase Channel Degradation Issues Identified**

NRC inspectors recently identified degradation issues related to the containment floor steel shell and liner plate leak-chase channel systems at several pressurized-water reactor (PWR) plants, examples of which are summarized below.

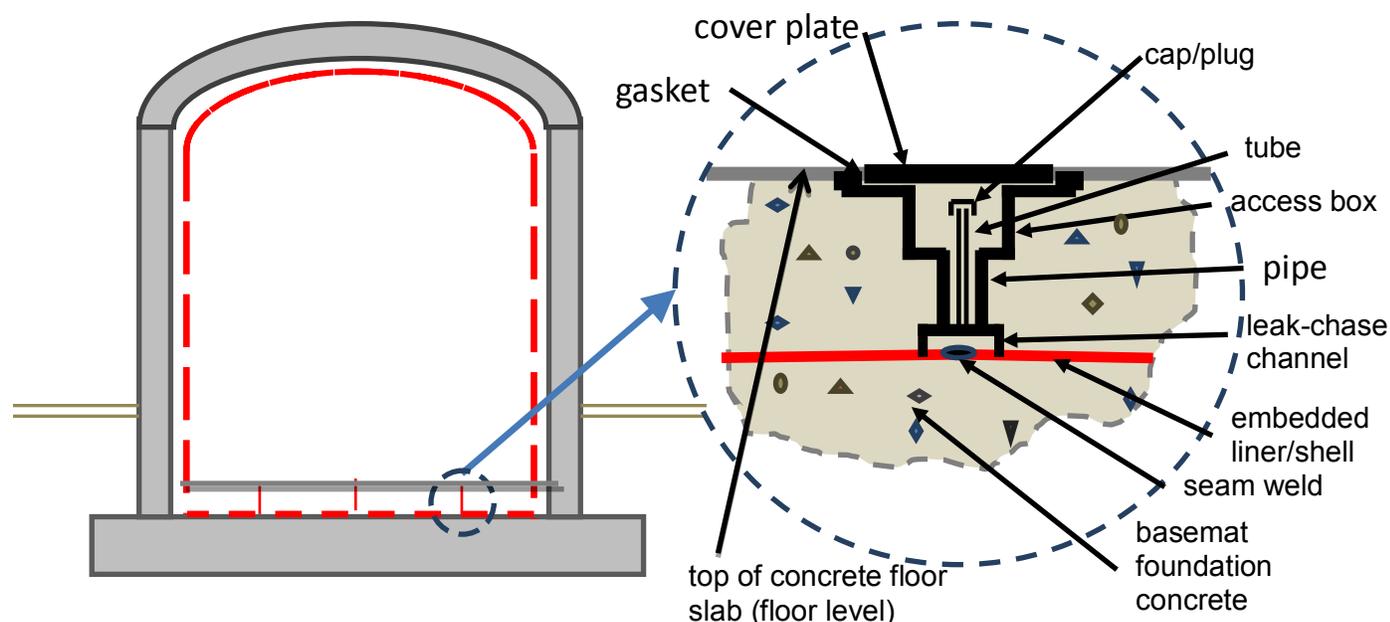
Figure 1: Conceptual illustration of typical containment basemat shell/liner leak-chase system

The tube extends up through the concrete floor slab to a small steel access (junction) box embedded in the floor slab. The steel tube, which may be encased in a pipe, projects up through the bottom of the access box with a threaded coupling connection welded to the top of the tube, allowing for pressurization of the leak-chase channel. After the initial tests, steel threaded plugs or caps are installed in the test tap to seal the leak-chase volume. Gasketed cover plates or countersunk plugs are attached to the top of the access box flush with the containment floor. In some cases, the leak-chase channels with plugged test connections may extend vertically along the circumference of the cylindrical containment shell or liner to a certain height above the floor. The NRC staff notes that there are variations in the design and layout of the leak-chase channel systems used in different containments.

The containment floor weld leak-chase channel system forms a metal-to-metal interface with the containment shell or liner, the test connection end of which is at the containment floor level. Therefore, the leak-chase system provides a pathway for potential intrusion of moisture that could cause corrosion degradation of inaccessible embedded areas of the pressure-retaining boundary of the basemat containment shell or liner within it. In addition to protecting the test connection, the cover plates and plugs and accessible components of the leak-chase system within the access box are also intended to prevent intrusion of moisture into the access box and into the inaccessible areas of the shell/liner within the leak-chase channels, thereby protecting the shell and liner from potential corrosion degradation that could affect leak-tightness.
