Part 21 (PAR)

Event # 49230

## PART 21 REPORT - DEVIATION OF HK CIRCUIT BREAKER CLOSE LATCH SPRING

**Subject: Amendment to Previous 10CFR Part 21 Notification of Deviation re. HK Circuit Breaker  
Close Latch Spring**

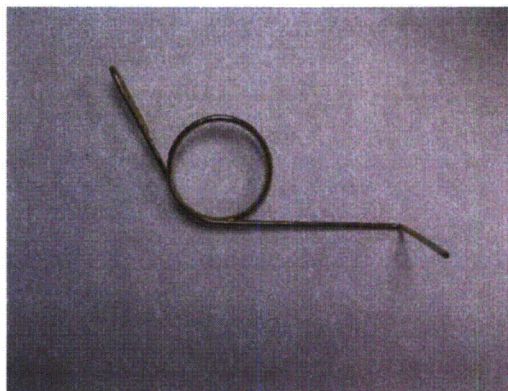
4. Nature of the deviation: The close latch springs provided during the reported time period have acceptable dimensional, material type and finish critical characteristics; however a sampling of springs were found to be as much as 34% lower initial moment and as low as 18% lower final moment relative to the nominal requirements of the master drawing. There is a potential for an aged HK circuit breaker with hardening grease (towards the end of the ABB 10-year recommended maintenance periodicity) and this reduced spring force not to close when commanded. No field failures or shop failures of this closing latch spring have been identified.

Figure 1 - Closing Latch Spring

- f. Revised part number 162374A00 spring drawing to revision 8 to include a larger free position angle. (Action complete)
  - g. Notified all customers affected from January 2010 to present. (Action Complete)

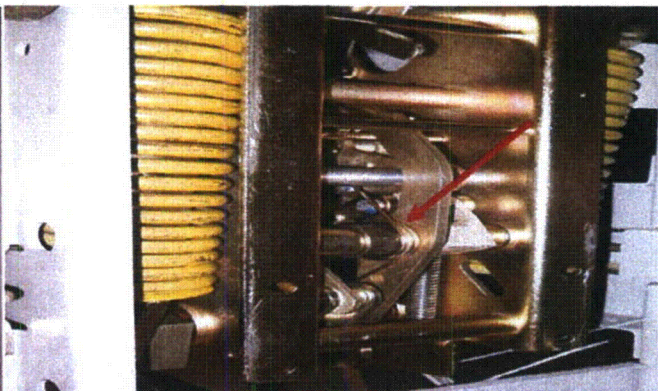
Figure 2 - Close Latch Spring in HK operating mechanism

7. Because of the large potential variety of usages of the affected HK circuit breakers, as well as the maintenance condition and periodicity, ABB (Medium Voltage Service) cannot determine if the potential for a substantial safety hazard exists at any licensee's facility due to this reduced spring force performance. It is recommended that the Licensees replace HK circuit breaker closing latch springs at the next convenient maintenance opportunity defined in the ABB HK circuit breaker Information Bulletin.
