**V. C. SUMMER NUCLEAR
STATION
Alpha Hot Leg
Evaluation and Repair**

**Presented to the Office of
Nuclear Reactor Regulation (NRR)
Rockville, MD
November 21, 2000**

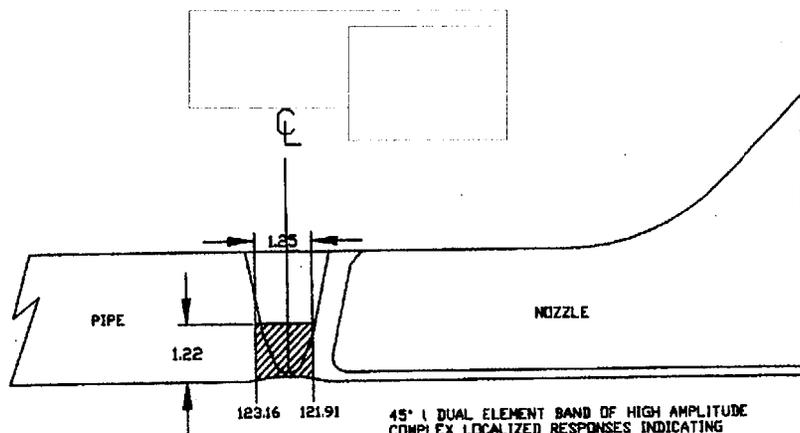
45° / DUAL ELEMENT BAND OF HIGH AMPLITUDE
COMPLEX LOCALIZED RESPONSES INDICATING
POSSIBLE METALLURGICAL CHANGES OR WELD
REPAIR CAVITY
