V. C. SUMMER NUCLEAR STATION

Alpha Hot Leg Evaluation and Repair

**Presented at the
V.C. Summer Nuclear Station
Jenksville, SC
January 18, 2001**

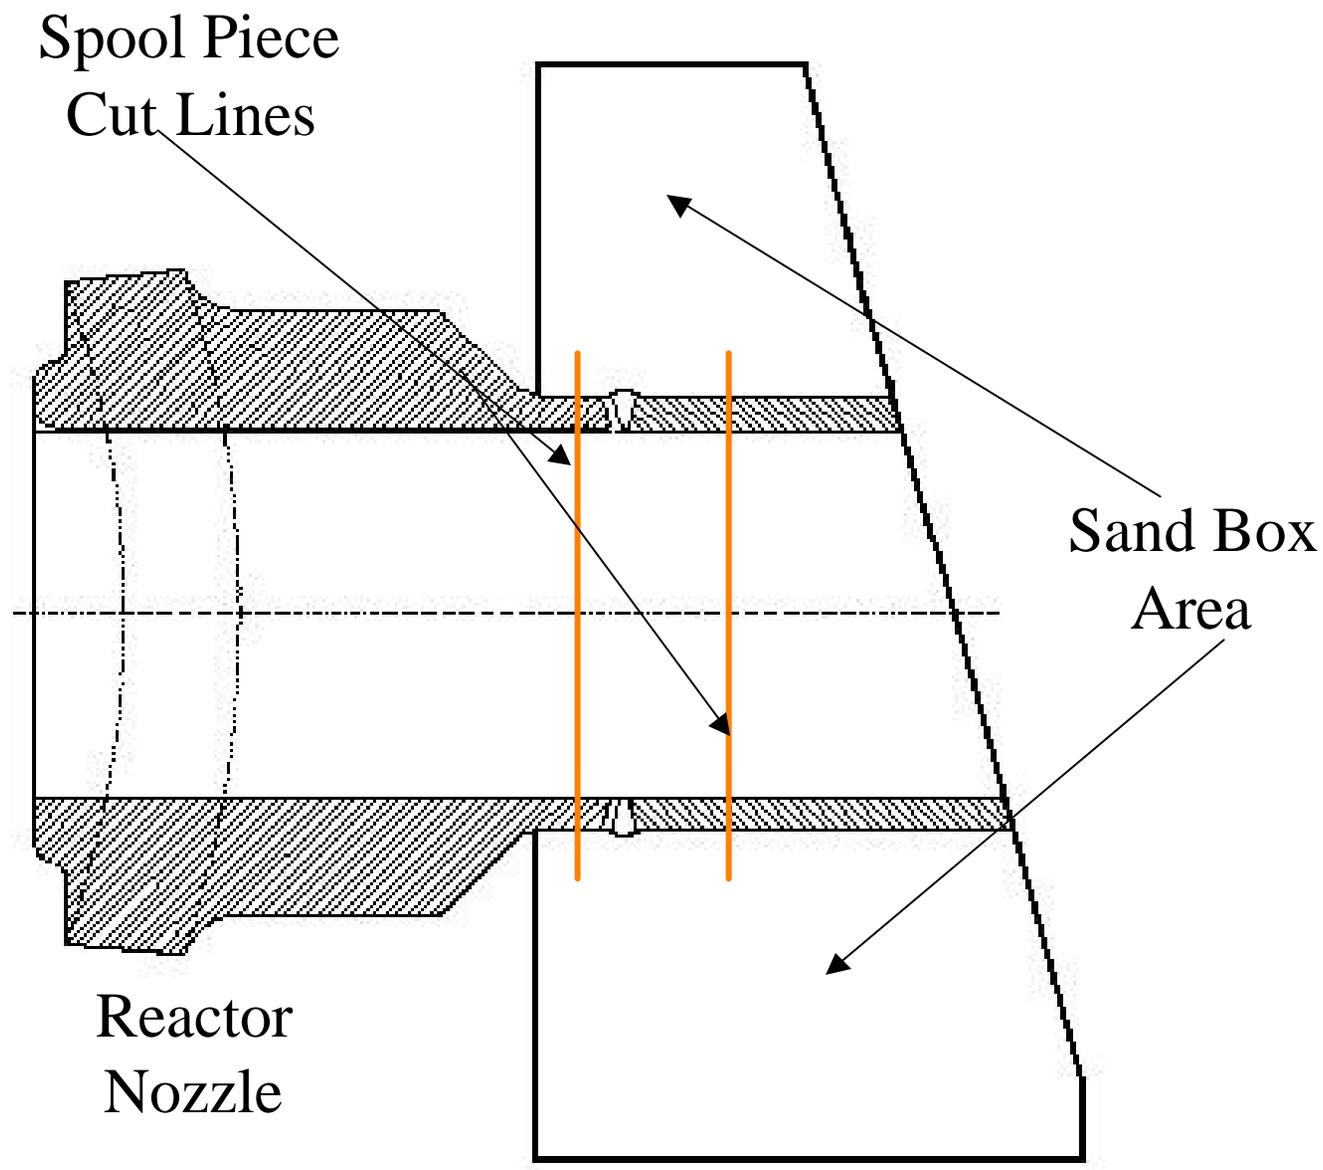
- Remove Section of Pipe Including Original Weld
- Create Two New Welds
- Narrow Groove Weld Design
 - Entire Weld Made Externally from Inside to Outside
 - Reduces ID Tensile Stresses
- Challenges
 - Limited Space for Repair Tooling & Personnel
 - Long Repair Process
 - Radiation Exposures

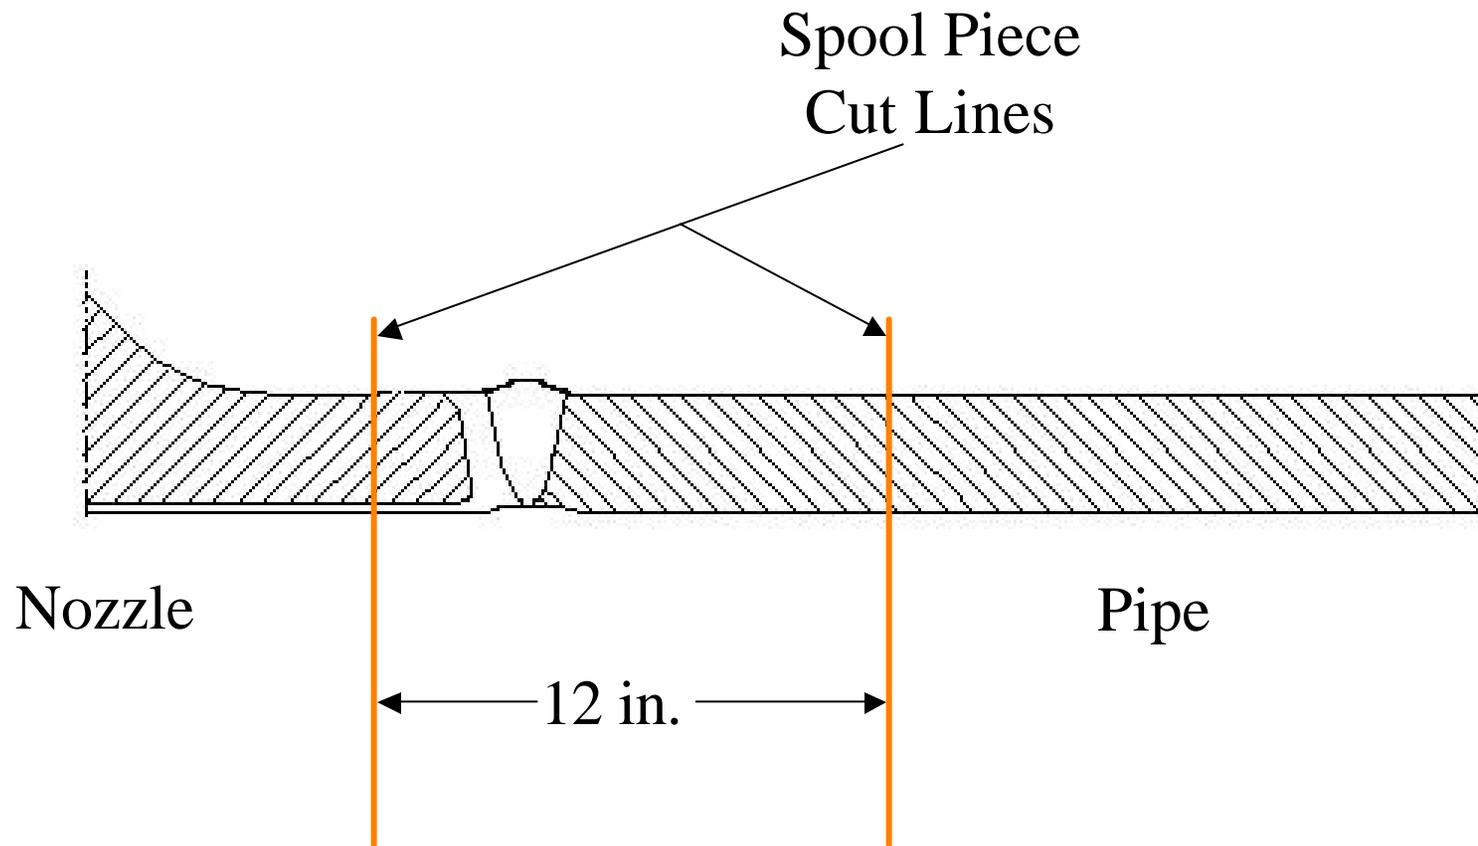
STEP 1 - SPOOL PIECE REMOVAL

- Sever Reactor Vessel Nozzle to Ensure All of Flaw Was Removed
- Sever Pipe About 12 Inches Away From Nozzle Cut
- Remove Section of Pipe to Send Offsite for Evaluation

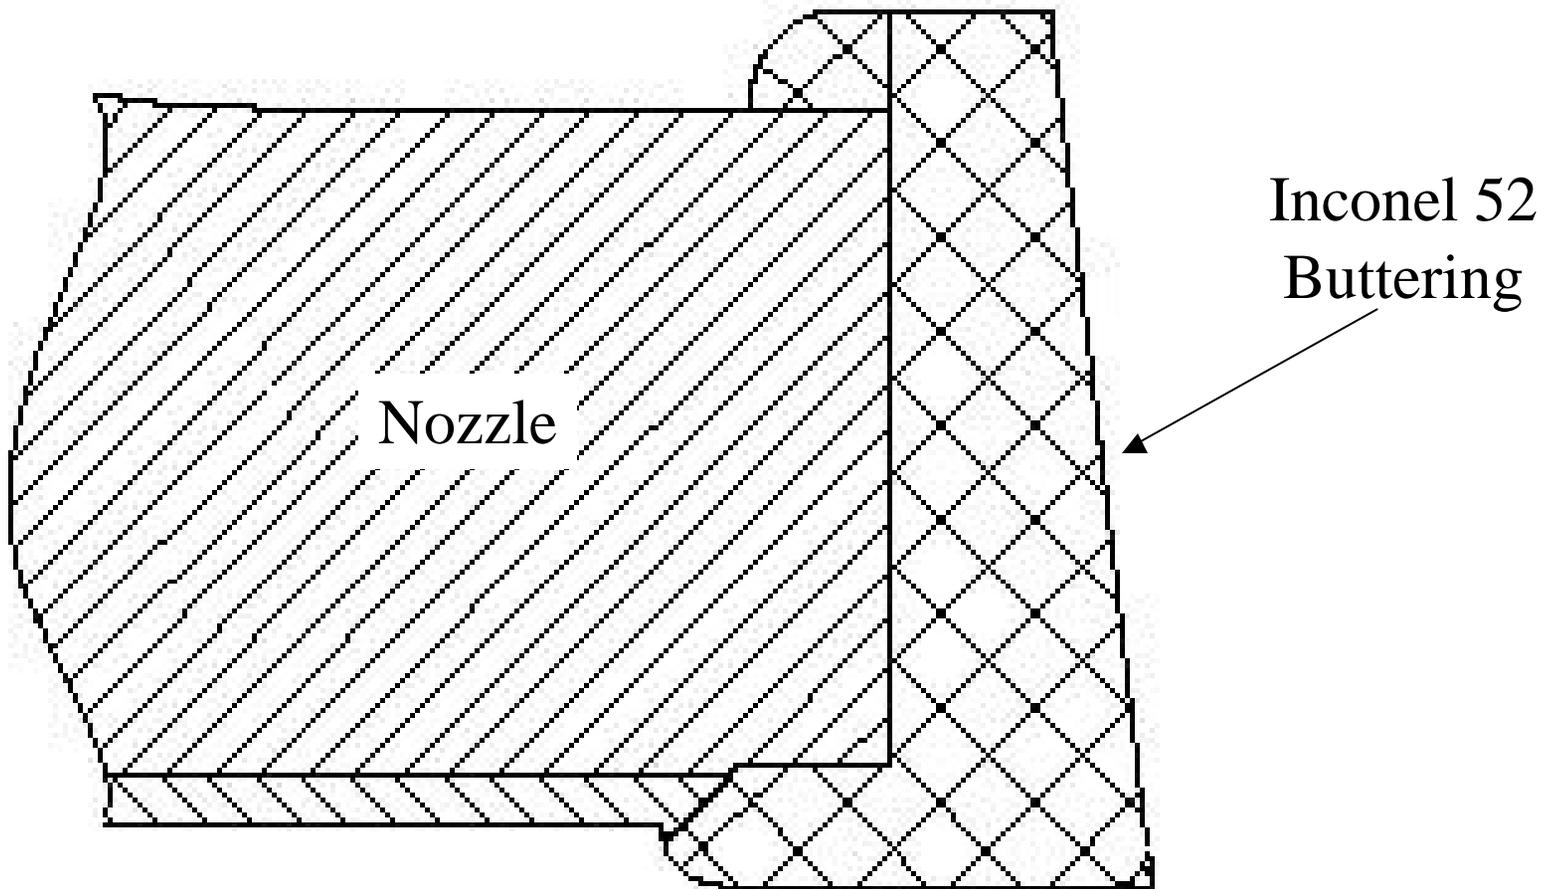
STEP 2 - PREPARE NOZZLE

- Preheat the Nozzle
- Deposit New Inconel 52 Material (Buttering) on Nozzle Face Using Temperbead Process

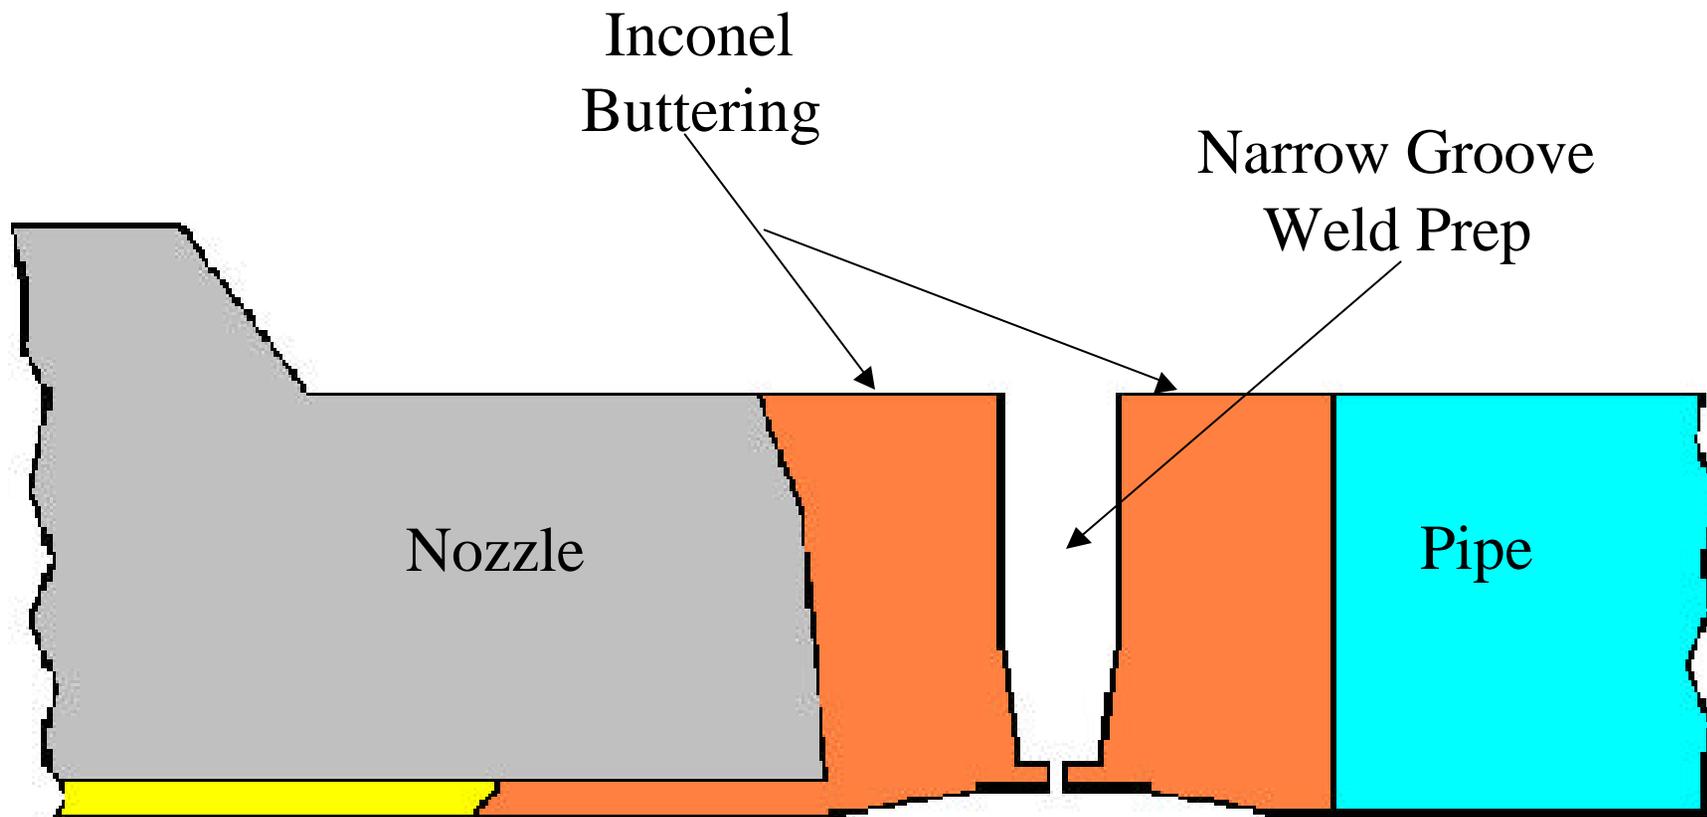
STEP 4 - MACHINE WELD PREPS

- Buttered Nozzle
- Existing Pipe
- Both Ends of New Replacement Spool Piece

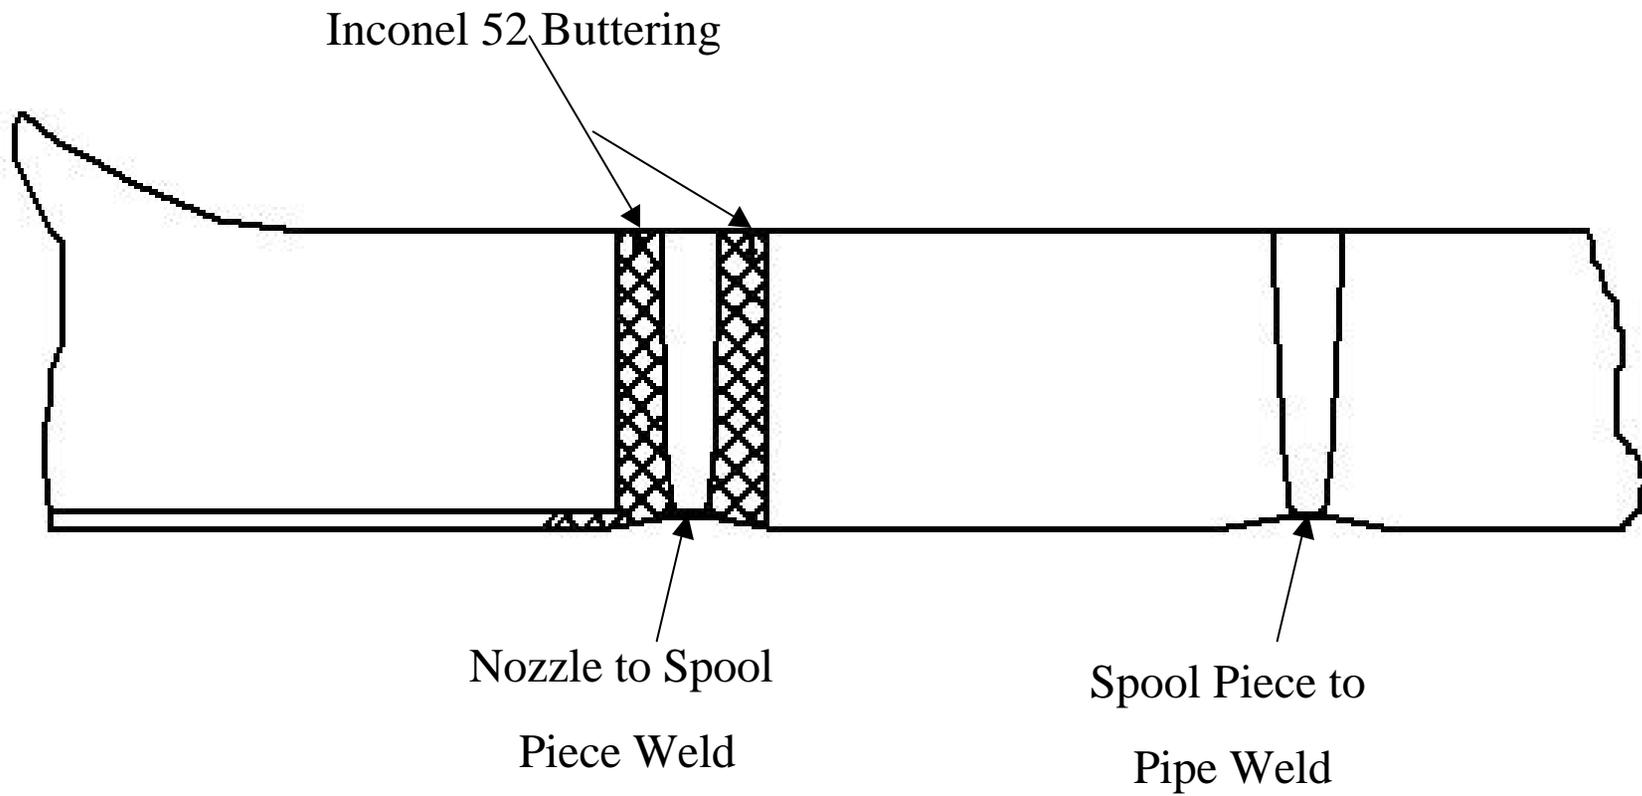
STEP 5 - INSTALL REPLACEMENT SPOOL PIECE

- Install New Spool Piece Into Open Section of Pipe
- Progressively Weld Both Spool Piece Welds Externally From ID to OD

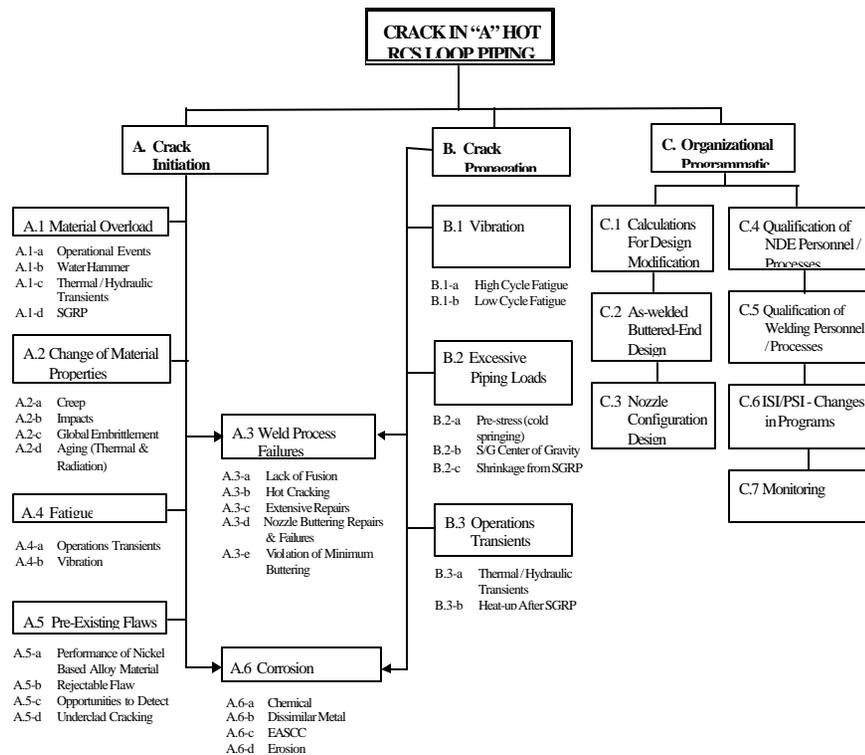
Root Cause Failure Modes

- 30 Failure Modes
- 7 Org / Programmatic
- 5 Supported Failure Modes
- 4 Org / Programmatic Contributing Factors.

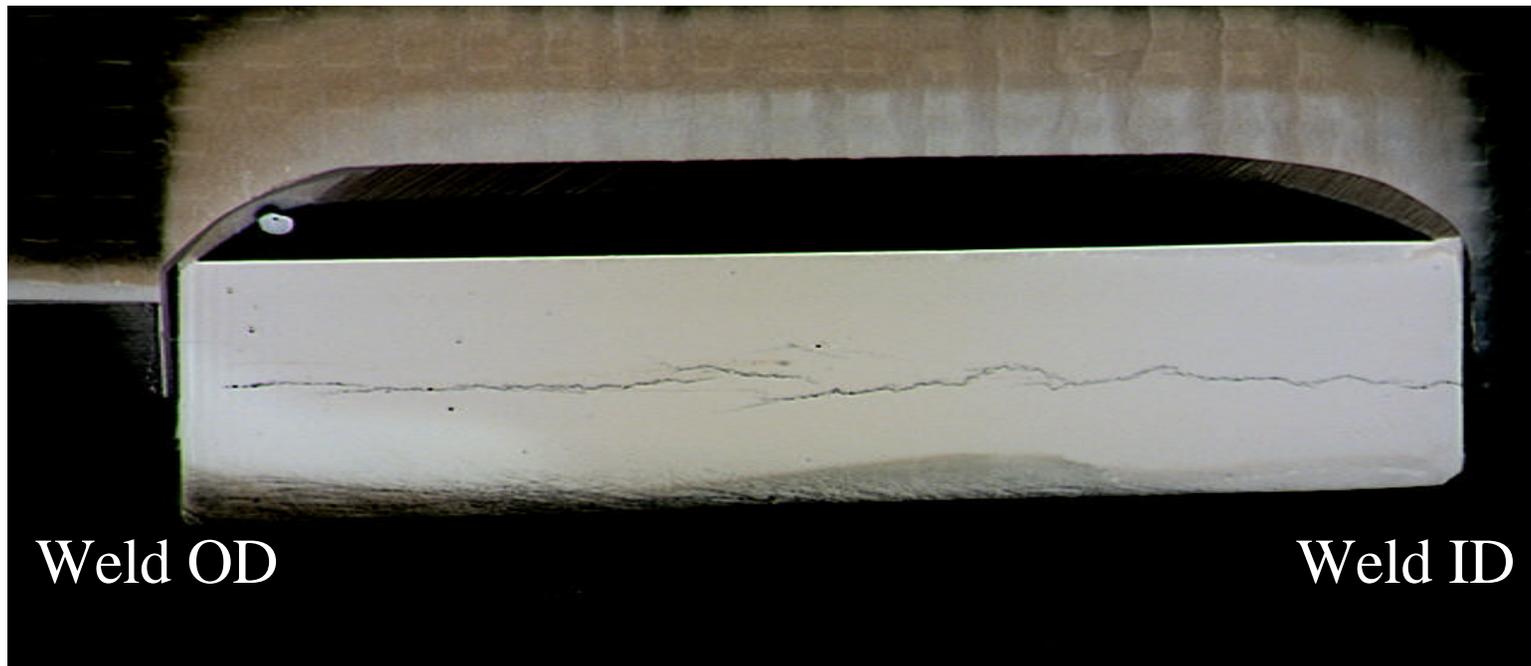
Metallography Results of Axial Crack (7°)

Looking From the Nozzle Towards the Pipe.

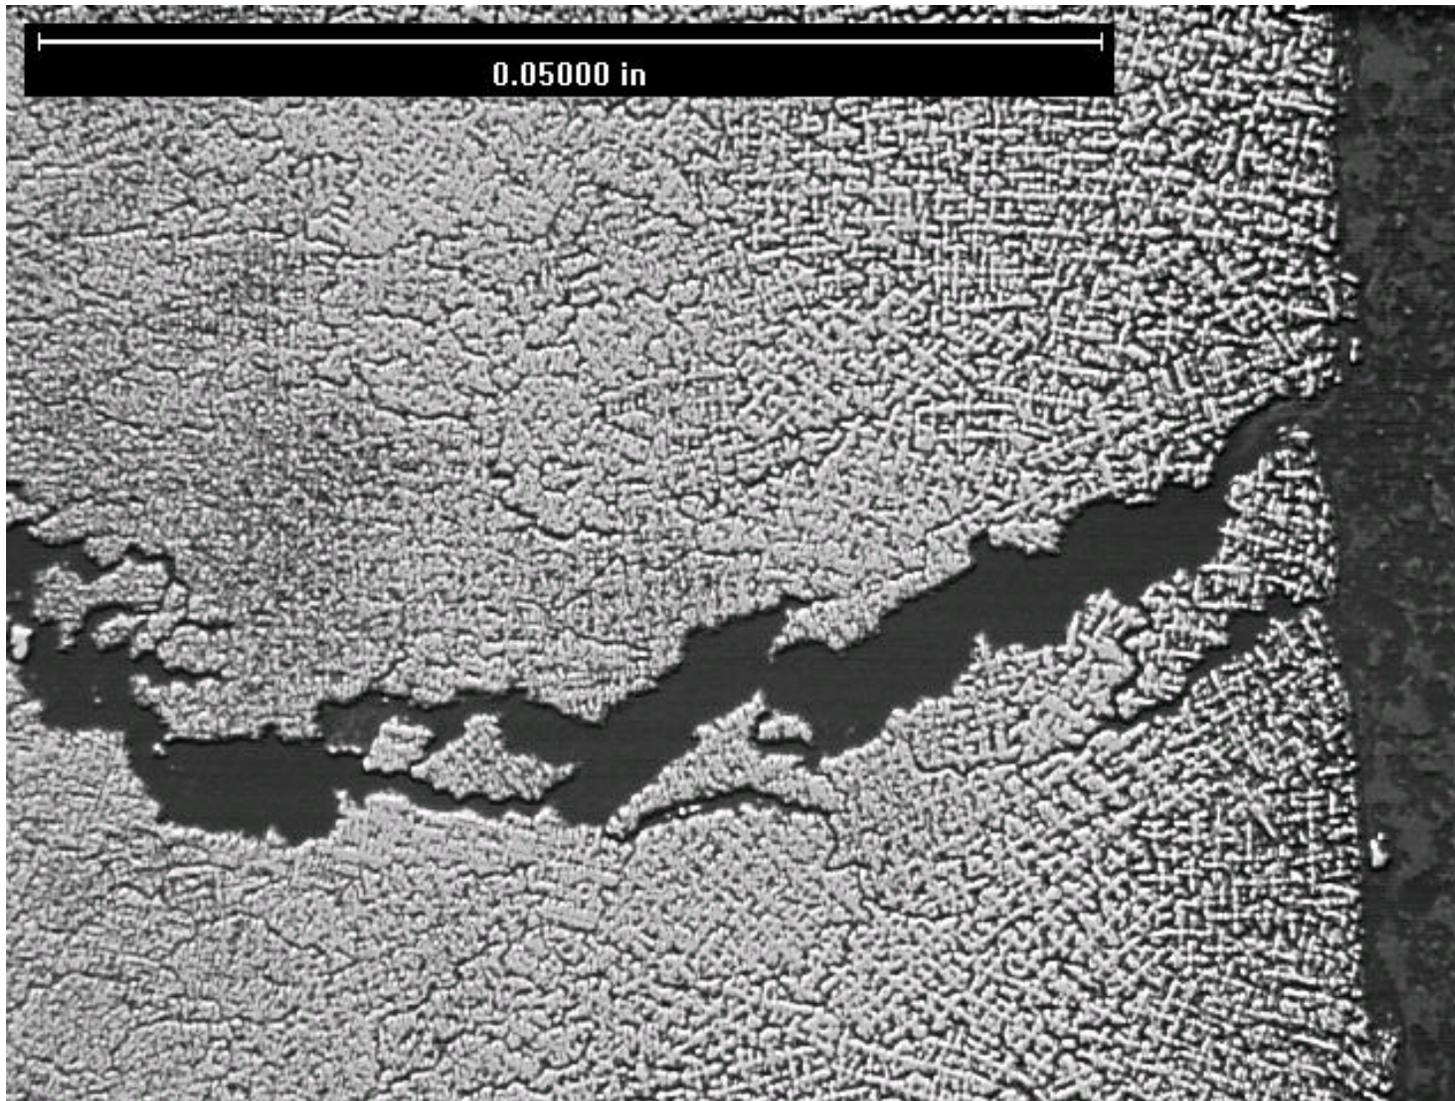
**Metallography of Through Wall Crack at the ID Surface (7⁰)
Magnified 50x**

- Some ET Indications Confirmed -- PWSCC Cracks Following Interdendritic Morphology.
- Some ET Indications Were Not Cracks
- Axial Through Wall Crack - Multiple Initiation Sites.
- Axial Crack Contained Within Weld, Butter, HAZ.
- Circumferential Crack Contained in Cladding.

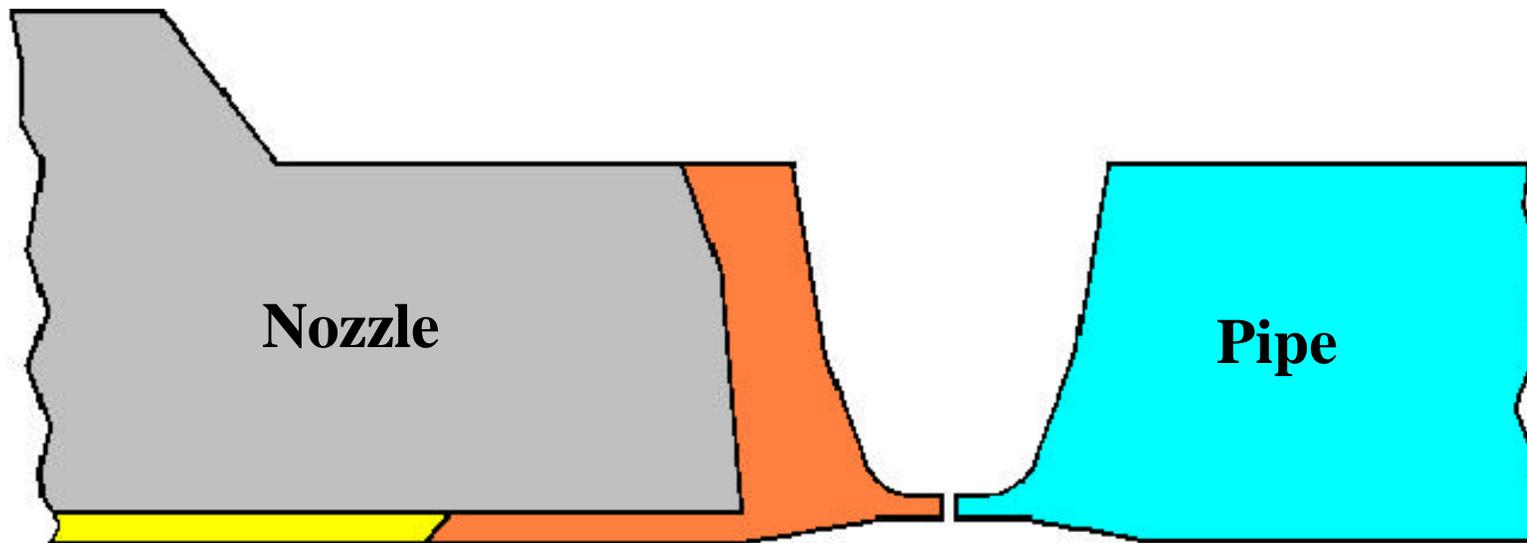
This is the start of the original weld. It was designed to be filled from the ID out toward the OD

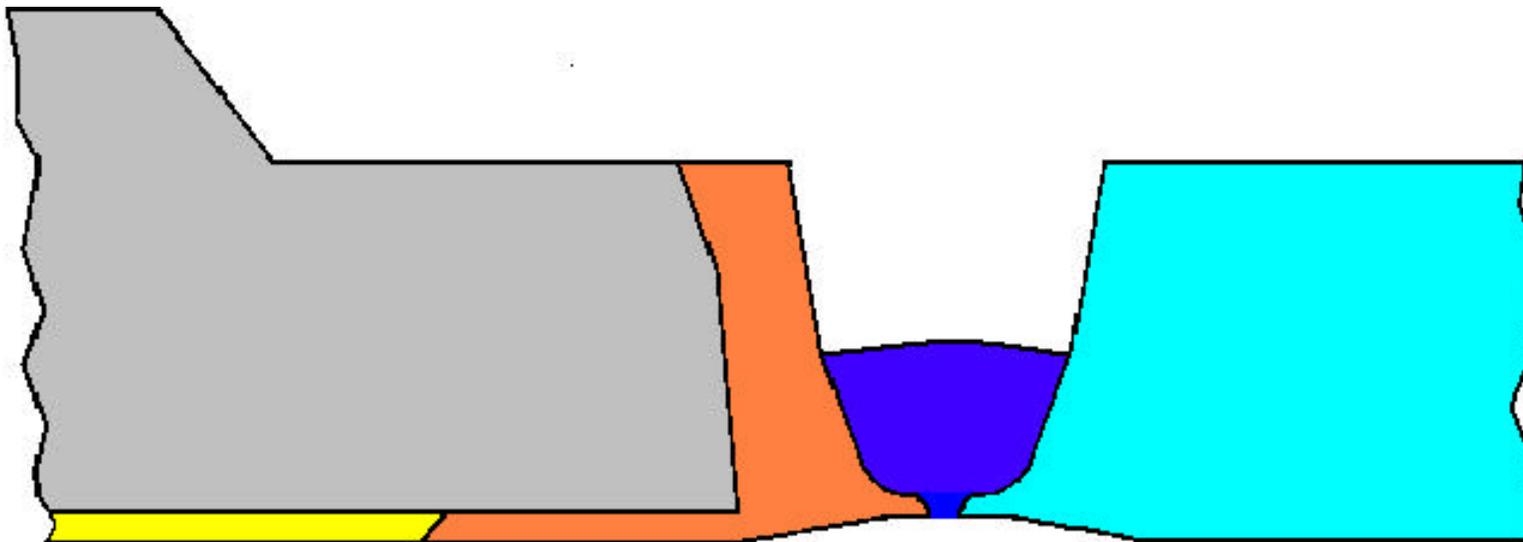
The first pass was made per design but rejected

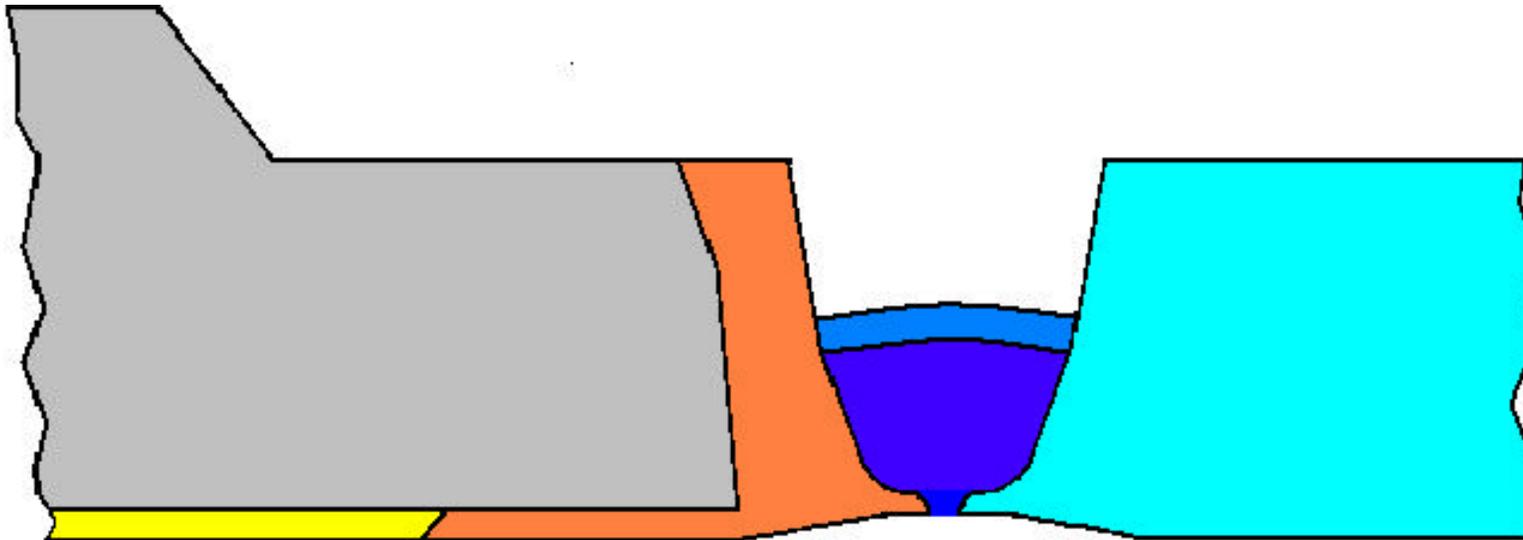
A bridge was laid in to stabilize the pipe

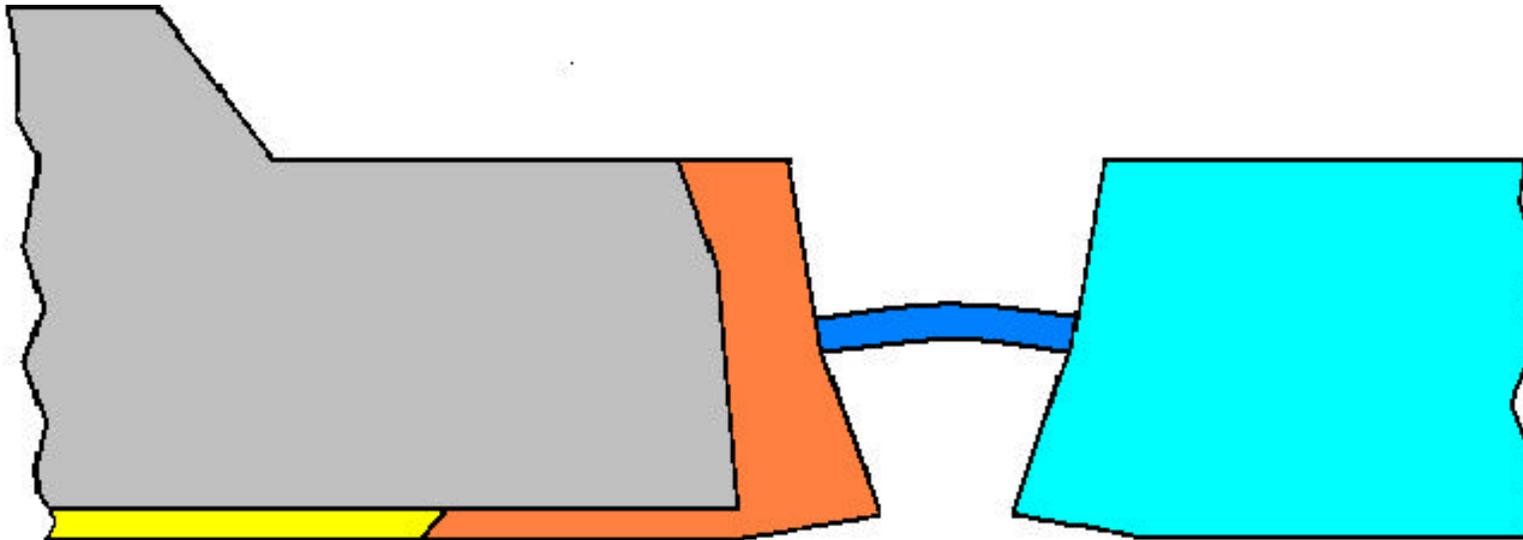
The rejected area was removed

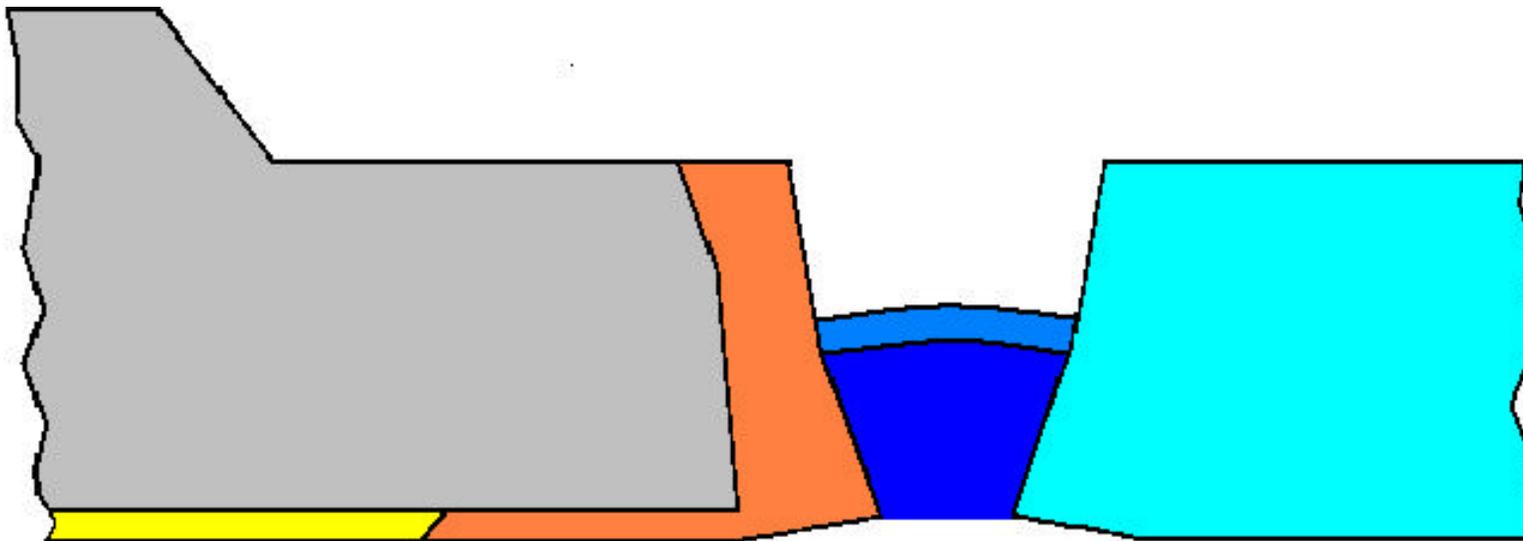
Weld was reapplied from the bridge to the ID

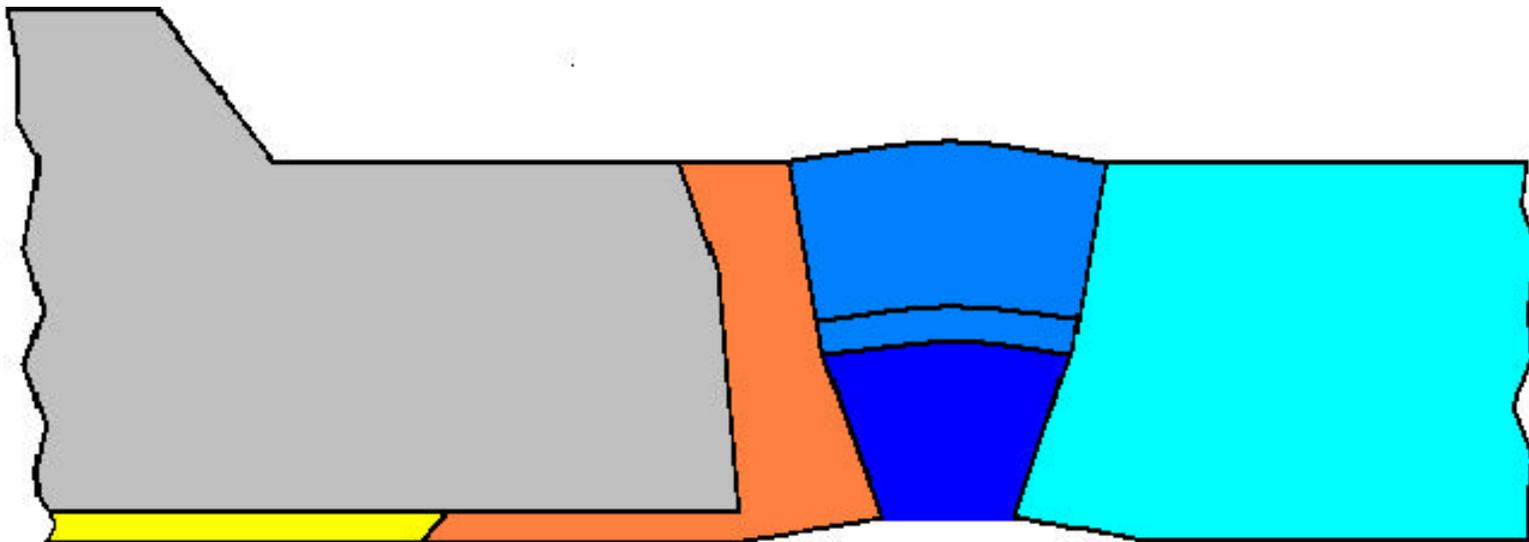
The weld was then completed from the bridge to the OD

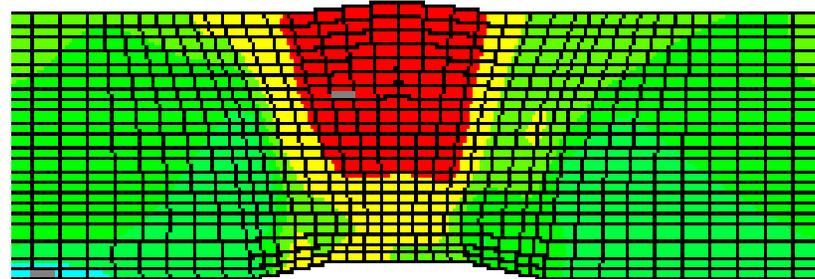
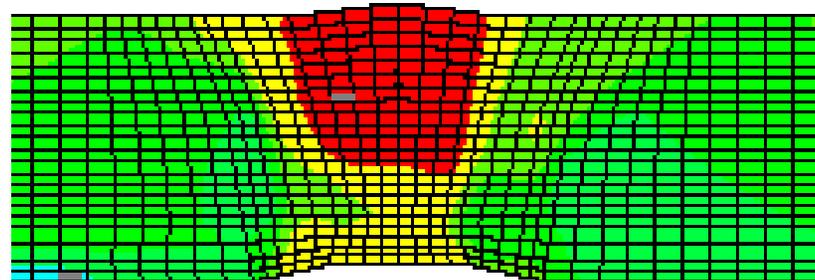
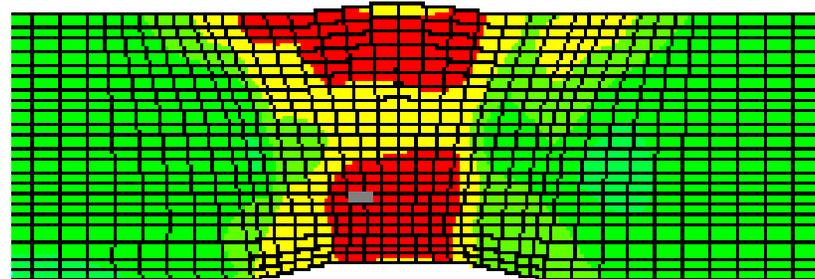
*VC Summer Nozzle
Stresses*

- As Designed
- ID Welded First
- ID Welded Last

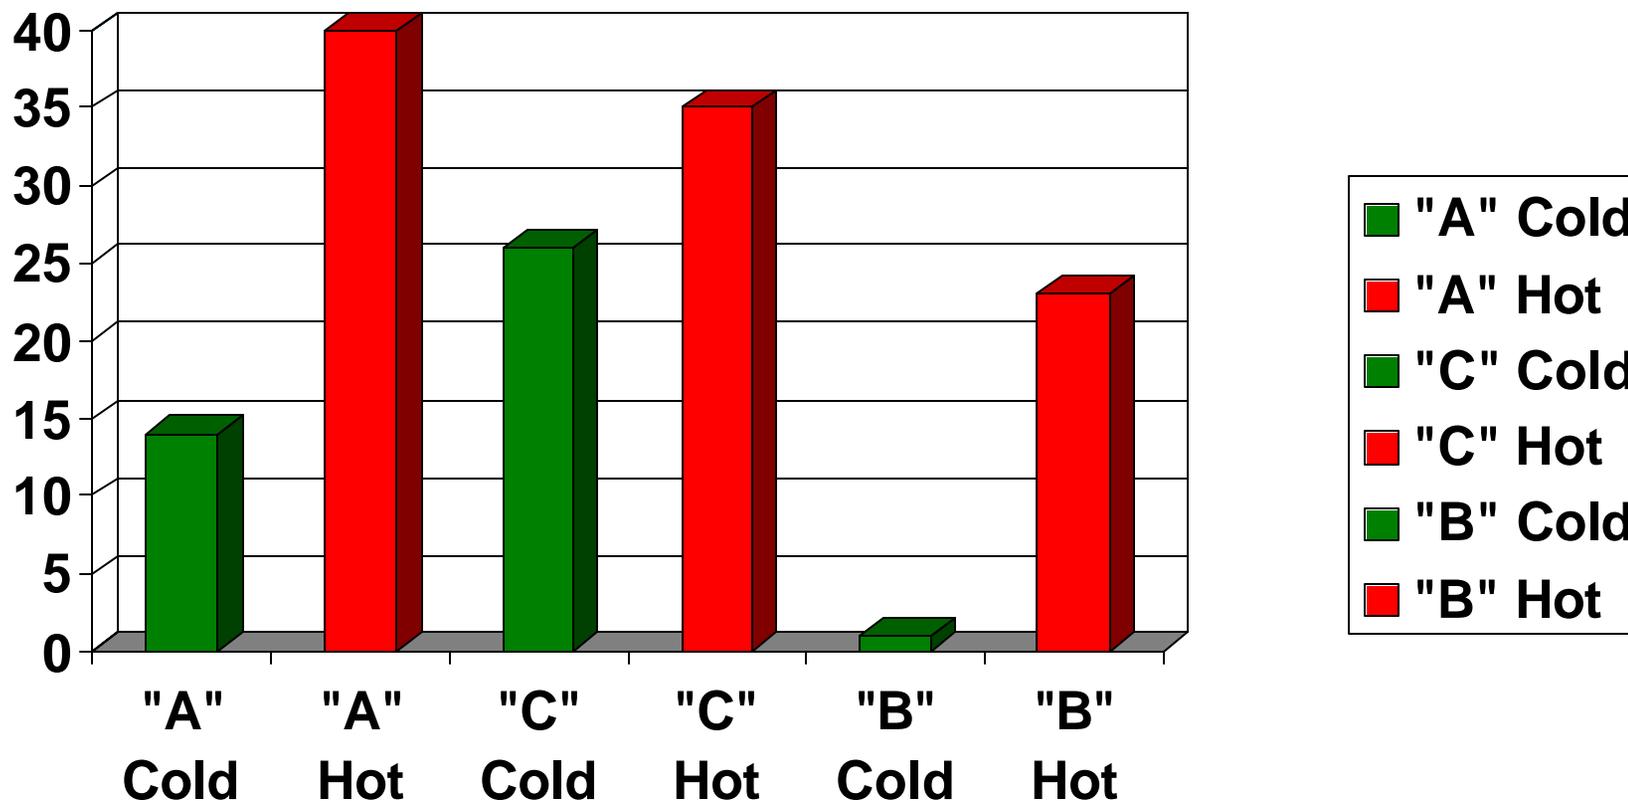
**ET Identified 139 Indications in the Nozzle
to Pipe Connections**

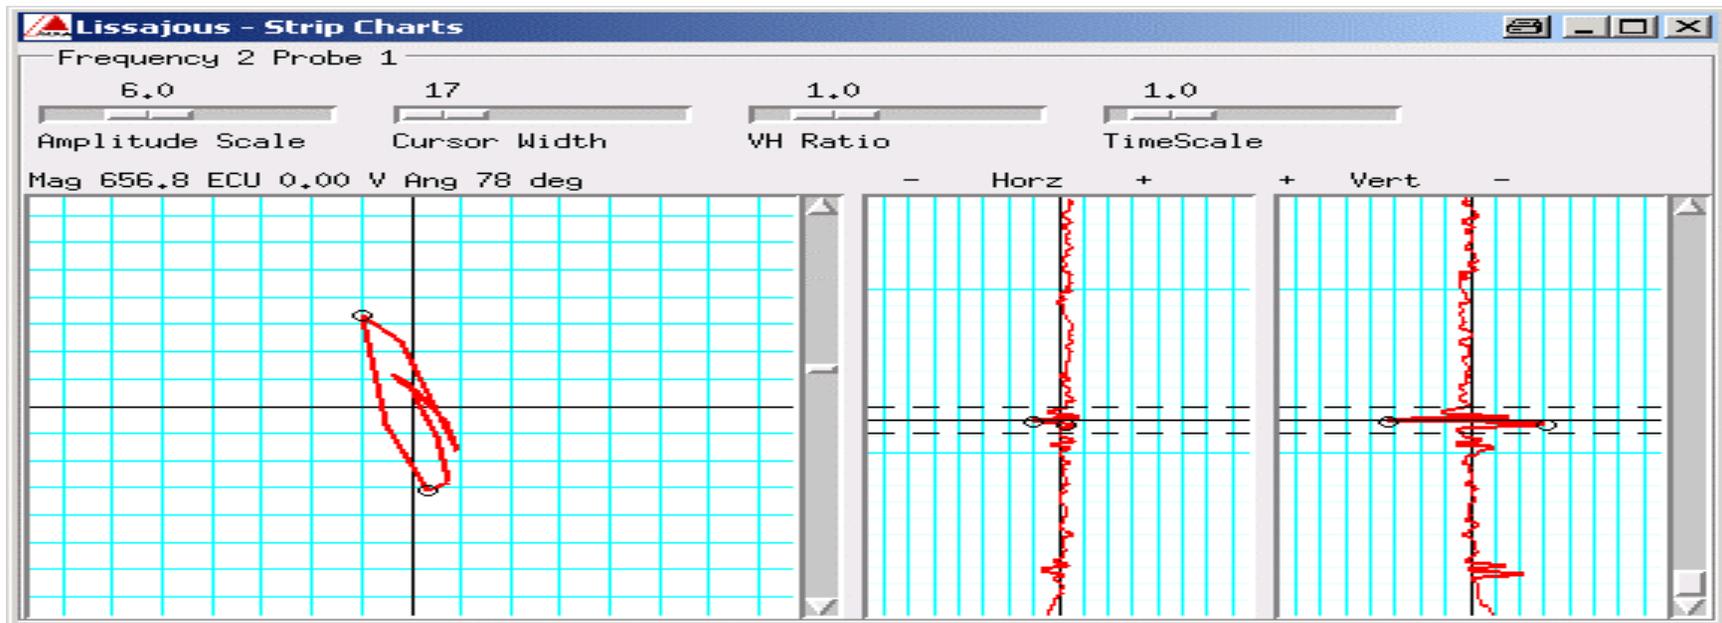
Lissajous from NQI 1 Indication in Nozzle N-95

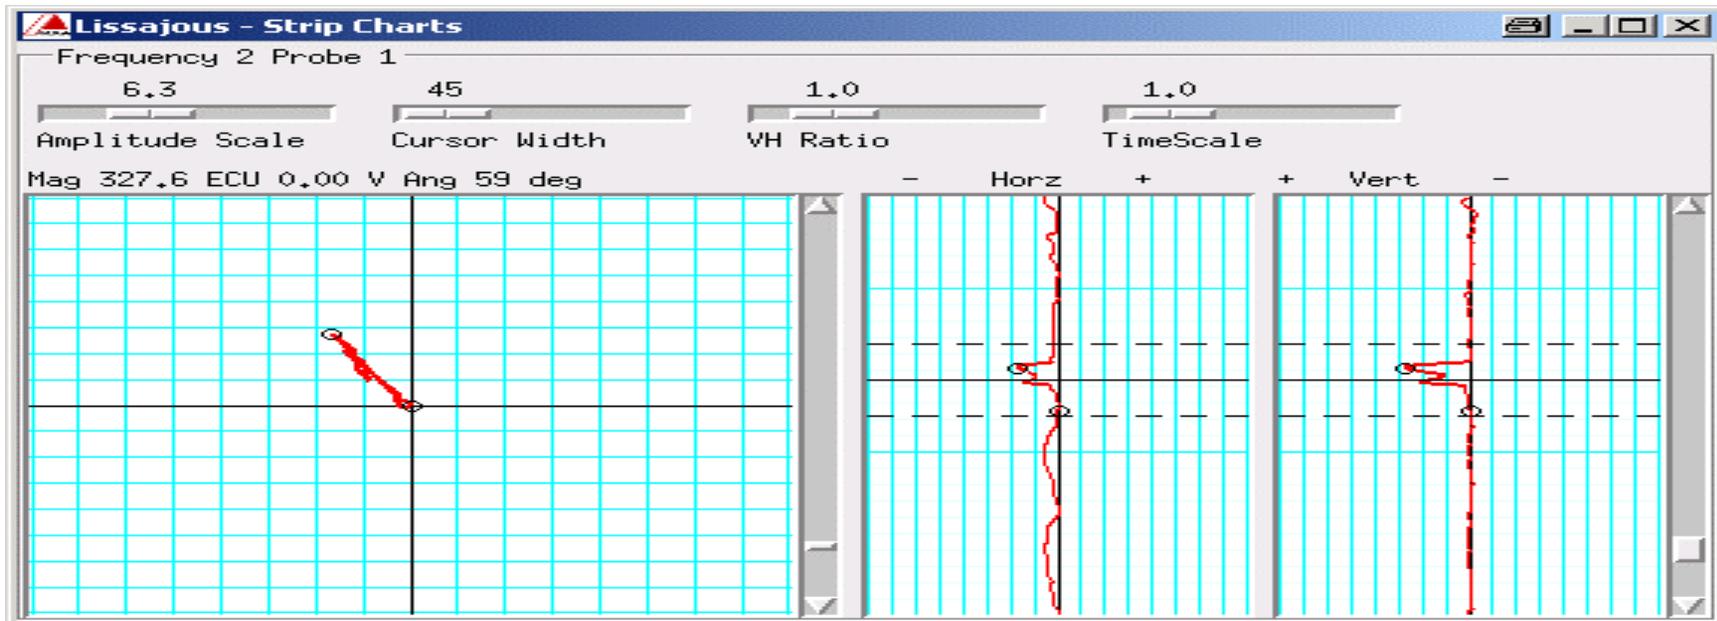
Lissajous from Circumferential Indication in Nozzle N-335
(Axial: 125.00; Circ.: 326 deg. Actual)

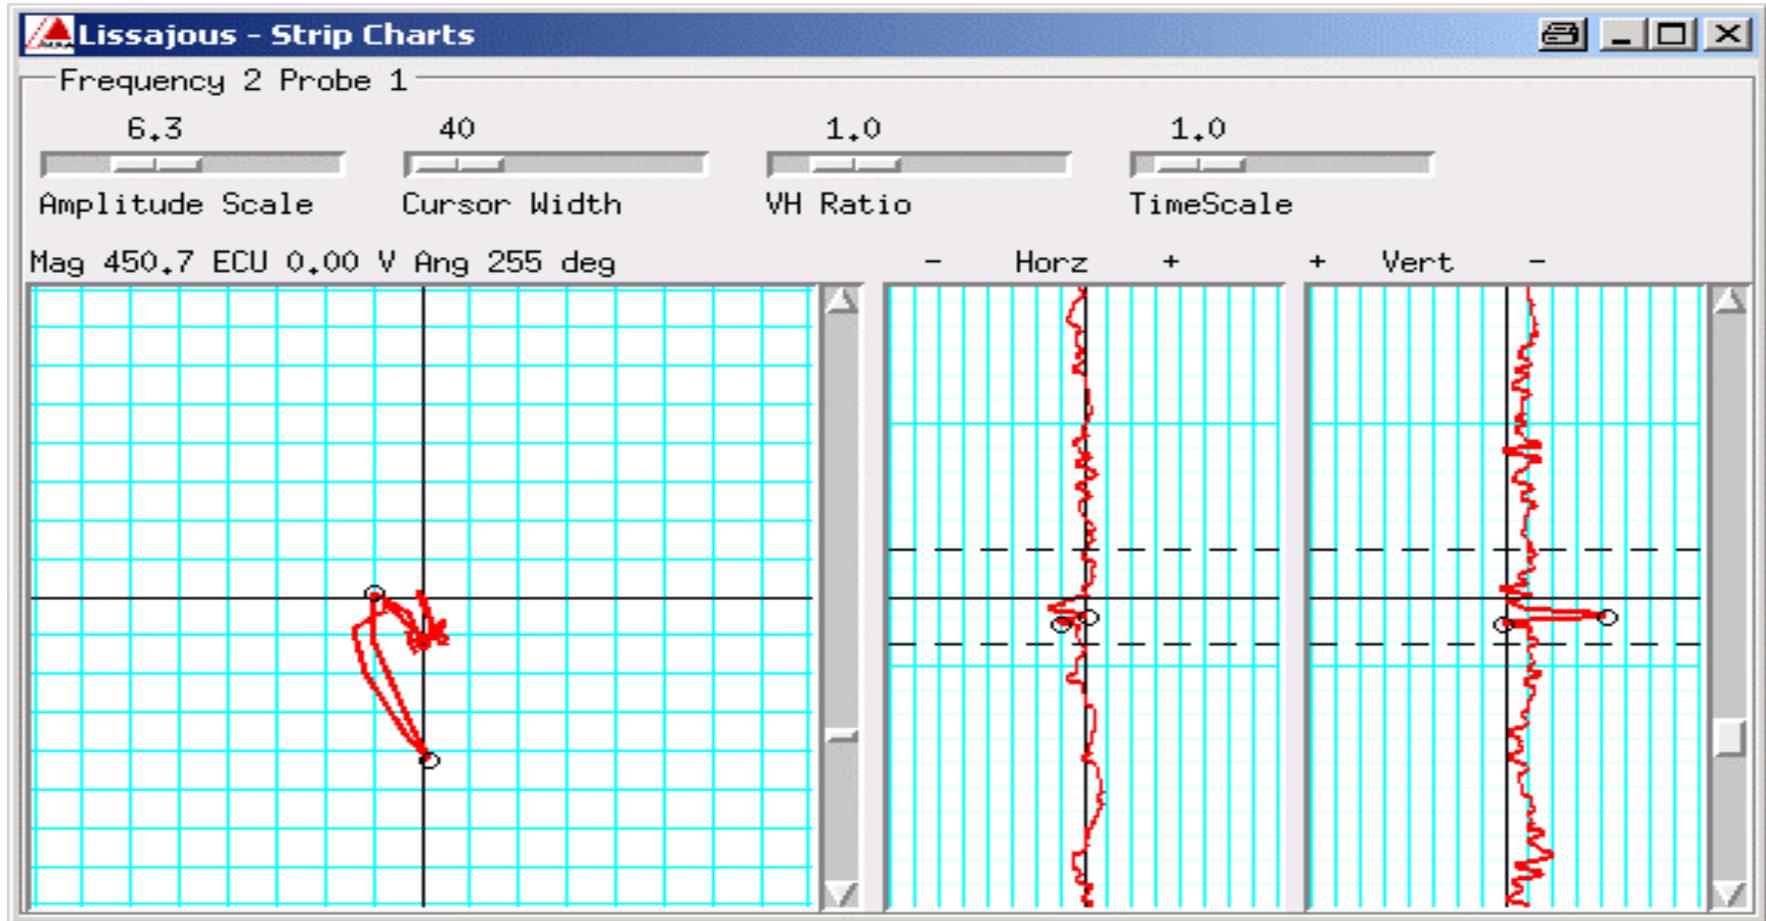
Lissajous from Axial Indication in Nozzle N-145
 (Axial: 121.375; Circ.: 282 deg. Actual)

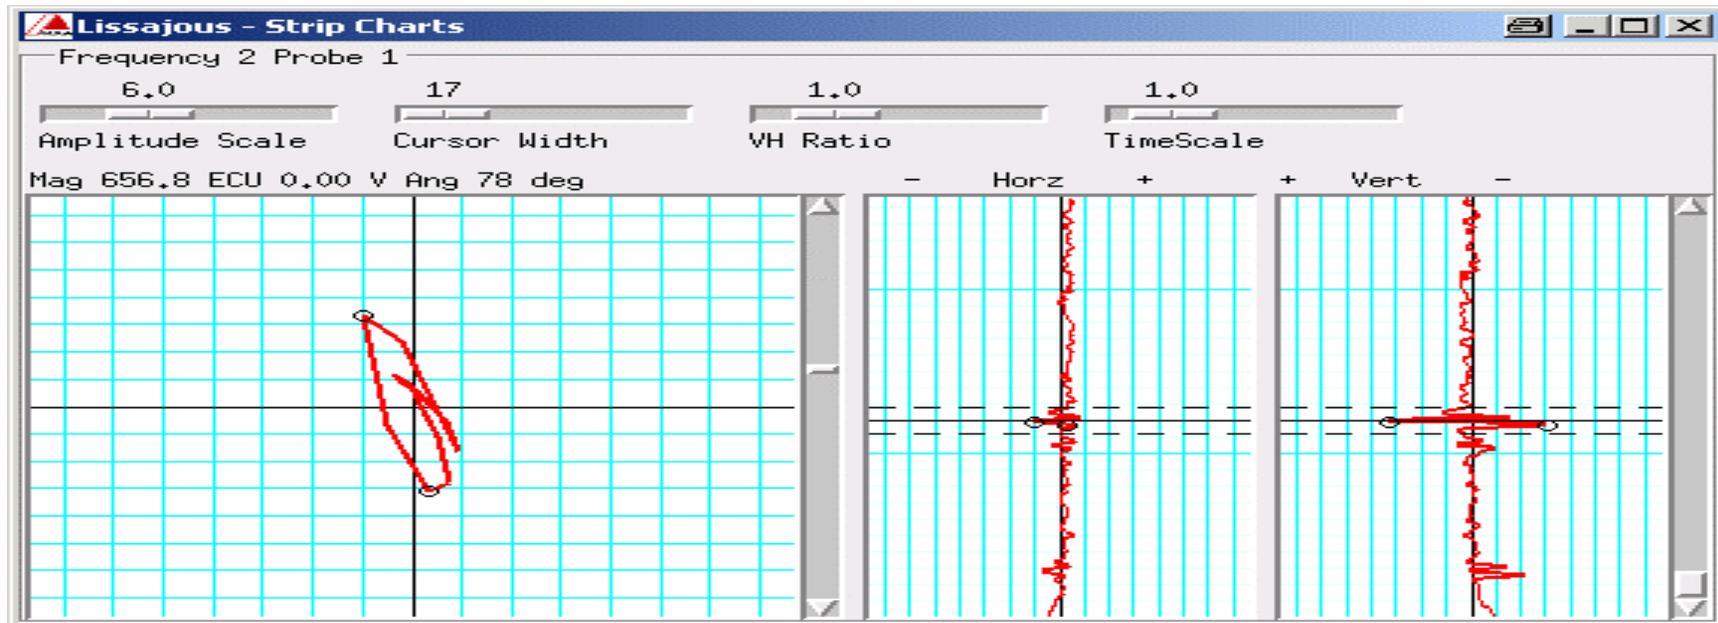
Lissajous from NQI 1 Indication in Nozzle N-95
