V. C. SUMMER NUCLEAR STATION

Alpha Hot Leg Evaluation and Repair

**Presented at the
V.C. Summer Nuclear Station
Jenksville, SC
January 18, 2001**

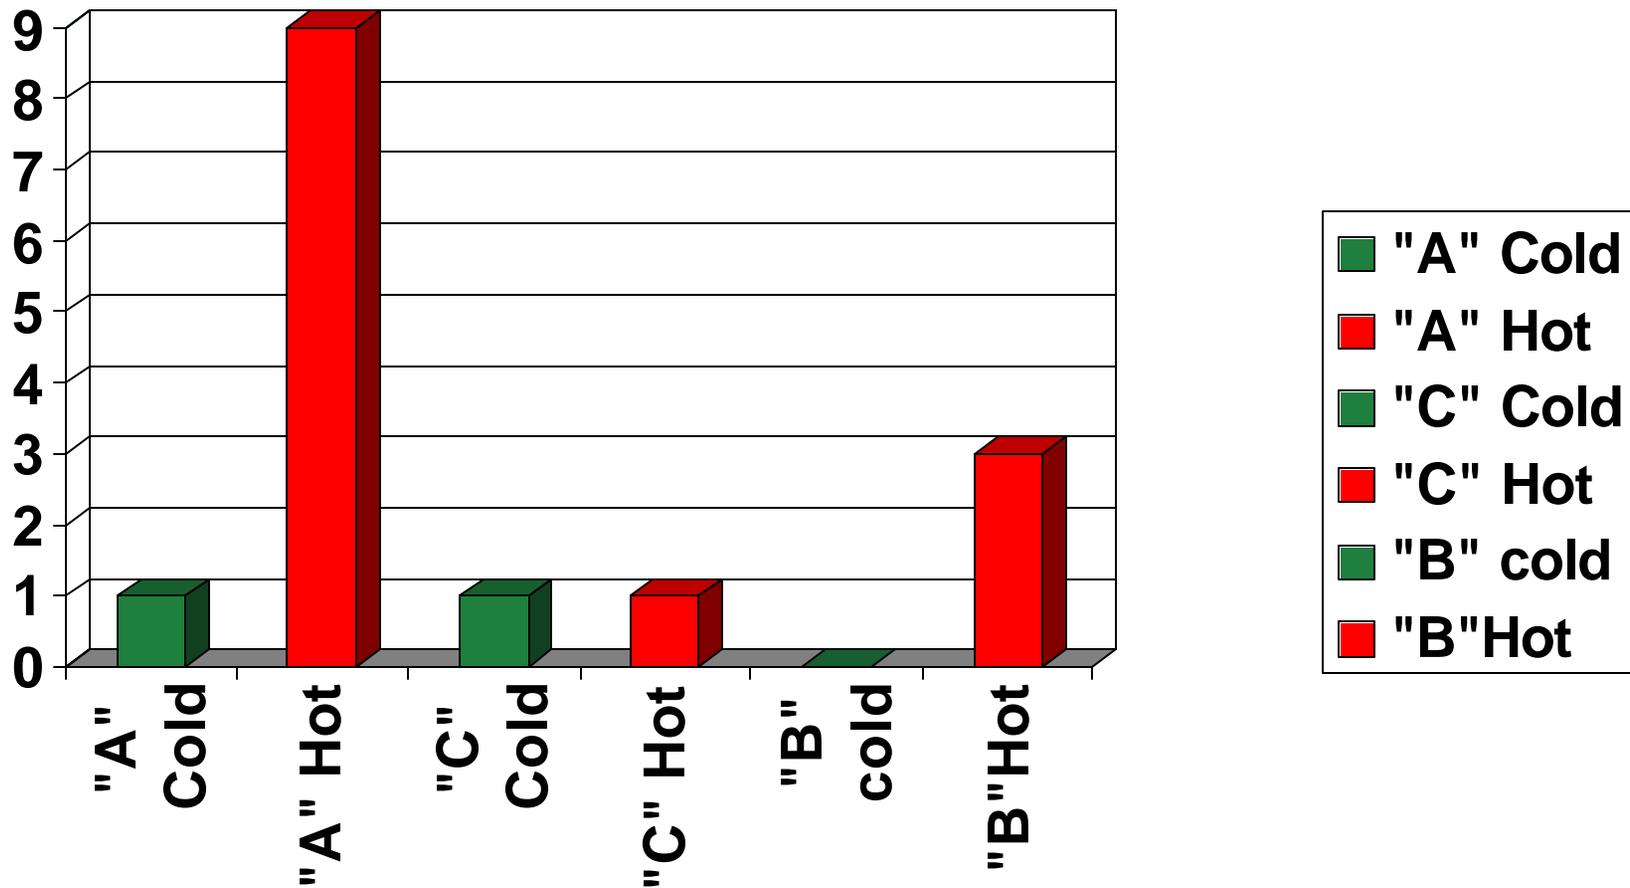
15 Relevant Indications

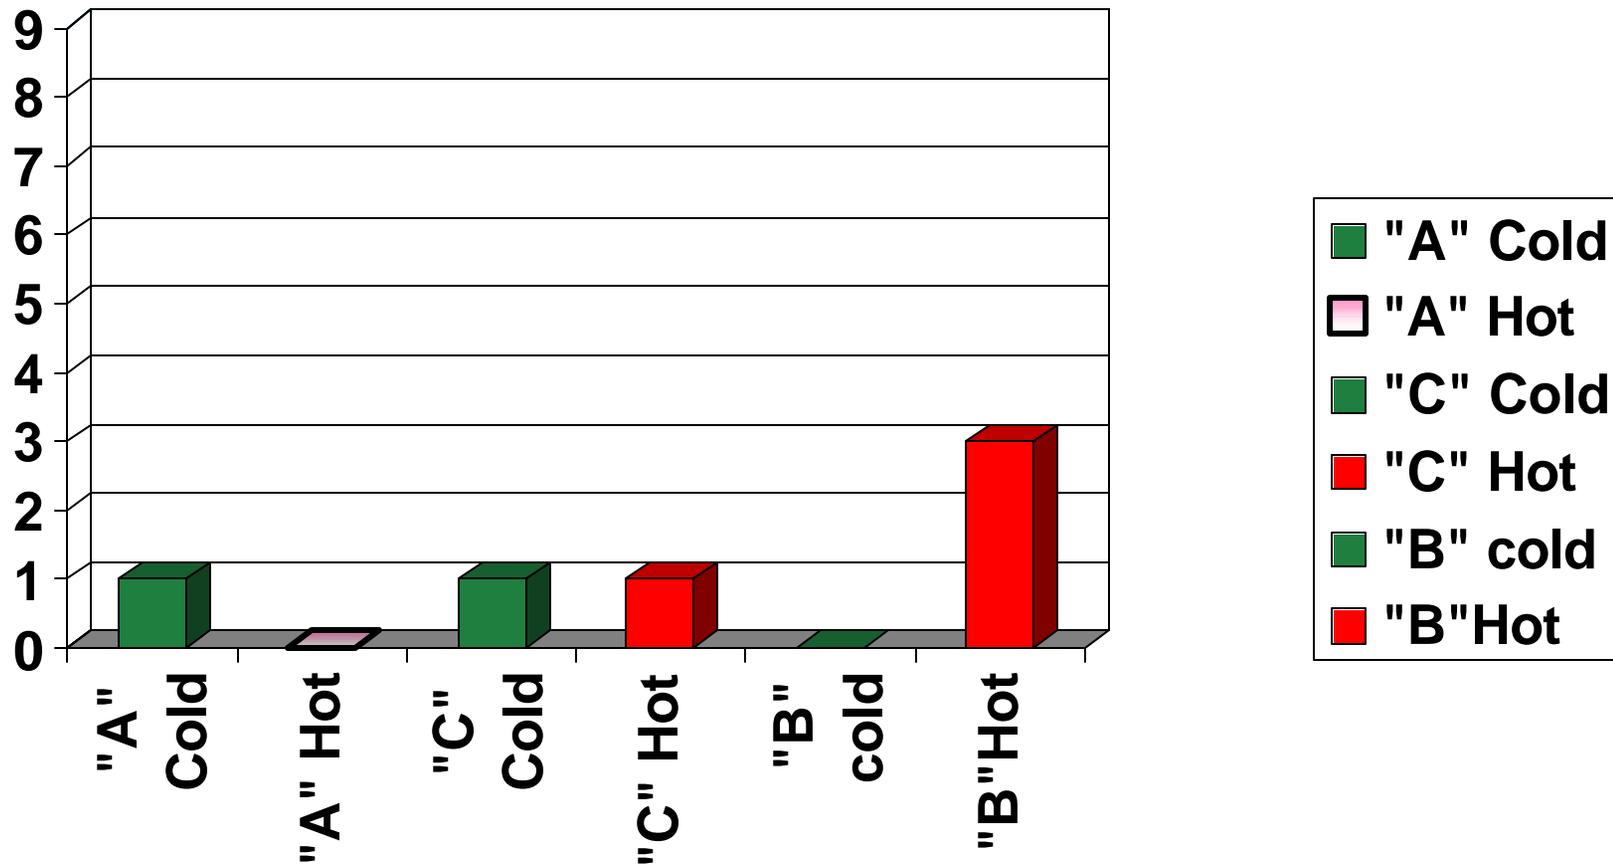
6 Relevant Indications

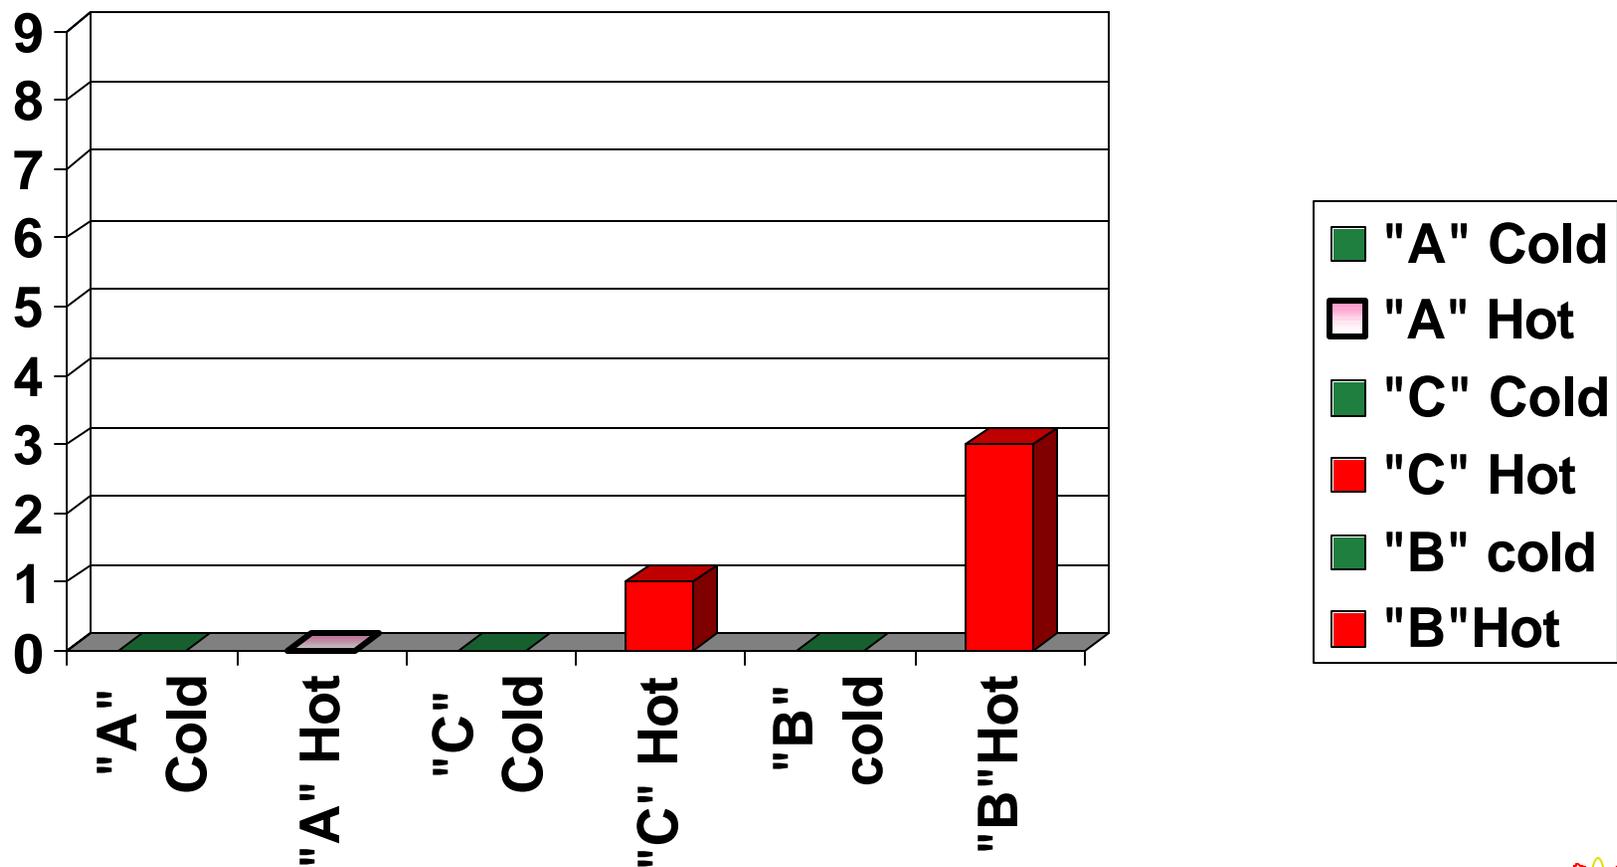
4 Relevant Indications
