Figure 1. Davis-Besse RPV Top of Head Section View

Figure 7. Locations of Cracks and Corrosion on Davis-Besse RPV Head at 13RFO

Root Cause Analysis Report

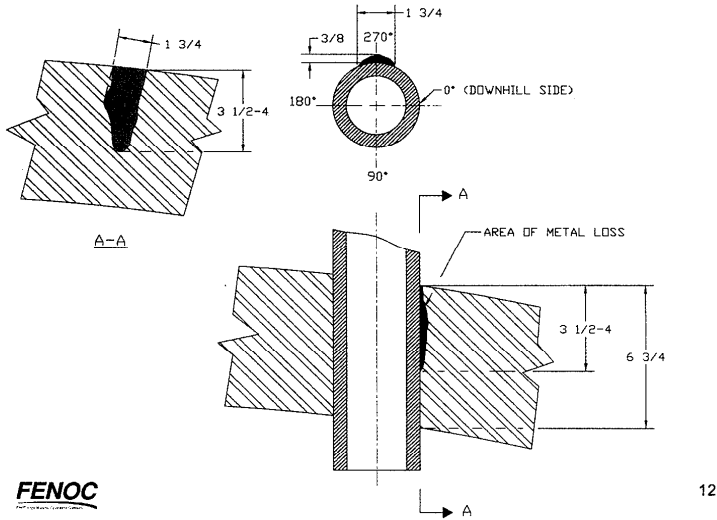
Figure 5 Nozzle 2 Corrosion Area Location, Size, and Profile.

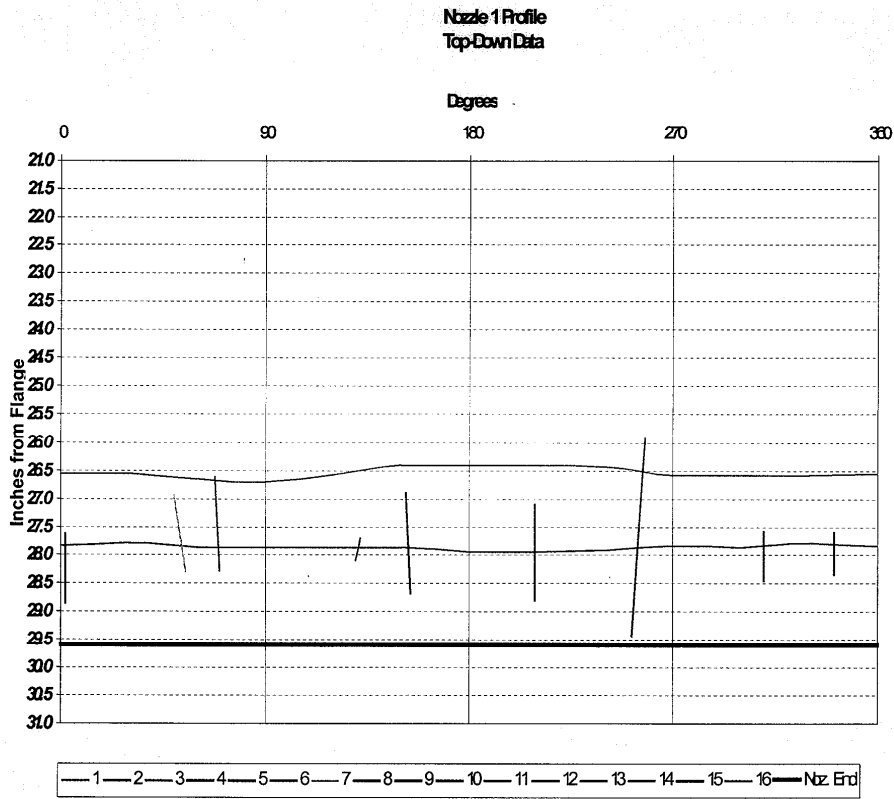
Figure 8. Nozzle 1 Crack Locations and Sizing

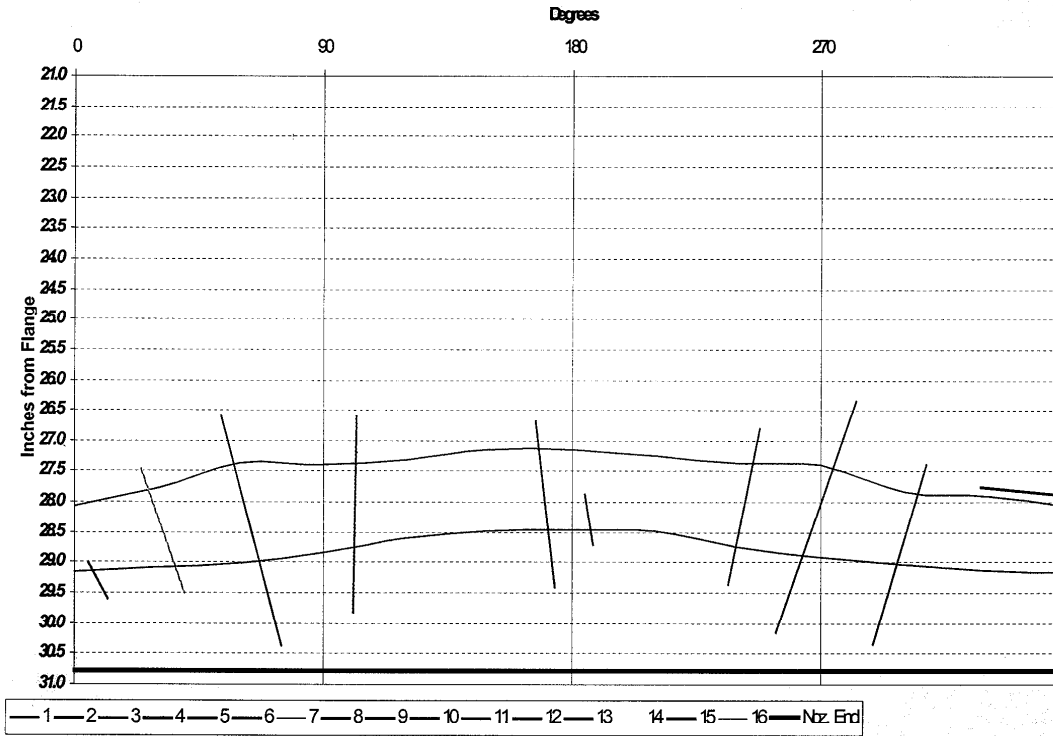
Figure 9. Nozzle 2 Crack Locations and Sizing

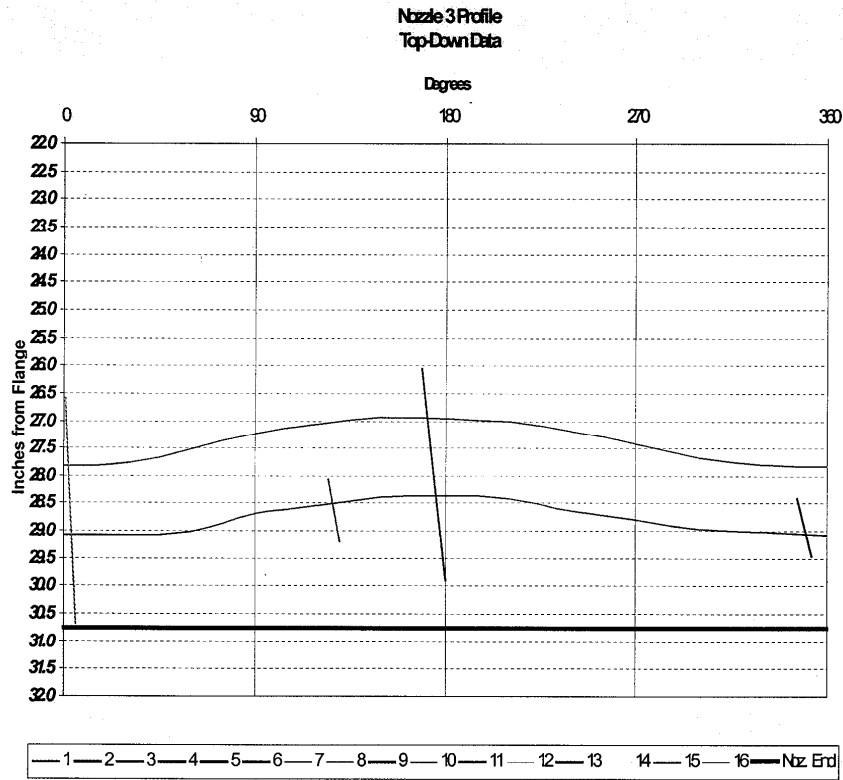
Figure 10. Nozzle 3 Crack Locations and Sizing

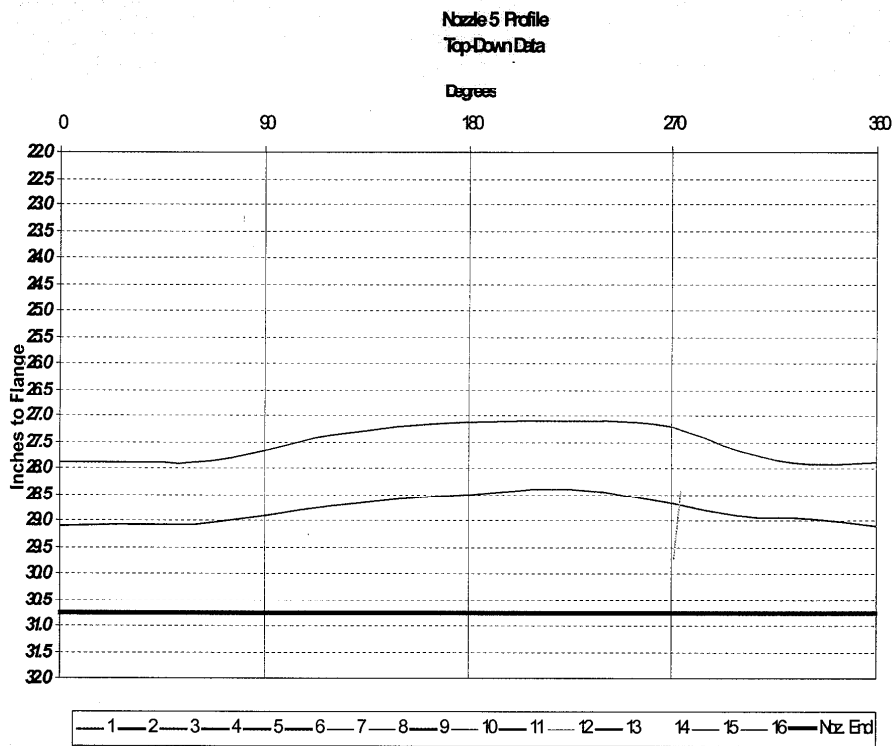
Figure 11. Nozzle 5 Crack Locations and Sizing

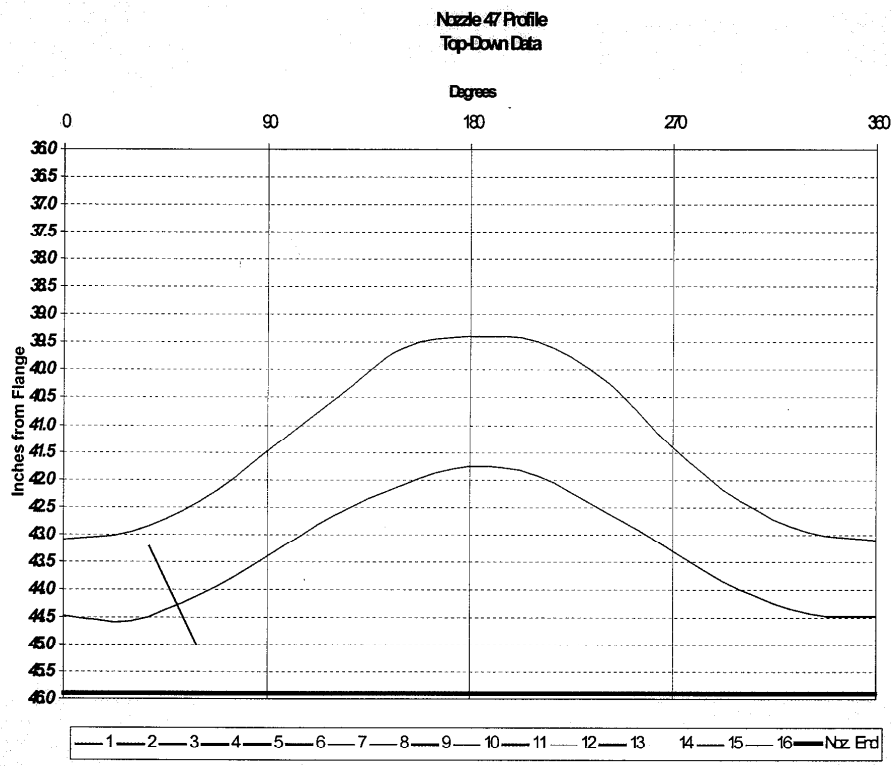
Figure 12. Nozzle 47 Crack Locations and Sizing

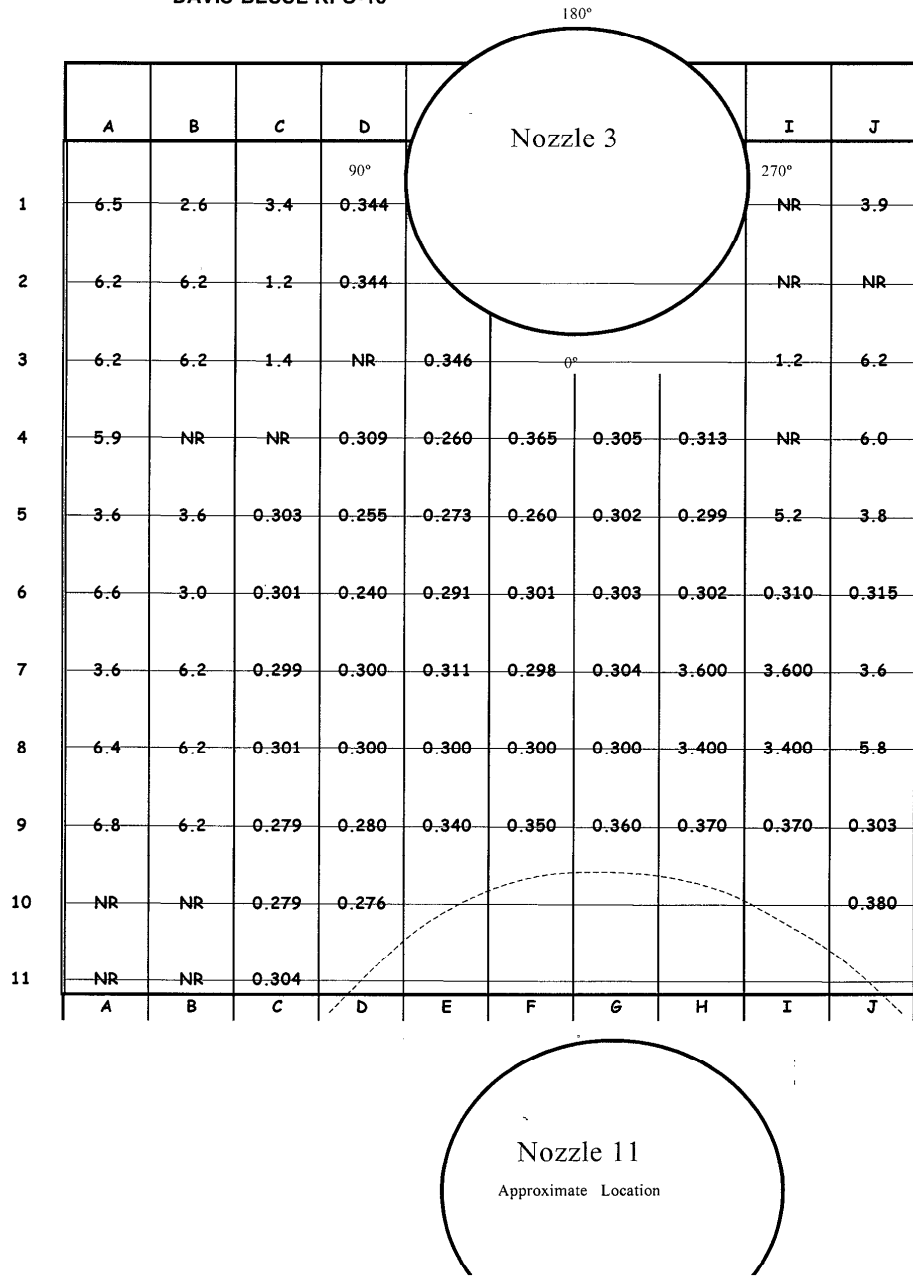
Figure 14. Nozzle 3 Clad Thickness Measurements

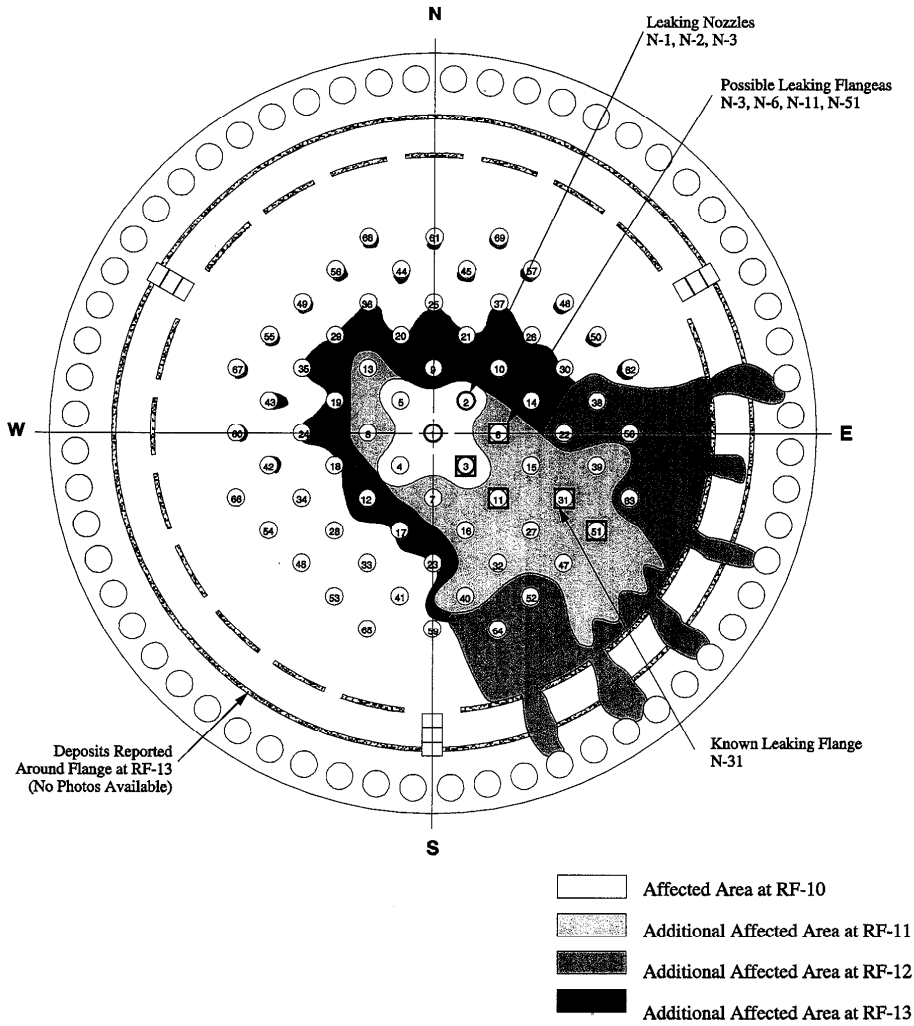
Figure 20. As-Found Locations of Boric Acid Deposits on Davis-Besse Vessel Head (10RFO to 13RFO)

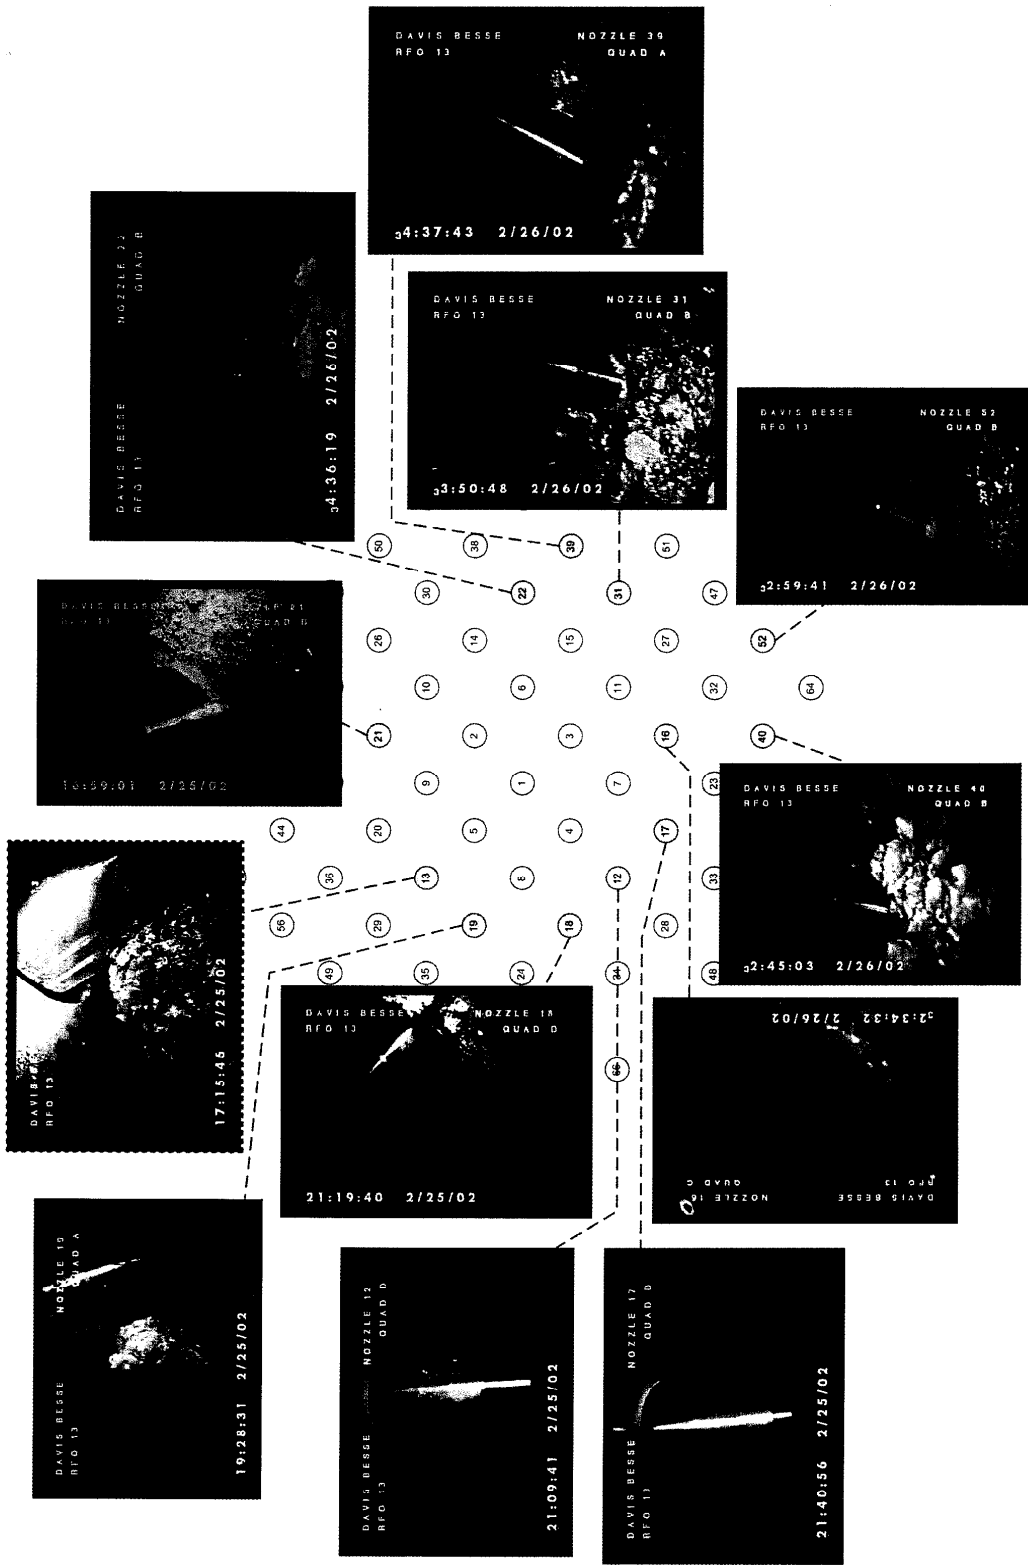
Figure 24. Boric Acid Deposits on Top of Head at Start of 13 RFO

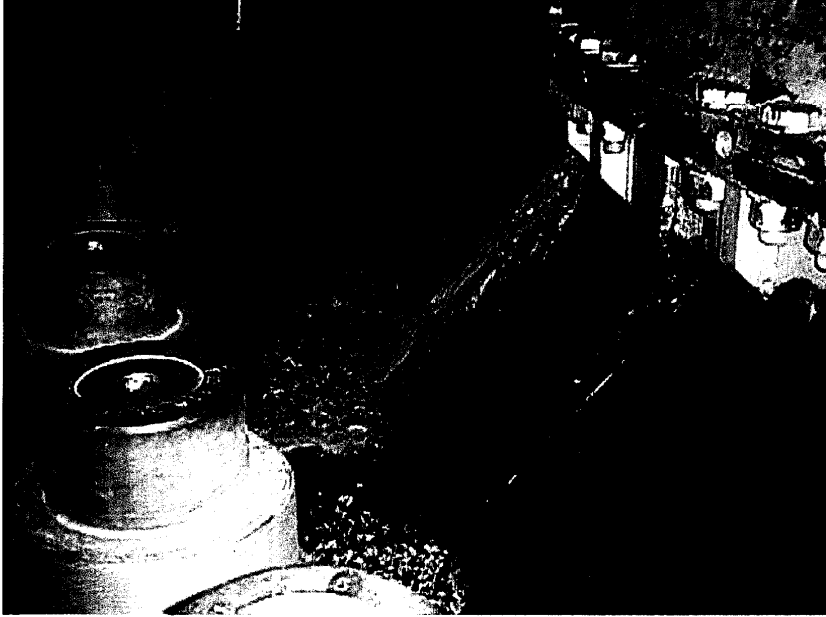
Figure 36. Red Rusty Boric Acid Deposits on Vessel Flange at 12RFO

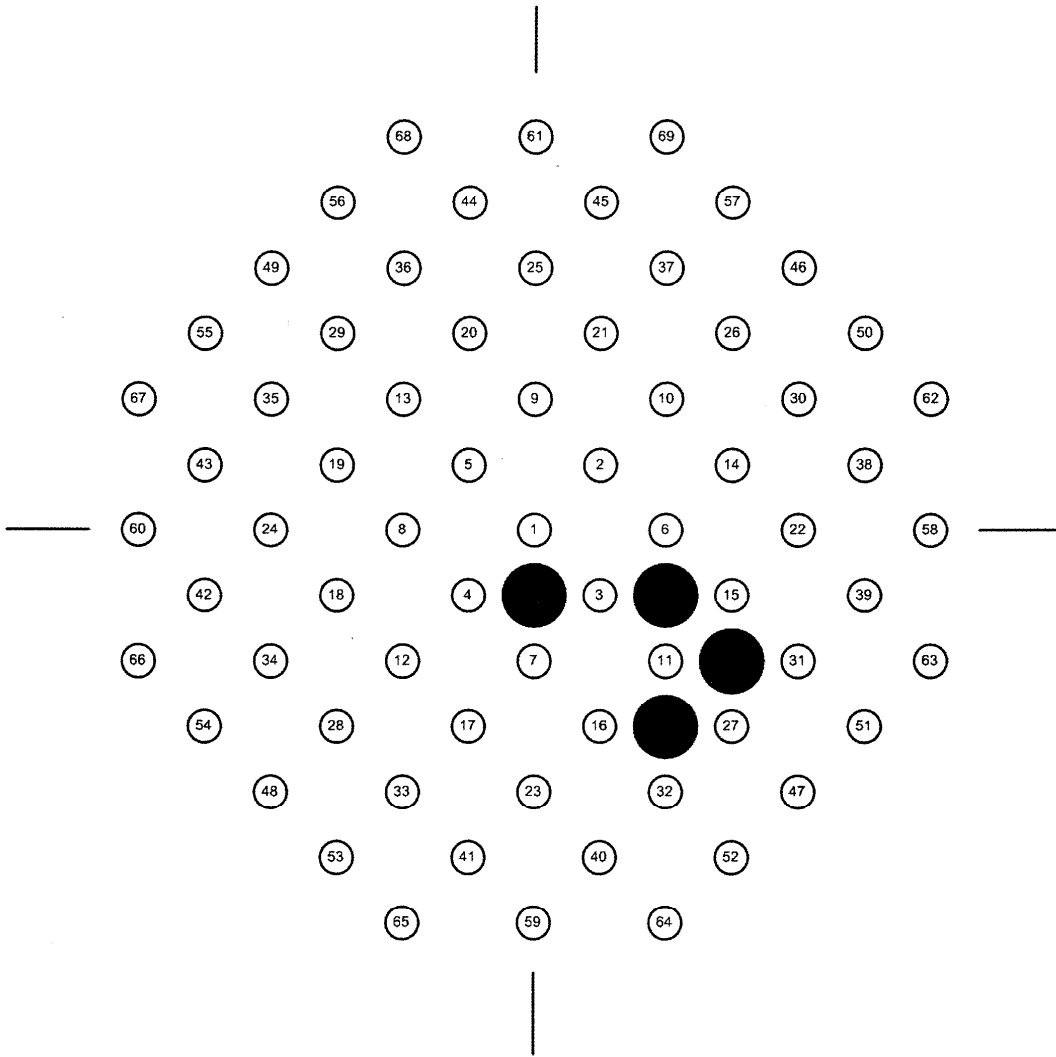
Figure 39. 2000 Interferences with CRDM Flange Inspection

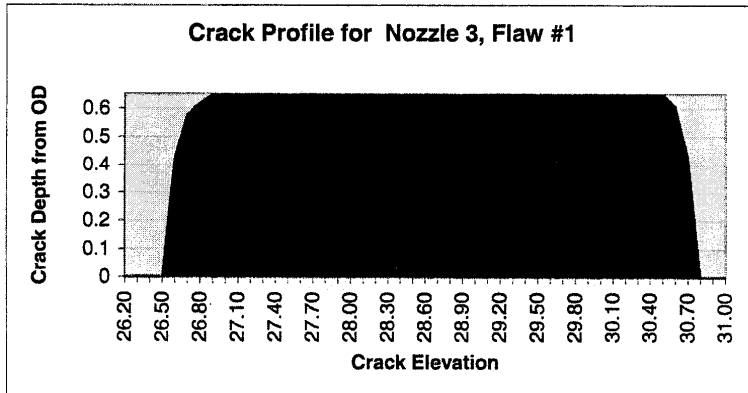
Figure 44. Crack Profile for Nozzle 3, Flaw #1
