Subject: Confirmatory Action Letter Response – Revision 1 to Root Cause Analysis  
Report Regarding Reactor Pressure Vessel Head Degradation

# Root Cause Analysis Report

Significant Degradation of the Reactor  
Pressure Vessel Head

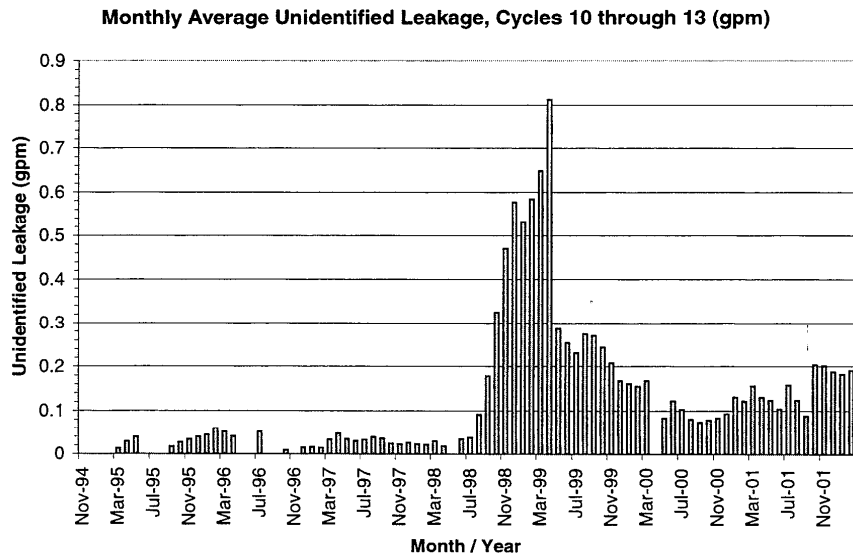
**Unidentified Primary System Leakage Rates at Davis-Besse**

Normal operational leakage in the RCS is recorded and analyzed in MODES 1-4, looking for adverse trends and to verify compliance with Technical Specification 4.4.6.2. This Technical Specification requires that there is no pressure boundary leakage, and that unidentified leakage is maintained at less than 1 gpm. Although the surveillance is required once per 72 hours, RCS leakage is generally trended once per day. DB-SP-03357, RCS Water Inventory Balance, provides the methodology to determine the RCS leakage rate. The test calculates total RCS leakage by resolving changes in initial and final values of Pressurizer and RCS Makeup Tank levels over a 1 to 4 hour period, and providing corrections based on RCS temperatures and pressures. Identified sources of leakage that are apparent through changes in Pressurizer Quench Tank level, normal (measured) Reactor Coolant Pump seal leakage, or quantified primary to secondary tube leakage, are subtracted from the calculated total RCS leakage to obtain the unidentified leakage value. This method of determining unidentified leakage has a significant daily variation (in the range of 0.05 to 0.1 gpm) that depends on accuracy of identified leakage measurements, stability of the plant during data collection, and duration of data collection. Therefore, monthly or running averages are most useful to determine leakage trends, similar to that presented in the figure below.

During operating cycles 10 through 13 (November 1994 through February 2002), measured unidentified leakage has ranged from slightly negative to as much as approximately 0.8 gpm in April 1999. From review of data over that time span, it would appear that average unidentified leakage tends to be in the range of 0.0 to 0.03 gpm when the plant is "tight" with no pending maintenance concerns. If unidentified leakage begins to trend upward, efforts are expended to determine the cause, and if necessary, effort is made to repair the source of the leakage. For example, the high leakage in April 1999 was identified as from the Pressurizer Code Safety Valves and the plant was shutdown to service the valves. Following that shutdown, unidentified leakage remained in the range of 0.15 to 0.25 gpm, some of which was attributable to CRDM flange leakage and some of which may have been attributed to CRDM nozzle leakage.

When a CRDM nozzle begins to leak, experience has shown that one of the first signs is the appearance of a small boric acid deposit crust at the base of the CRDM flanges where it emerges from the RPV head. To put nozzle leakage in perspective, a leak rate of 0.00001 gpm could deposit 10 cubic inches of boric acid over the course of a fuel cycle, which would be quite visible on a clean RPV head. Compared with unidentified leakage of a "tight" RCS at 0.03 gpm, it is apparent that unidentified leakage measurements cannot be used to detect early through-wall leakage at a CRDM nozzle. Figure 19 shows the unidentified leakage rate over cycle 13. It is possible that the approximately 0.10-0.15 gpm increase in unidentified leakage starting in October 2001 is related to changing conditions at the crack in nozzle 3. Subtracting a base leakage rate of 0.05 gpm from the total unidentified leak rate in Figure 19, the maximum leakage rate from the CRDM nozzles did not exceed 0.15- 0.20 gpm at any point in time.
