FirstEnergy, DAVIS-BESSE NUCLEAR POWER STATION

Root Cause Analysis Report

Significant Degradation of the Reactor Pressure
Vessel Head

CR 2002-0891, Dated 3-8-2002

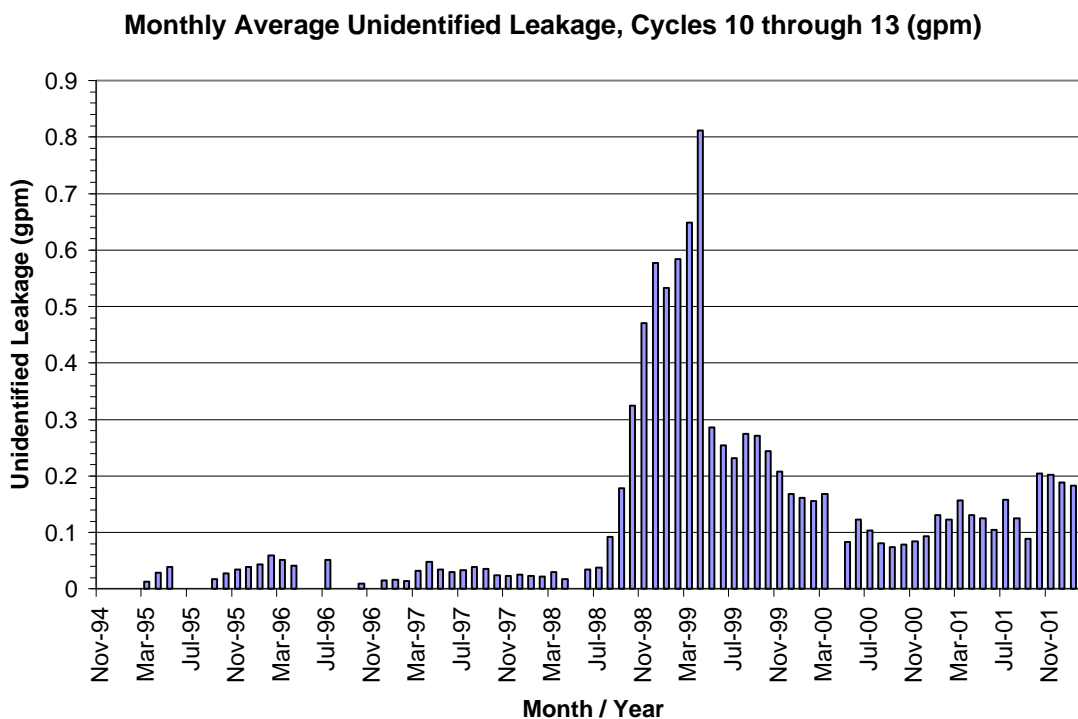
Normal operational leakage in the RCS is recorded and analyzed in MODES 1-4, looking for adverse trends and to verify compliance with Technical Specification 4.4.6.2. This Technical Specification requires that there is no pressure boundary leakage, and that unidentified leakage is maintained at less than 1 gpm. Although the surveillance is required once per 72 hours, RCS leakage is generally trended once per day. DB-SP-03357, RCS Water Inventory Balance, provides the methodology to determine the RCS leakage rate. The test calculates total RCS leakage by resolving changes in initial and final values of Pressurizer and RCS Makeup Tank levels over a 1 to 4 hour period, and providing corrections based on RCS temperatures and pressures. Identified sources of leakage that are apparent through changes in Pressurizer Quench Tank level, normal (measured) Reactor Coolant Pump seal leakage, or quantified primary to secondary tube leakage, are subtracted from the calculated total RCS leakage to obtain the unidentified leakage value. This method of determining unidentified leakage has a significant daily variation (in the range of 0.05 to 0.1 gpm) that depends on accuracy of identified leakage measurements, stability of the plant during data collection, and duration of data collection. Therefore, monthly or running averages are most useful to determine leakage trends, similar to that presented in the figure below.

During operating cycles 10 through 13 (November 1994 through February 2002), measured unidentified leakage has ranged from slightly negative to as much as approximately 0.8 gpm in April 1999. From review of data over that time span, it would appear that average unidentified leakage tends to be in the range of 0.0 to 0.03 gpm when the plant is “tight” with no pending maintenance concerns. If unidentified leakage begins to trend upward, efforts are expended to determine the cause, and if necessary, effort is made to repair the source of the leakage. For example, the high leakage in April 1999 was identified as from the Pressurizer Code Safety Valves and the plant was shutdown to service the valves. Following that shutdown, unidentified leakage

remained in the range of 0.15 to 0.25 gpm, some of which was attributable to CRDM flange leakage and some of which may have been attributed to CRDM nozzle leakage.
