Subject: 10CFR21 Reporting of Defects and Non-Compliance -
Engine Systems, Inc. Report No. 10CFR21-0084, Rev. 0

Norgren R18 relieving style pressure regulating valves

Report No. 10CFR21-0084
Rev. 0: July 30, 2002

10CFR21 REPORTING OF DEFECTS AND NON-COMPLIANCE

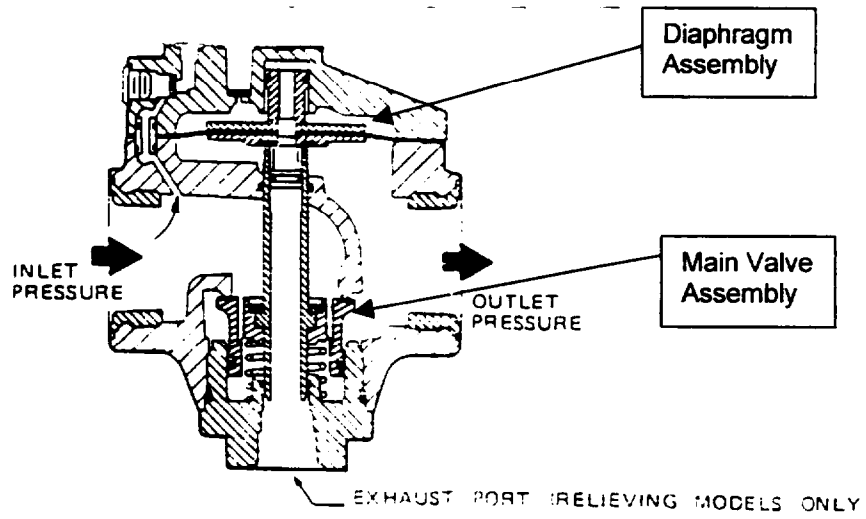
FIGURE 1
Valve Assembly with no flow

C.A. Norgren Company, the manufacturer of the valve, was contacted to evaluate the condition and assist in a resolution. After evaluating the problem Norgren determined that the sudden demand in flow during an engine start caused the main valve to open further than is normally expected. When the air flow is suddenly terminated following the engine start, the resulting backpressure within the valve causes the diaphragm assembly to travel to its maximum upper position and allows its o-ring to separate from the valve tube. The relative positions of the two components causes the main valve to stick in the open position and opens the air relief path through the relieving tube of the regulator. The o-rings around the relief tube and on the diaphragm retainer in addition to the forces generated by the flow through the valve contribute to hold the valve open. As the pressure in the air receiver falls, the forces acting to hold the valve open decrease and the valve returns to its closed position. Refer to figures 1 & 2.

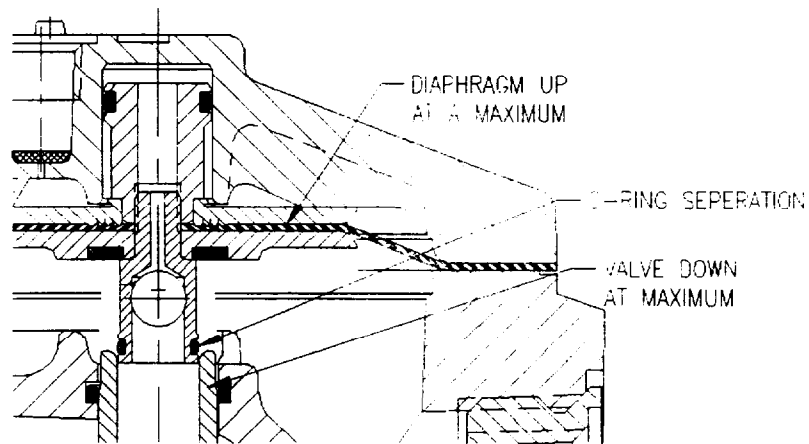
FIGURE 2
Valve Position during event

The first change is to a sub-component of the diaphragm assembly. As seen in Figure 2 the retainer has become separated from the relief tube during sudden backpressure situations causing a resistance to the relief tube returning to the neutral position at no flow. The retainer was extended to ensure the tube cannot come free when the valve and diaphragm are at their furthest separation. Refer to figure 3 depicting the extended retainer installed.

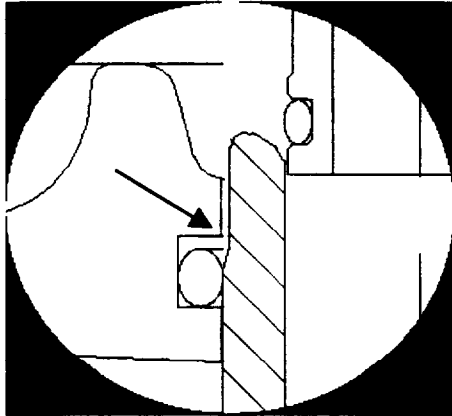
FIGURE 4
Retainer O-Ring in tube

The second change is to the valve tube. As seen in Figure 4, when the valve is open at a maximum, there is room for the o-ring to start extruding from the cavity. When the relief tube tries to return to its normal position, the o-ring provides resistance. The geometry of the valve tube at the o-ring interface was modified to eliminate the smaller diameter on the tube to prevent the o-ring from extruding. Refer to figure 5.
