UNITED STATES  
NUCLEAR REGULATORY COMMISSION  
OFFICE OF NUCLEAR REACTOR REGULATION  
WASHINGTON, D.C. 20555

June 16, 1994

NRC INFORMATION NOTICE 94-44: MAIN STEAM ISOLATION VALVE FAILURE TO CLOSE ON DEMAND BECAUSE OF INADEQUATE MAINTENANCE AND TESTING

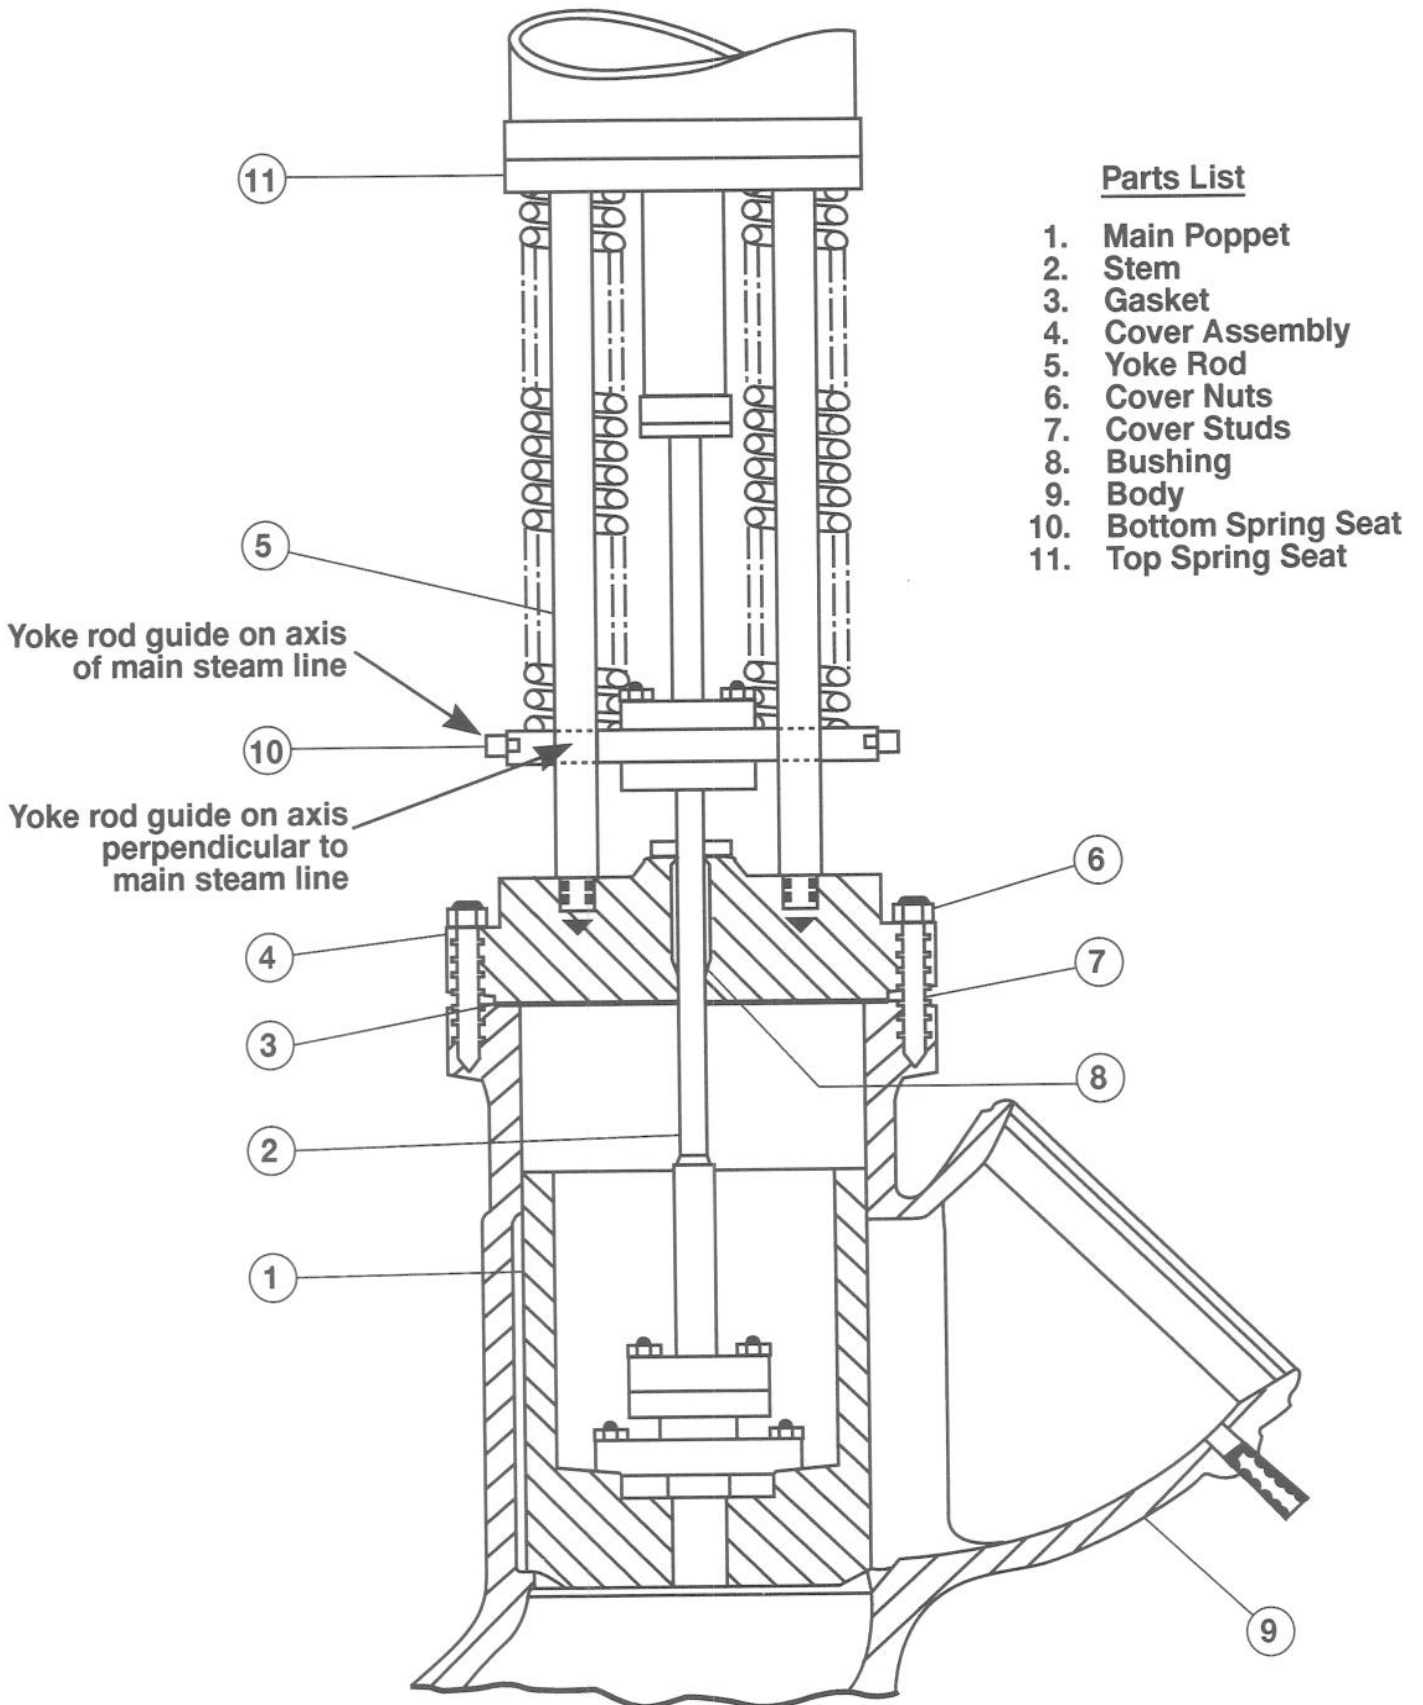
# Atwood and Morrill 34 Inch "Wye" Type Main Steam Isolation Valve (Valve Parts & Actuator)

McGuire Nuclear Station Unit 2 is a four-loop pressurized-water reactor designed by Westinghouse with nominal 34-inch Atwood & Morrill air-operated "we" type globe MSIVs, with the actuators mounted horizontally. The valve actuator is constructed as follows (see attached Figures 1 and 2). The four springs that provide the motive force for closure encase the yoke rods and rest on a bottom spring seat. The stem of the valve passes through and is attached to the bottom spring seat. The four yoke rods penetrate the bottom spring seat in the corners and attach to the valve bonnet. The springs are attached at the top to the top spring seat. As the valve is opened, the bottom spring seat rises and compresses the springs between the bottom spring seat and the top spring seat. Yoke rod guides are provided as part of the

When the valve is cold, the yoke rods are essentially parallel to each other. However, when the valve is hot, the bonnet of the valve expands slightly and causes the lower section of the yoke rods to move laterally outward from the centerline, forming a tapered shape. The yoke rods had formed a tapered shape (wide at the bottom) and caused the clearance between the yoke rods and the yoke rod guides to close. Lack of control over the yoke rod guide clearances can cause binding in at least two ways. First, the clearances between the yoke rod guides and the yoke rods can close completely and cause the bottom spring seat to bind on the yoke rods. Second, when properly set (with the valve hot), the upper yoke rod guides do not have any clearance and should just touch the yoke rods. However, excessive torquing of these guides causes misalignment of the bottom spring seat so that it moves the attached valve stem off its proper line of travel, causing it to bind on the valve packing as the valve attempts to stroke.

include performing testing at the operating conditions that would exist at the time a valve would be required to perform its design-basis function. The current IST requirements, rather, are intended to establish a monitoring program for identifying degrading trends in the operation of the tested components. The event at McGuire illustrates an example where IST alone could not be relied upon to ensure operability of the MSIV. The licensee determined that additional testing, supplemental to that required by the IST program, is necessary to verify that the valves are capable of performing their design-basis function. One of the corrective actions taken at the Sequoyah Nuclear Plant is to test the MSIV at approximately 286 degrees C [547 degrees F] until an adjustment method that is not temperature dependent can be developed. These events highlight the importance of vendor recommendations and adequate testing programs to ensure that safety-related equipment is capable of performing its safety function.

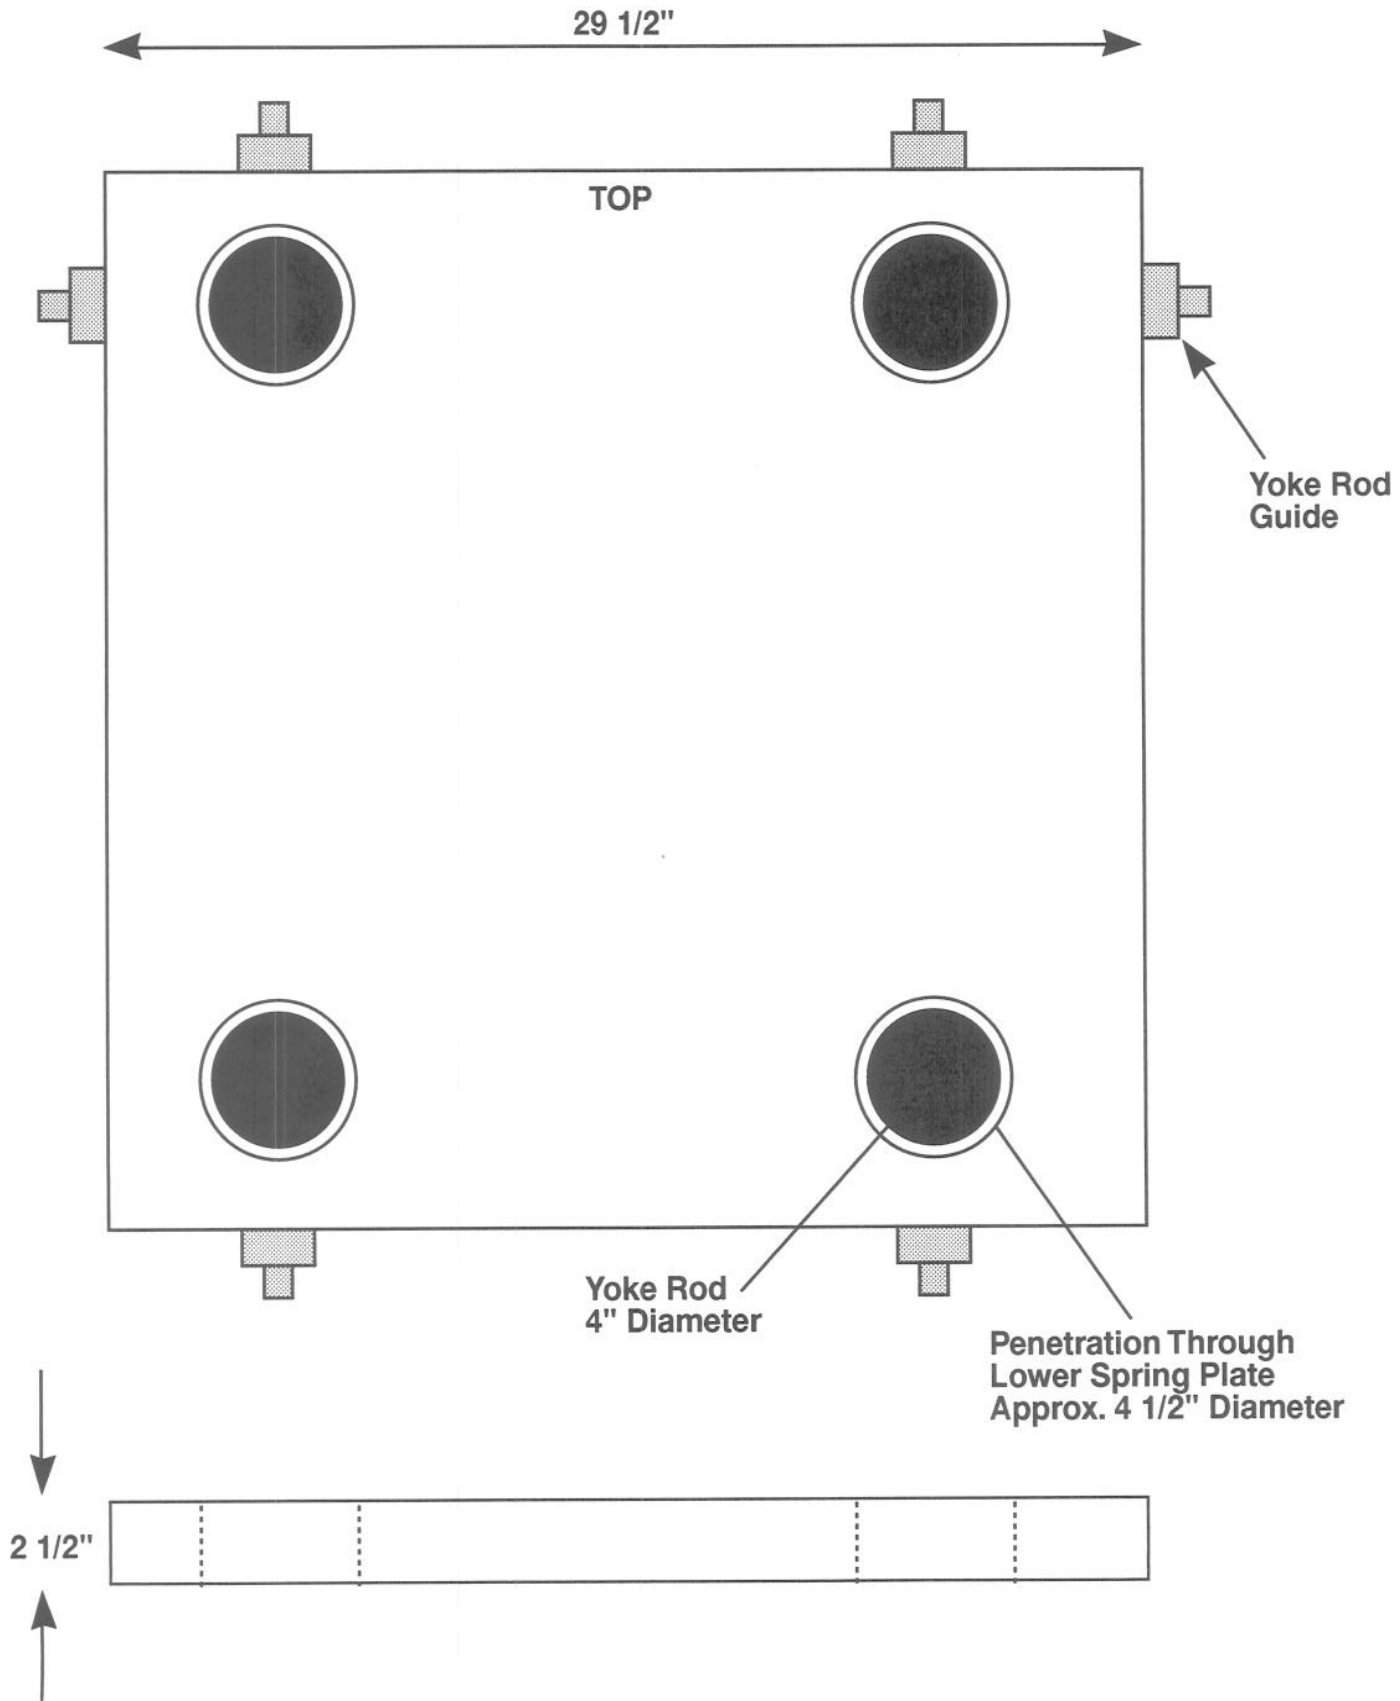
# Atwood and Morrill 34 Inch "Wye" Type Main Steam Isolation Valve (Bottom Spring Seat)

seismic qualification of the valves to minimize lateral movement of the bottom spring seat. The guides are brass bolts that screw into the sides of the bottom spring seat. The bolts are aligned to the centerline of the holes on the bottom spring seat through which the yoke rods pass. Four guides prevent deflection of the bottom spring seat along the axis of the main steam line (vertical), and two guides prevent deflection along an axis perpendicular to the main steam line (see Figure 2). Failure of the two MSIVs to close as designed is attributed to inadequate setting of clearances between yoke rod guides and yoke rods and to inadequate testing. According to the manufacturer, clearances between the yoke rod guides and the yoke rods for a valve should be set when the valve is closed and heated to normal operating temperature. Also, the manufacturer indicated that the valve should be tested at normal operating temperature. Licensee procedures specified that clearances be set while the valve was at ambient temperature, and all testing was done under cold conditions.
