SUBJECT: Potential manufacturing problem with certain limit switch assemblies used in ASCO General Controls Hydramotor[®] Actuators.

**POTENTIAL MANUFACTURING PROBLEMS WITH
LIMIT SWITCH ASSEMBLIES USED IN ASCO GENERAL CONTROLS
HYDRAMOTOR® ACTUATORS**

Limit Switch
Assembly

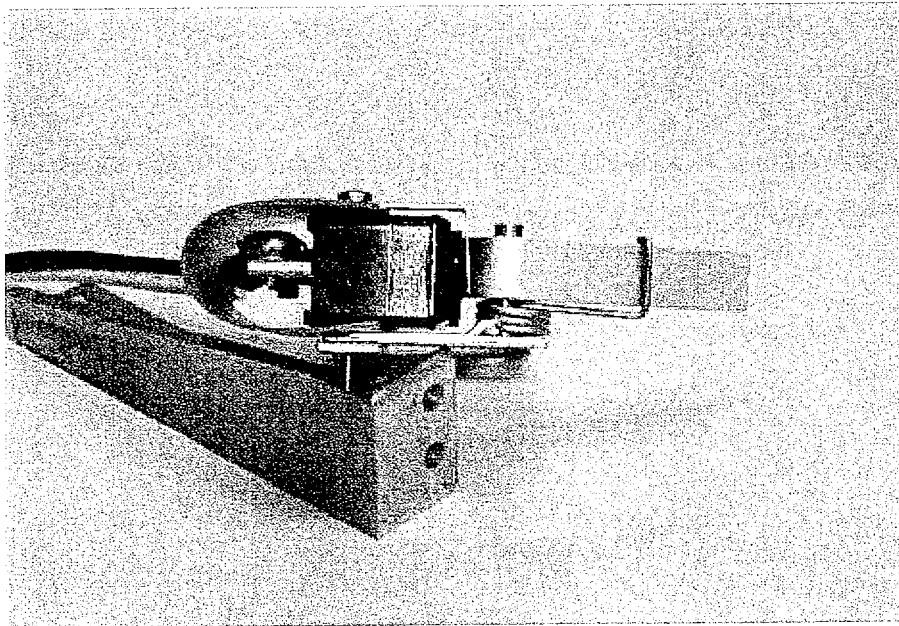
VIEW SHOWING LIMIT SWITCH ASSEMBLY WITH PROPERLY SWAGED SHAFT
