**DAVIS-BESSE REACTOR VESSEL HEAD DEGRADATION
LESSONS-LEARNED TASK FORCE REPORT**

On March 12, 2002, the NRC dispatched an Augmented Inspection Team (AIT) to gather facts surrounding the circumstances associated with the March 5, 2002, discovery of a cavity in the DBNPS RPV head. The discovery of the cavity occurred following a plant shutdown for a refueling outage, during which the licensee was conducting inspections for reactor pressure vessel head penetration (VHP) nozzle cracking due to primary water stress corrosion cracking (PWSCC). These inspections were being conducted in response to an NRC bulletin. During these inspections, the licensee discovered cracks in several VHP nozzles. Subsequent to the machining process to repair VHP Nozzle 3, the nozzle was observed to displace, or tip in the downhill direction as the machining apparatus was withdrawn. The displacement led DBNPS personnel to examine the region adjacent to VHP Nozzle 3. The licensee discovered a cavity with a surface area of approximately 20-30 square inches. Upon further examination, the licensee identified that the cavity extended completely through the 6.63 inch thick carbon steel RPV head down to a thin int

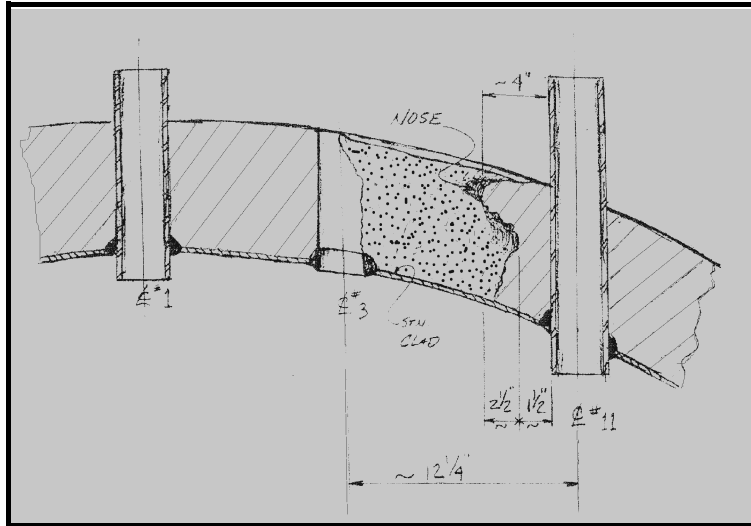
Figure 2-4
DBNPS VHP NOZZLE NO.3 DEGRADATION CAVITY

On March 5, 2002, the licensee for DBNPS in Oak Harbor, Ohio, discovered a cavity in the RPV head, adjacent to VHP Nozzle 3. Davis-Besse Nuclear Power Station is a pressurized water reactor (PWR) plant. A schematic of a typical PWR reactor is shown in Figure 2-1. The DBNPS Nuclear Steam Supply System (NSSS) was fabricated by the Babcock & Wilcox (B&W) Company. Typical B&W RPV head and VHP nozzle design and fabrication details are depicted in Figures 2-2 and 2-3. Details of the degradation cavity in the DBNPS RPV head are shown in Figure 2-4.

In a May 7, 2002, meeting between the NRC and FENOC, the licensee presented its technical root cause of the RPV head degradation. Boric acid corrosion of the carbon steel RPV head was clearly the primary contributor to the degradation. The primary corrosive attack of the RPV head was likely caused by leakage from a long through-wall axial crack in VHP Nozzle 3, but may also have been assisted by control rod drive mechanism (CRDM) flange leakage onto the RPV head from above. The potential for boric acid degradation of the carbon steel of an RPV head, as a result of leakage through a cracked VHP nozzle, was recognized and analyzed in industry safety evaluations submitted to the NRC in 1993 (refer to Section 3.2.3). However, at

The discovery of the cavity occurred following a plant shutdown for a refueling outage, during which the licensee was conducting inspections for VHP nozzle cracking caused by primary water stress corrosion cracking (PWSCC). These inspections were being conducted in response to NRC Bulletin 2001-01. During these inspections, cracks were discovered in several VHP nozzles, including VHP Nozzle 3. The licensee had contracted with Framatome ANP, Inc., to perform repairs of cracked VHP nozzles, where necessary, by machining away the affected portion of the VHP nozzle and re-establishing the pressure boundary by welding the VHP nozzle further up into the RPV head.

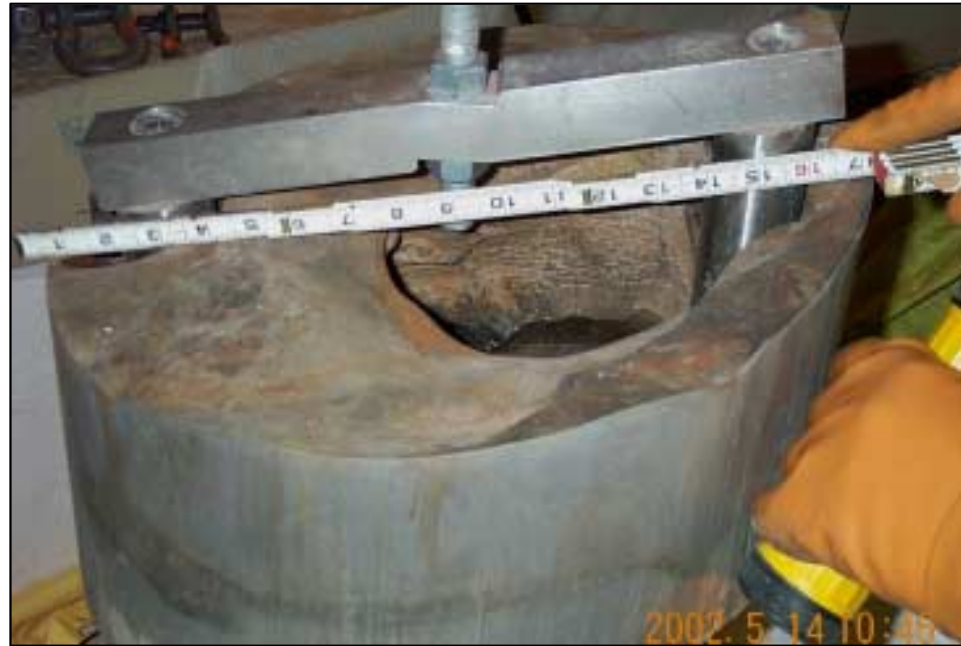
Degradation Between Nozzle#3 and Nozzle#11.
The Sketch Provided by the Licensee

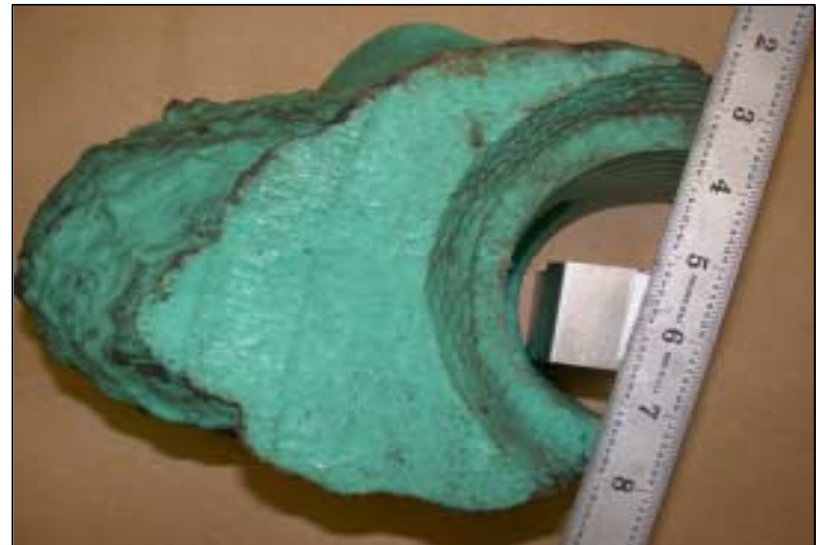
Close-Up View of Cavity
