**SUBJECT: NOTICE OF VIOLATION (BROWNS FERRY NUCLEAR PLANT UNIT 1
RECOVERY - NRC INSPECTION REPORT NO. 05000259/2004011)**

**TENNESSEE VALLEY AUTHORITY
BROWNS FERRY NUCLEAR PLANT
UNIT 1**

PREDECISIONAL ENFORCEMENT CONFERENCE

LONG-TERM TORUS INTEGRITY PROGRAM

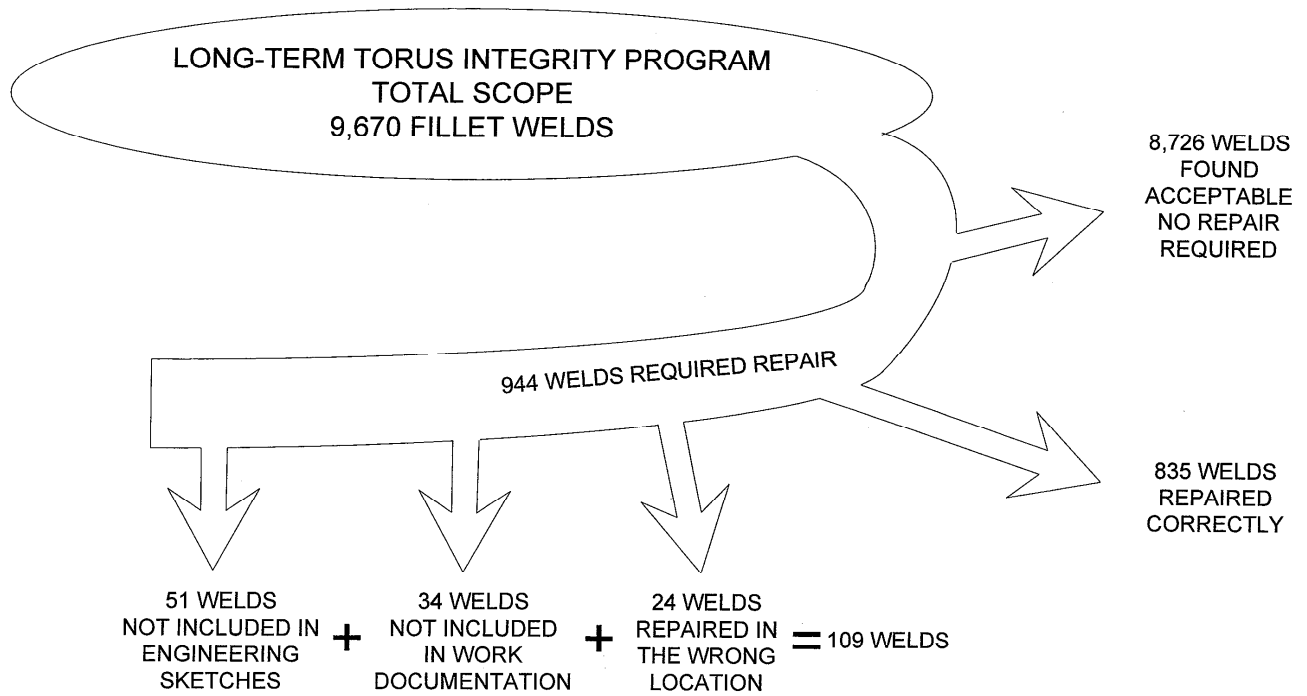
INITIAL PROGRAM IMPLEMENTATION FINDINGS

- January 26 - February 13, 2004, NRC inspections identified
 - Examples of welds being performed and QC accepted in the wrong location
 - Examples of required weld repairs not included in Work Order
 - Sketches were confusing
- PERs issued to determine extent of condition, causes and corrective actions as each issue was identified

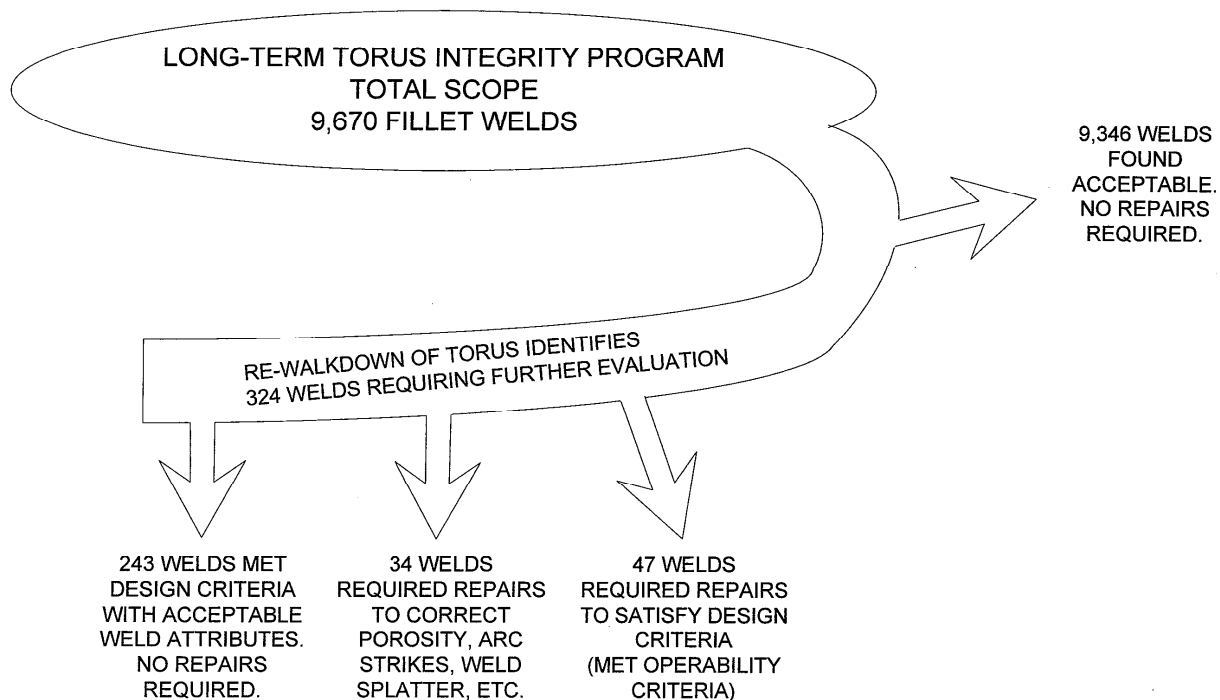
DISPOSITION OF TORUS WELD ISSUES

- The full scope of all torus weld issues was identified
- The collective condition was analyzed
- The torus would have performed its design basis functions even if the weld deficiencies were not identified or corrected

- Developed and implemented a plan to systematically verify torus weld scope
 - Training was given to Engineering, Modifications and QC regarding torus orientation and proper use of the sketches
 - Both Modifications and Engineering-QC teams independently reviewed the welds that were to be repaired for proper location, size and attribute acceptability
 - Engineering and Modifications reviewed design output, sketches and Work Orders to ensure the required torus weld repairs were identified in the work documents
 - Engineering re-walked down the torus welds that did not require repair using conservative walkdown criteria that eliminated measurement tolerances
