NUCLEAR LOGISTICS INC

Letter #QA-2044

Subject: 10CFR21 notification

Technical Bulletin TB-0948431-02 PCP Firing Board P.C. Assemblies

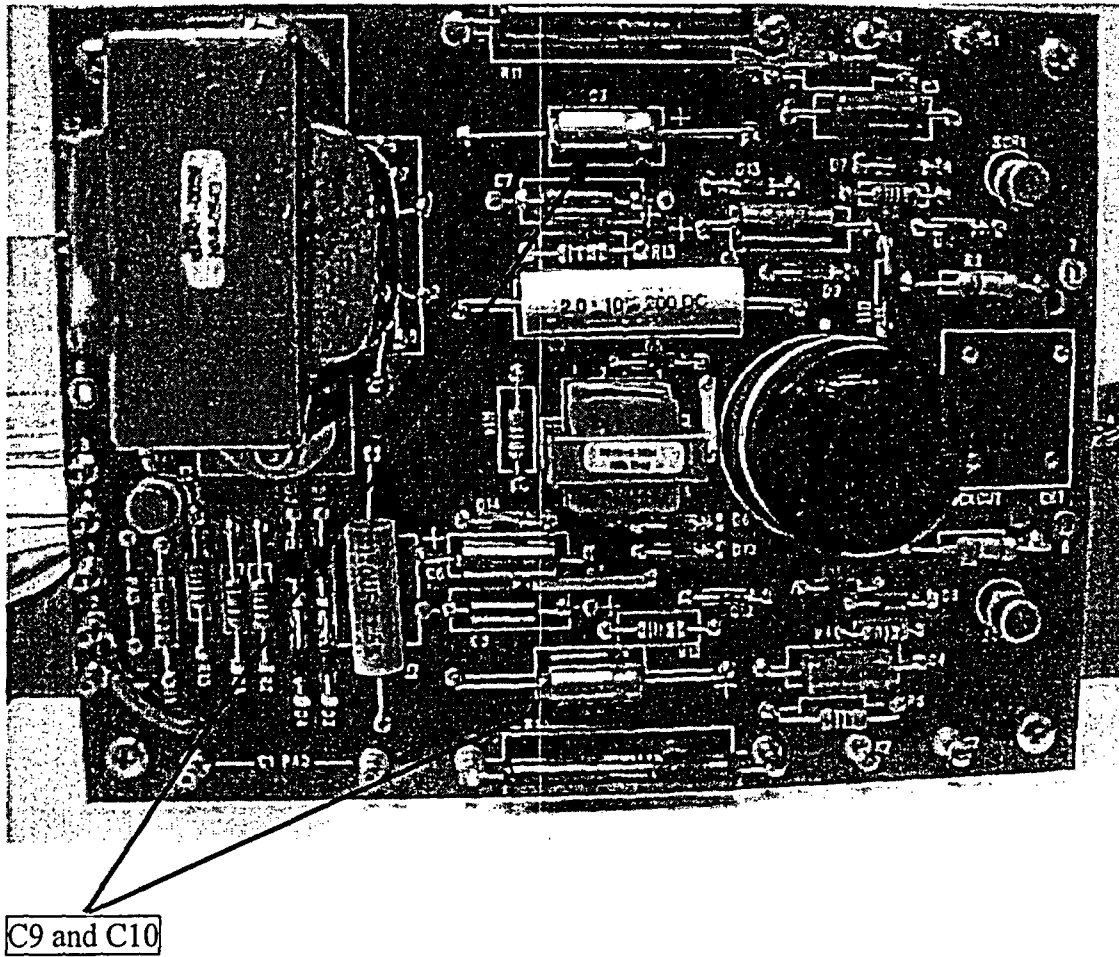
Figure 1

- Examine C9 and C10 on all three tiers of the firing board assembly (6 capacitors total) as follows:
 - Inspect the C9 and C10 capacitors (refer to figures 1 and 2 for location and identification). The capacitors with the shortened life are labeled with 109D. If the capacitors are labeled other than 109D, they are acceptable and the circuit board can be used.
 - While examining the circuit boards, inspect the capacitors for evidence of degradation (yellow color or black/brown burn spots). Discoloration is a

- good early indication of capacitor degradation. Discoloration will appear on the capacitors before the capacitance starts to decrease.
- If there is evidence of capacitor degradation, the circuit board should be replaced.
 - If there are not burn spots on the capacitors, the capacitor is acceptable for continued use. The capacitors on the circuit boards that are in service should be inspected monthly until the boards can be removed and the capacitors replaced.

Firing board assemblies with capacitors labeled 109D should be returned to NLI for rework and retesting. As an alternative, NLI can supply the replacement capacitors for installation on the circuit board by the plant.

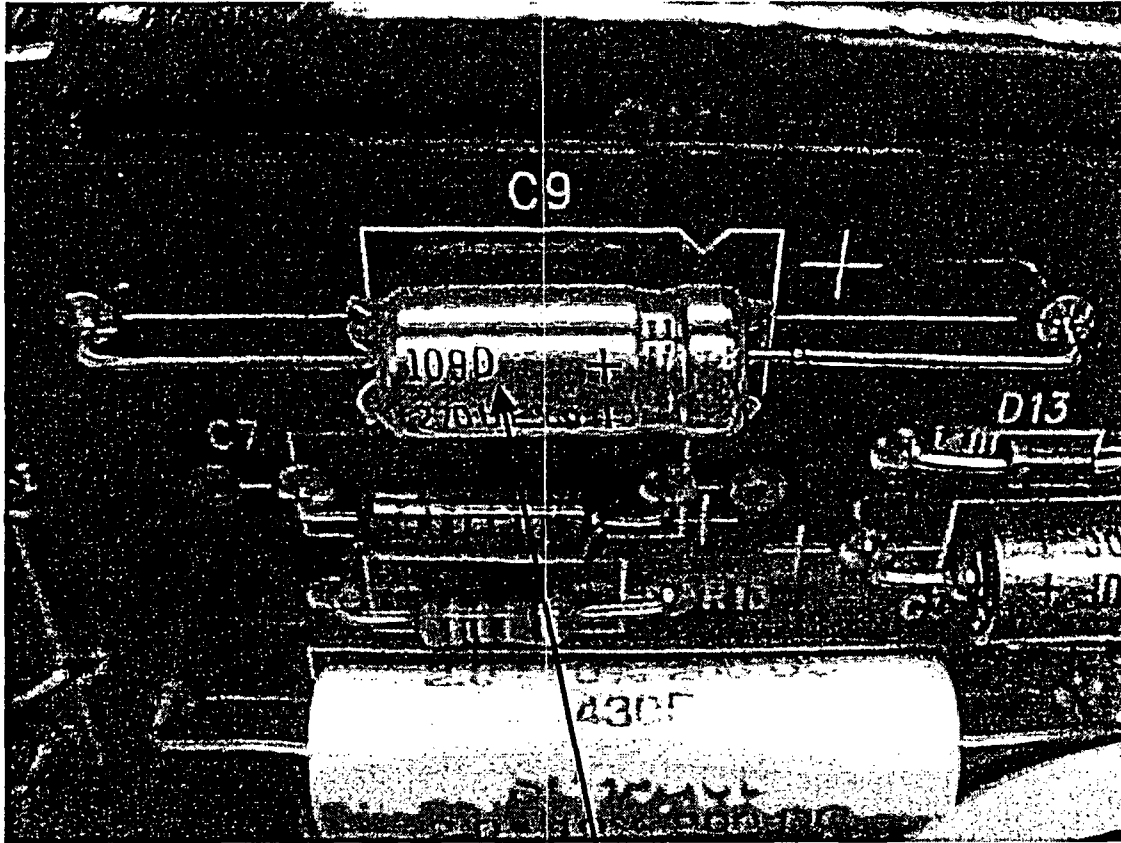
Figure 2

Note case markings
