NUREG/CR-4596
SAND86-0394
RP
Printed June 1986

Screening Tests of Representative Nuclear Power Plant Components Exposed to Secondary Environments Created by Fires

Mark J. Jacobus

Abstract

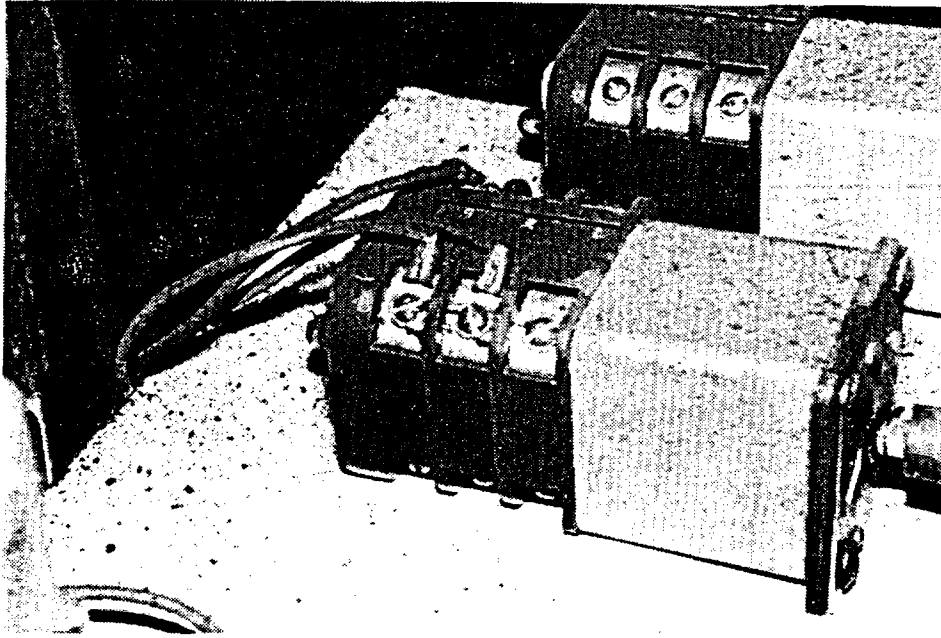
The switches were tested in various orientations with some panel mounted in a cabinet with an open back, some mounted on their sides to allow more particulate deposition in the contact area, and some put upright on horizontal surfaces. The amount of particulate deposition varied significantly with different tests, with ventilation rate and room size apparently the most important considerations with a given size fire. With higher ventilation rates and the larger room, much less particulate was deposited on the switches. In fact, the switches in test 5 were found to be virtually free of particulate. The particulate which did appear in test 5 was very light and could be removed with very little effort (light blowing or even just picking up the switch). In contrast, the lower ventilation rate of test 4 produced more particulate on the switches. The switch that was powered in test 4 was noted to have particulate polarized between adjacent powered and grounded terminals as shown in Fig. 6; similar behavior was not noted in test 5.

Fig. 6 Polarized Particulate Between Adjacent Terminals of Switch

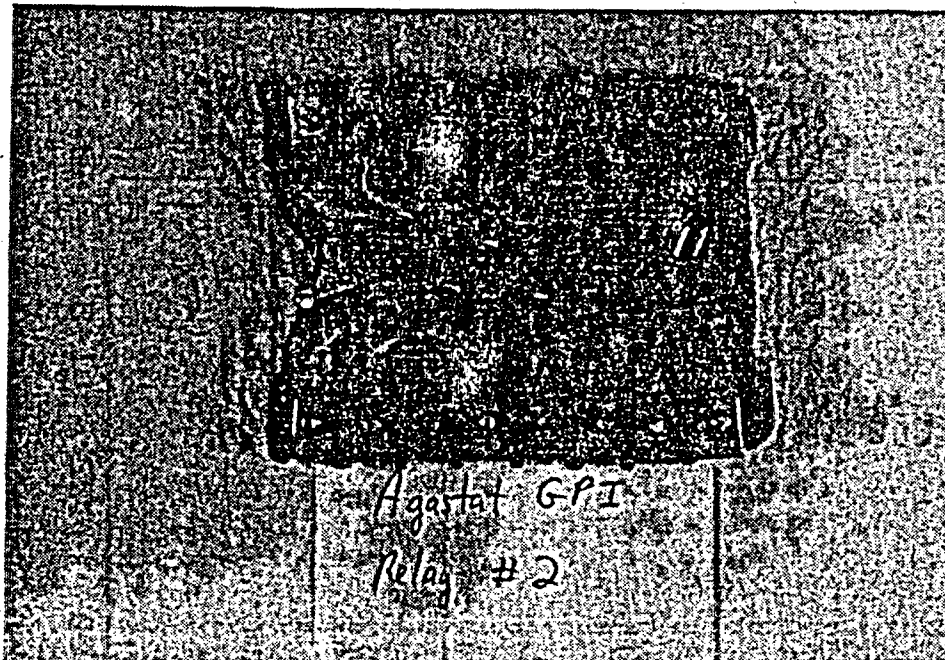
Fig. 16 Shorted Wires in the Socket from the First Thermal Failure Test

failure had to be a short between the hot side of the relay coil and the normally closed terminal of contact #2. No such failure could be found in examining the relay after the test. However, the base of the relay was so severely warped that apparently two or more of the terminal screws on the socket came into contact with the metal baseplate and shorted together. This was partially confirmed by checking continuity of different terminals when the socket was held onto a metal plate; several definite possibilities of shorting terminals were found.

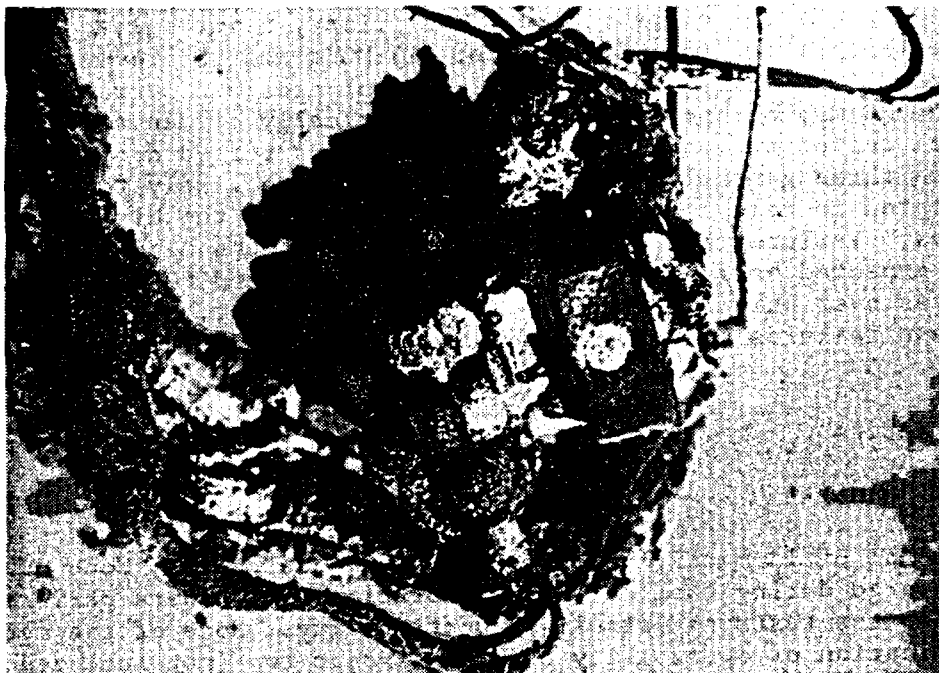
Finally, the relays tested to thermal failure experienced various failure modes, all at temperatures ranging from 150°C to above 350°C. Two Agastat GPI relays tested both had failures associated with the relay sockets warping severely. Both short circuits and open circuits were observed in the sockets. One additional failure of the Agastat relays was a melted contact support on the contact carrying a load current. One General Electric model HMA relay had its coil lead wires shorted above 350°C, resulting in a fire in the test chamber.

Fig. 26 Post-test Photograph of HMA Relay After Fire Occurred

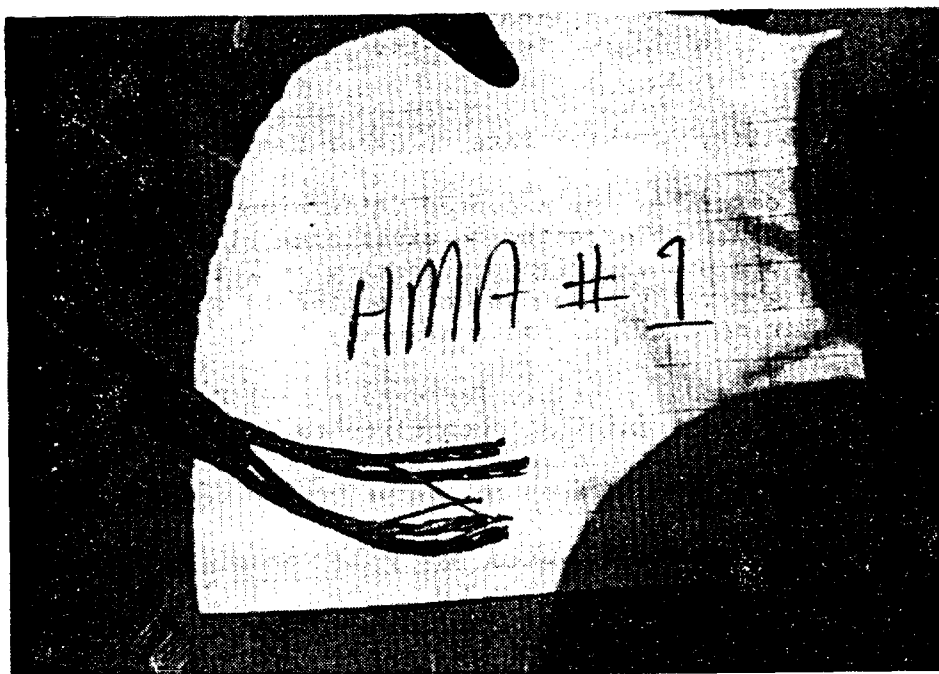
Fig. 27 Coil Wires Shorted Together to Cause Fire

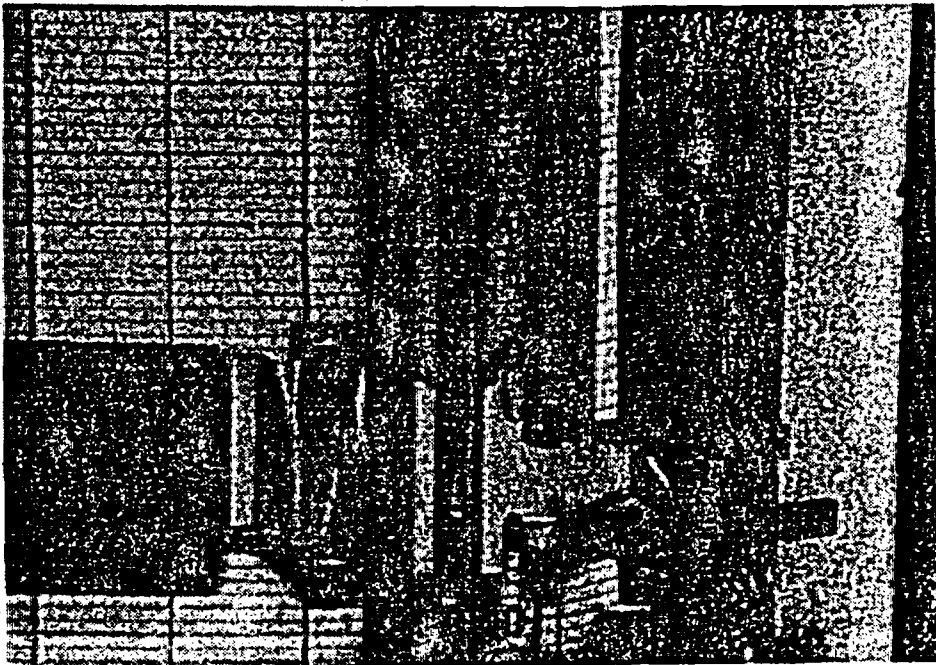
The general failure modes expected for strip chart recorders are corrosion or particulate buildup between moving parts (failure mode actually observed), thermal failure or degradation of electronic components, or low level leakage currents on the circuit boards leading to loss of correct recorder operation.

Fig. 29 Failed Slider Mechanism of Strip Chart Recorder

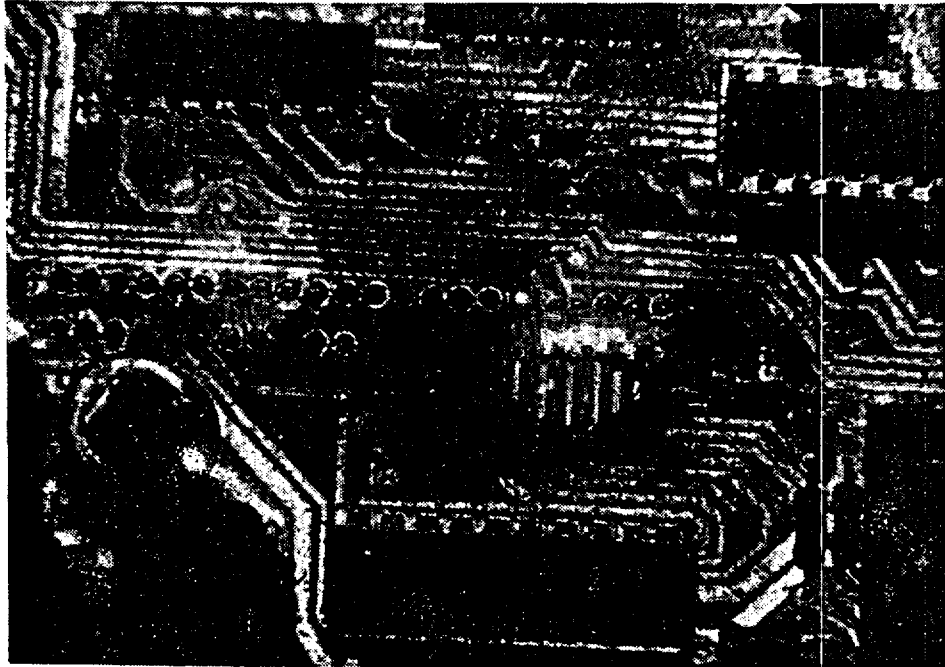
Fig. 30 One Location of Leakage Currents on Counter Circuit Boards

normally again. The counter was returned to the humidity chamber to see if the problem would return. The counter was powered and the conditions were 40°C (104°F), 95% relative humidity for 18 hours. The counter was found failed as before, again not knowing the exact time of failure. The problem was eventually traced to what appeared to be a transistor failure in the power supply. Based on examination of the counter schematics, failure of the transistor, manifested as high base-emitter leakage current, could cause the noted failure. Replacement of the transistor returned the power supply to normal, but curve traces of the original transistor did not show any problems. Subsequently, the original transistor was reinstalled and worked correctly. The only conclusion is therefore that a conductive media (probably corrosion related) had formed in the vicinity of the transistor and had allowed leakage currents. The transistor replacement must have removed enough of the conductive media to reduce the leakage current and allow the circuit to work properly.

of the particulate in a high humidity environment. A photograph of the area of the data lines is shown in Fig. 30.
