Subject: 10 CFR Part 21 report concerning 3" and 4" Borg Warner Check Valves

Reference: NRC Part 21 Report 2001-27-0

This letter is intended to amend information previously supplied in the Part 21 report referenced above. The report advised of a potential problem with 3" and 4" Borg Warner swing check valves and disc assemblies supplied in 1977 or earlier.

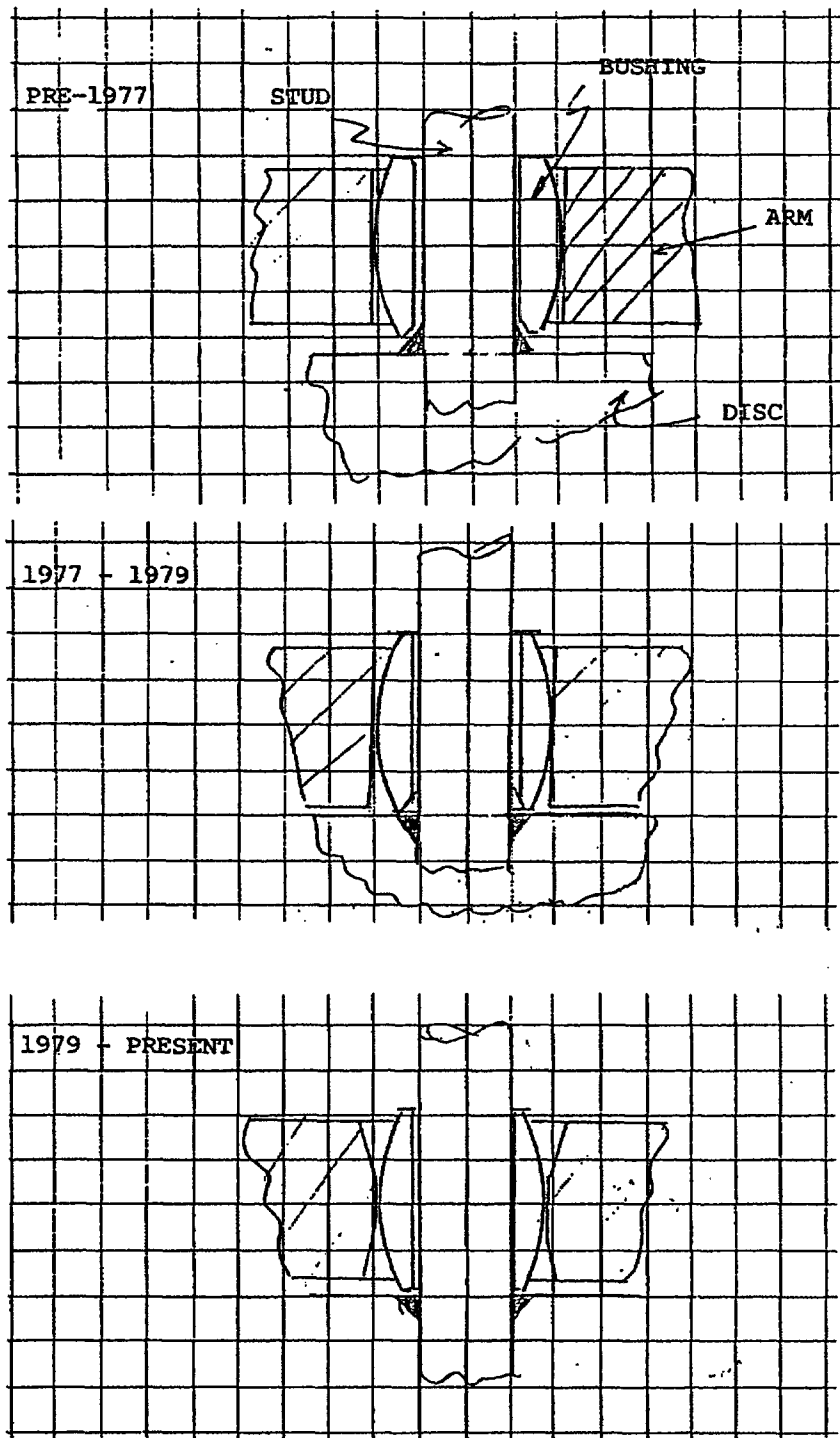
Figure 1 - Design History

During the Part 21 investigation regarding the stud failure, Flowserve reviewed the history of the disc assembly drawing and discovered that the weld configuration was not modified to provide a surface flat and flush with the back face of the disc until 1990. This finding is inconsistent with the information provided in the 10CFR Part 21 report issued by Flowserve – Williamsport in August of 2001.

The only known design with this condition is disc assembly drawing number 76333, which is identified as the disc and stud assembly part number on the Borg Warner valve assembly drawing. Flowserve has no reason to believe that the number of disc assemblies with raised welds produced after 1977 is extensive. However, knowing that there was one with this condition, Flowserve decided it would be prudent to re-notify all utilities originally notified in 2001.

Flowserve recommends that 3" and 4" Borg Warner swing check valves and spare part disc assemblies provided after 1977 be inspected for this condition at the earliest convenience.

Licensees with valve installations effected by this notice should install a new disk component or refurbish the existing disk.

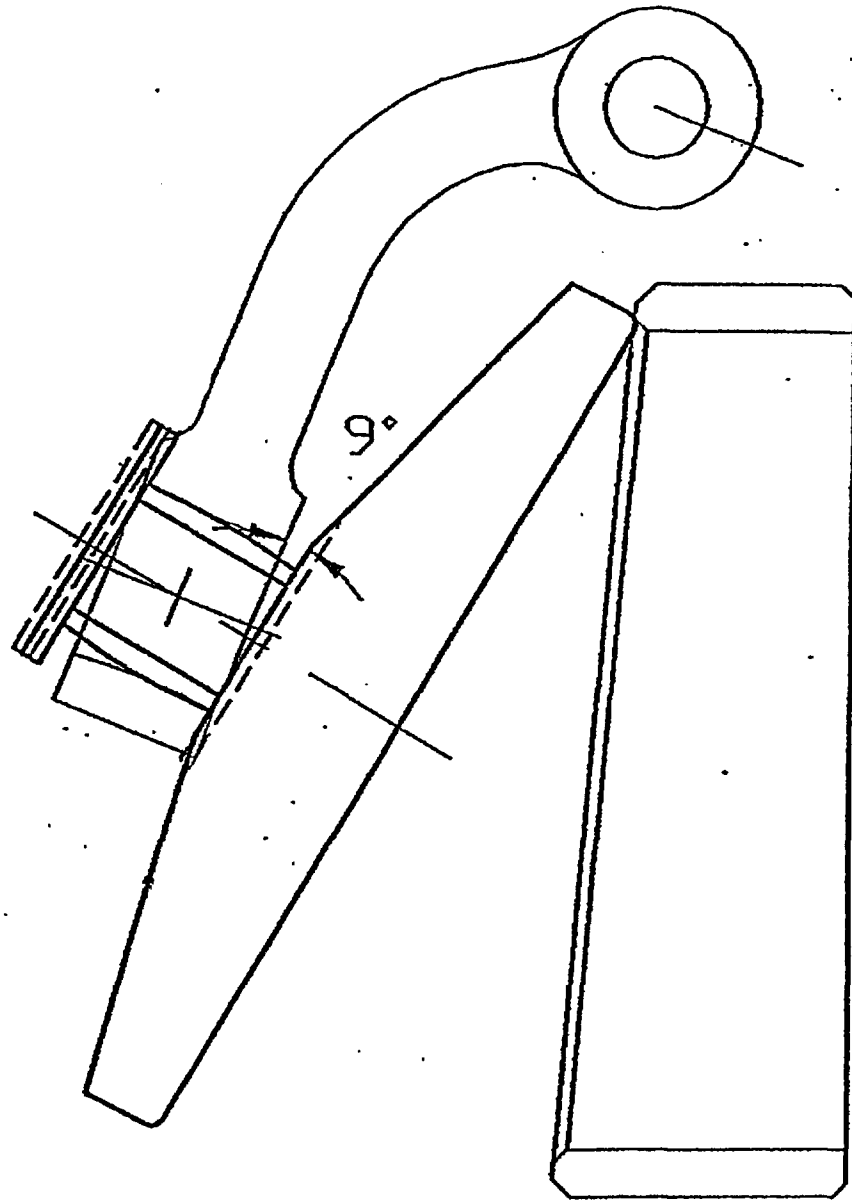
Required Angle of Disc Rotation and Axial Gap for Interference

On August 23, 2001, Flowserve – Williamsport, PA issued the enclosed 10CFR Part 21 report regarding Borg Warner 3" and 4" swing check designs. Some disc assemblies were shipped with an excessive stud-to-disc weld that could keep the disc washer too far from the back of the disc and consequently permit excessive angular movement of the disc. This could result in the top of the disc catching on the seat ring bore and prevent the valve from closing.
