NUREG/CR-6095
SAND93-1803

Aging, Loss-of-Coolant Accident (LOCA), and High Potential Testing of Damaged Cables

Prepared by
R. A. Vigil/SEA
M. J. Jacobus/SNL

Manuscript Completed: January 1994
Date Published: April 1994

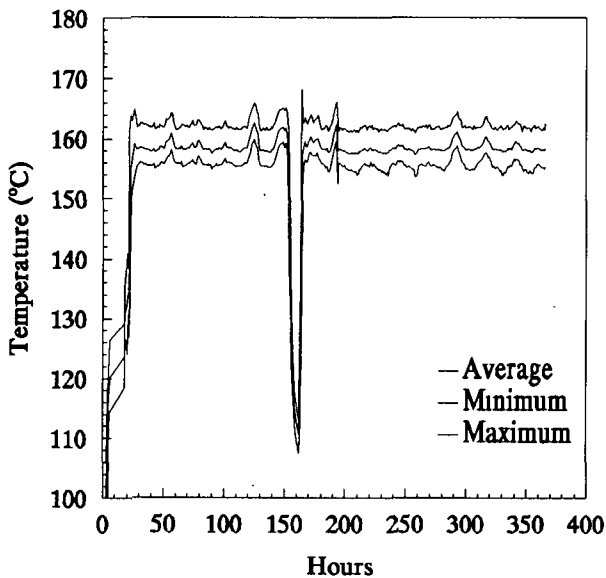
Figure 2 Thermal Aging Profile

thermal aging. Note the drop in temperature at approximately 6 days. This anomaly in temperature was caused by a failed electric circulation heater. The defective electric circulation heater was removed while the remaining electric circulation heater maintained the chamber temperature above 100°C until a new electric circulation heater was added to restore the chamber to the desired temperature. The drop in temperature existed for approximately 24 hours. The thermal aging was extended by 24 hours to compensate for this anomaly. The effect of this anomaly is an insignificant increase in the total thermal aging.

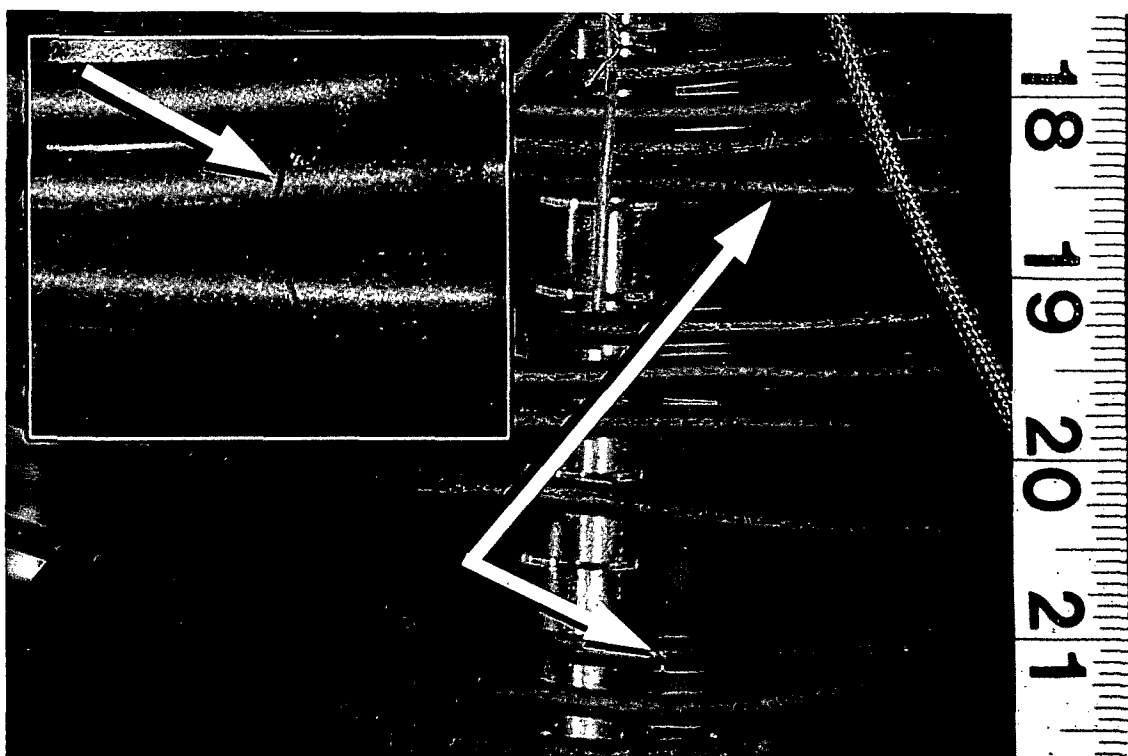
Figure 3 Cracks in Okonite Insulation After Thermal Aging

After completion of the thermal aging, a visual inspection revealed that all of the (intentionally) damaged Okonite cables had developed cracks in their insulation and/or jackets. The virgin sample did not appear to have any signs of cracks. Most of the cracks were adjacent to the damage locations, but outside the damaged area. Figure 3 is a photograph of these cracks in several of the Okonite cables. The cracks were circumferential and most were through to the conductor, although some cracks were apparent only in the CSPE jacket (especially on the cable with the least amount of damage). No cracks through to the conductor were noted on the cable with the least amount of damage. The exact cause of the cracks is unknown, but a major factor appears to be thermal aging of the bonded jacket material, followed by jacket cracking that propagated to the insulation. The bending of the cables around the test mandrel also appears to be a significant factor. The cracks were clearly not caused by sample preparation or handling during testing. Samples were carefully prepared using minimal clamping pressure and inspected after milling. There was no sample handling after aging. Because of these failures and other subsequent accident

Because of the cracks in the Okonite cables, we expected that all the damaged Okonite cables, except for the undamaged cable and the cable with the least amount of damage, would fail early in the LOCA test. In fact, the undamaged cable was one of the first cables to blow a 1 A fuse after the chamber environment became saturated steam at approximately 11 hours from the start of the LOCA exposure. (The undamaged cable blew its fuse at about 14 hours into the test as shown in Table 5.) The last surviving Okonite cable sample blew its 1 A fuse at approximately 182 hours into the LOCA simulation. Other cables that were known to have cracks through to the conductor did not blow 1 A fuses until as late as 137 hours into the LOCA test. Had chemical spray been present during the test, these cables would have almost certainly all blown fuses earlier because of the enhanced ground plane. These failures would probably have occurred soon after the chemical spray was started.

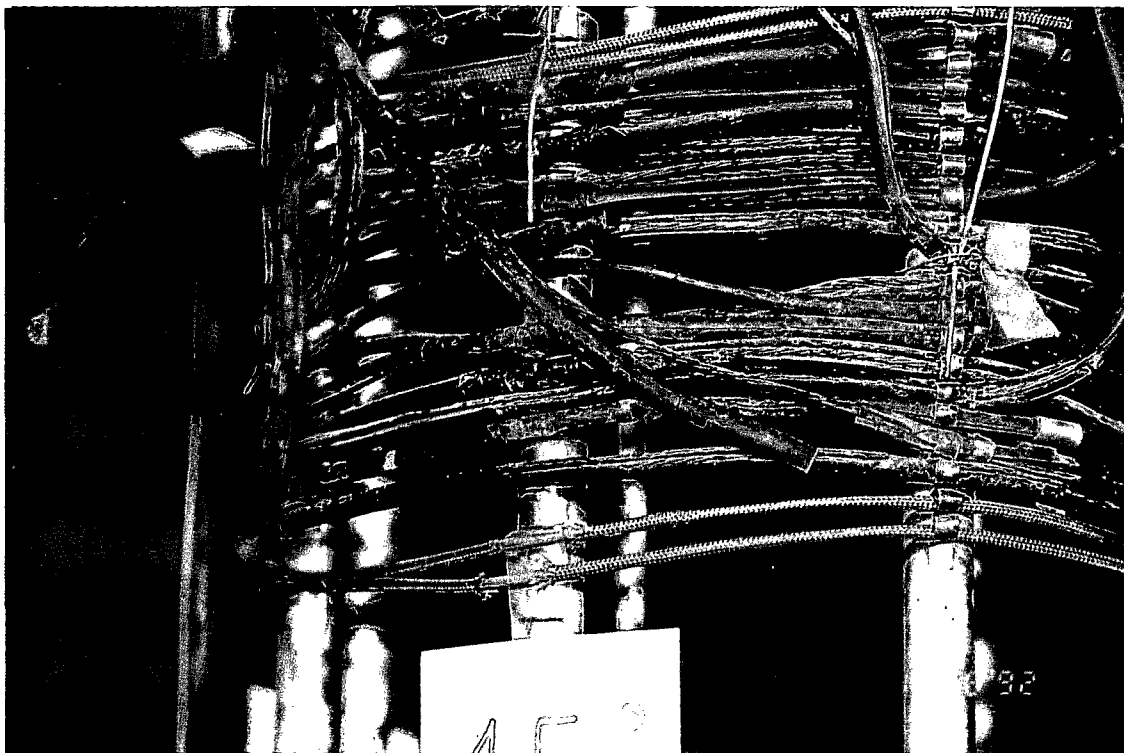
Figure 6 Okonite Cable Failures After LOCA Simulation

Additional results, beyond the objectives, were provided by this test program. The failures of the Okonite cables in this program and in a previous test program suggest that the bonded CSPE jacket is detrimental to overall cable integrity. These results indicate that even the undamaged cable cannot meet its rating with the bonded CSPE jacket when thermal aging is performed according to the Arrhenius theory as used in this testing. Another interesting result indicates that even though the Okonite

cables sustained cracks during thermal aging (prior to the LOCA simulation), all of the cables survived for a period of time in the LOCA simulation. The first Okonite failure (opening of 1 A fuse) occurred at 11 hours (just after the chamber environment became saturated steam) and the final Okonite failure occurred 182 hours into the LOCA profile (although there were indications of erratic behavior and perhaps even failure well before the fuse opened). It must be noted that no chemical spray was used during the LOCA simulation. Because of cracks through to conductors that existed prior to the LOCA tests, the use of chemical spray would almost certainly have caused electrical failures to appear shortly after the chemical spray was started because of the enhanced ground plane created by the chemical spray.

It was evident during the post-LOCA inspection that the Okonite cables had clearly deteriorated grossly during the LOCA exposure. All the Okonite cables had longitudinal cracks over much of their length, exposing the center conductor as shown in Figure 6. In addition, identical undamaged single conductor Okonite Okolon cables that were used as cable ties in the test chamber exhibited the same type of extensive longitudinal cracking. Because of the nature of these failures and comparison with previous testing (discussed later), we believe that the failure rate of the Okonite Okolon cables under our test conditions is essentially 100%. Because of their unexpected failures, no data for the minimum insulation thickness necessary to survive aging and accident tests can be determined for the Okonite cables. The observed failures were very similar in appearance to a failure of an Okonite cable and several failures of another cable that had bonded CSPE jackets in previous testing at Sandia [5].

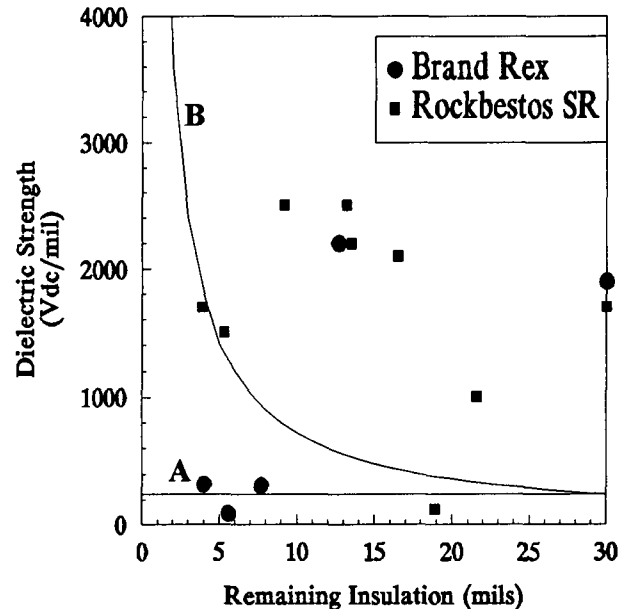
Figure 8 Dielectric Strength Based on Nominal Remaining Insulation Thickness

The results of these post-LOCA breakdown tests are given in Tables 6 and 7. Figure 8 presents the dielectric strength data in Vdc/mil of remaining insulation versus remaining insulation thickness for the Brand Rex and Rockbestos cables. Note that the two Brand Rex cables that passed the accident test with less than 7 mils of insulation remaining (samples 2 and 6) both had breakdown voltages less than the 600 Vac rating of the cable (considering 600 Vac to be equivalent to 1800 Vdc). In addition, the breakdown voltage in Vdc/mil for these two cables was much lower than the expected breakdown voltage of this material after LOCA (i.e. about 14000 kVac for an undamaged cable [6] or the equivalent of about 1800 Vdc/mil). If the cables had been energized with ac potential and/or if the applied voltage had been higher (but still within the rating of the cable), it is possible that these cables would have also failed during the accident exposure. However, unlike the cables that immediately failed the post-LOCA dielectric

tests, neither of these two cables had any indication of problems during the LOCA simulation. There appears to be a clear difference in breakdown voltage in Vdc/mil between the Brand Rex cables with less than 8 mils of insulation remaining and those with greater than 12 mils remaining. With less than 8 mils remaining, the breakdown voltage did not exceed 320 Vdc/mil, while above 12 mils the breakdown voltage was not less than 1900 Vdc/mil.

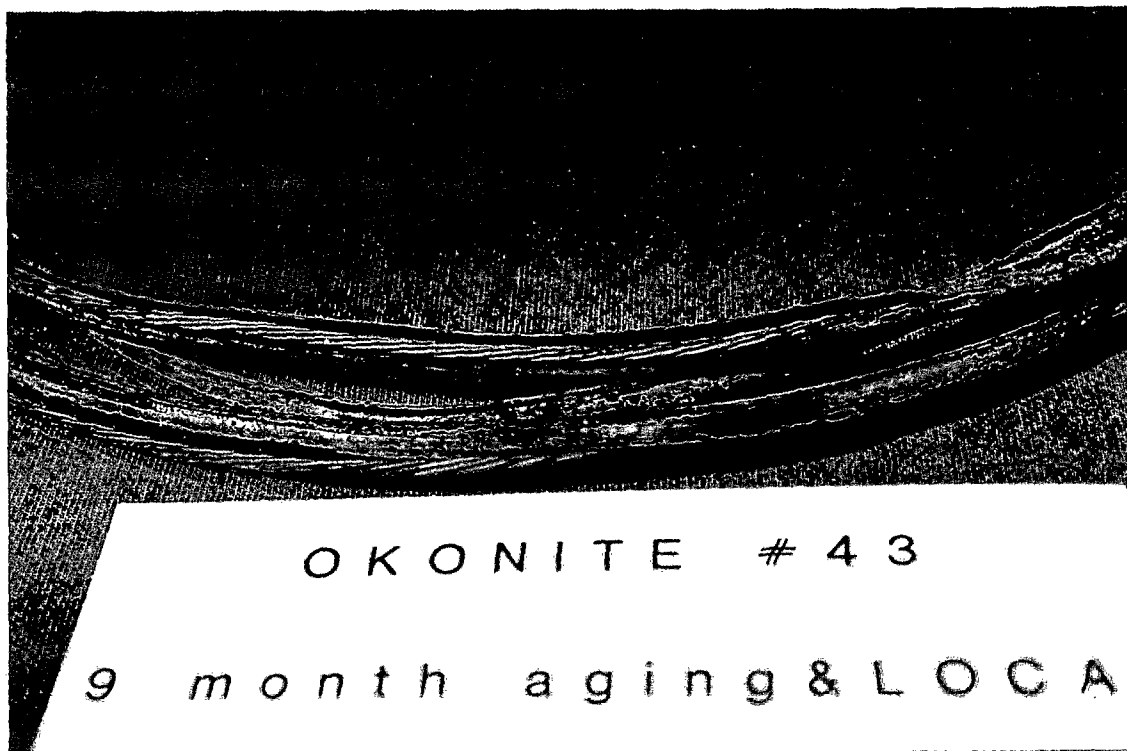
Figure B-1 Failure of Okonite Cable Sample from Reference B-1 Test Program

Because the sample that failed was aged to the maximum extent and a significant number of samples were less severely aged and did not fail, a connection with the degree of aging is strongly suggested.

Based on the analysis of equivalent thermal aging times, the fact that all of the cables had identical longitudinal cracking during the steam exposure is not very surprising. Since there is an almost certain connection between the failures and the degree of aging, we would expect the Okonite cables to fail a test where the thermal aging that was used in this test program was combined with **no radiation aging** and followed by a 110 Mrad accident exposure and the steam profile used in this test. Thus, although the application of the total radiation dose prior to thermal aging is perhaps more

severe than a different aging sequence, the evidence clearly indicates that the sequence was irrelevant in this test. However, the sequence may become important if testing at lower levels of thermal aging is conducted.
