Subject: 10CFR21 Reporting of Defects and Non-Compliance -
Engine Systems, Inc. Report No. 10CFR21-0093, Rev. 0

Camfil-Farr Air Intake Filter Housing, P/N: ESI50801-1

Report No. 10CFR21-0093

COMPONENT: Camfil-Farr air intake filter housing
P/N: ESI50801-1

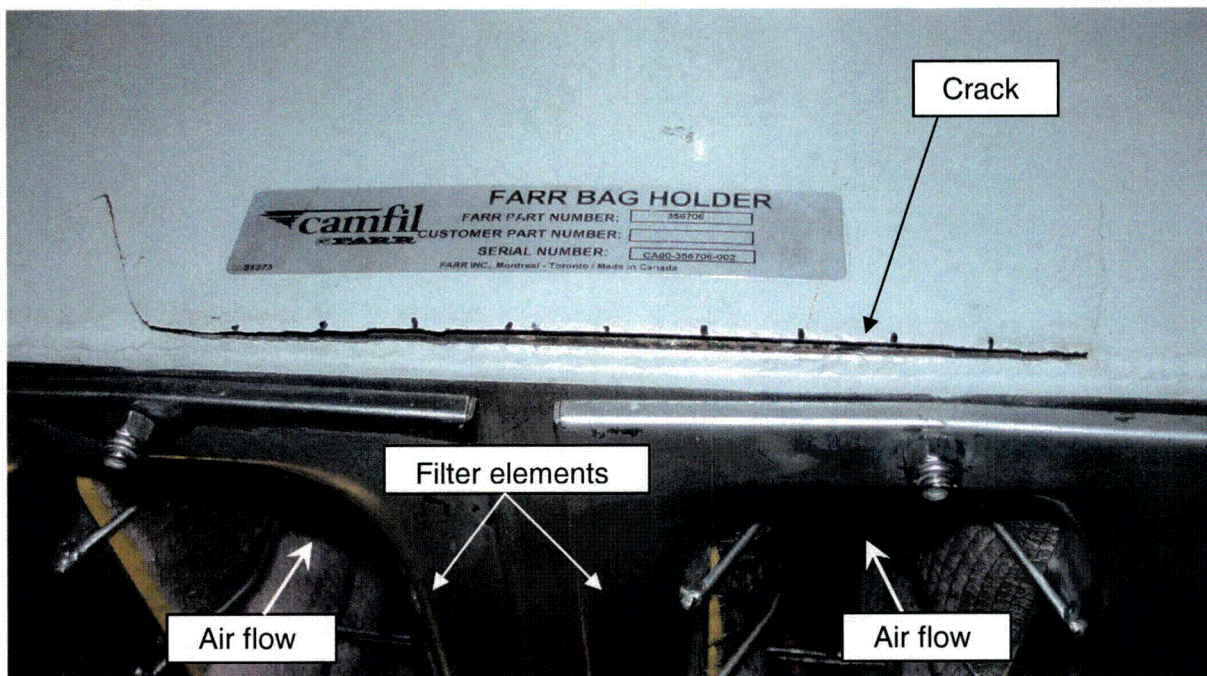
Engine Systems Inc. (ESI) began a 10CFR21 evaluation on 4/27/07 to investigate cracking of an air intake filter housing at the Kewaunee Power Station (KPS) as shown in Figure 1 below. The evaluation was concluded on 6/25/07 and was determined to be a reportable defect as defined by 10CFR21.

1A Emergency Diesel Generator Air Box

Cracking created a small gap to occur between the front and top surfaces of the housing. The gap was approximately $\frac{1}{4}$ " at the highest point (near the center) and decreased on either side of the center point (overall crack length was approximately 10" long). The filter housing utilizes four (4) bag-type filter elements aligned horizontally. The vertical centerline of the housing is between the two (2) elements shown in Figure 1; another element is located beside each of the pictured elements. The crack resulted in a pathway for unfiltered air to enter the engine turbocharger. Unfiltered air may contain foreign material that could cause turbocharger failure and/or premature engine wear.

1. Lack of weld penetration during fabrication of the housing.
2. High residual stresses related to bowing on the top surface and/or improper fit up during fabrication.
3. Overload event during shipment, storage, installation, or some other time to promote crack initiation.

1. Bowing of the filter housing was evident and documented by measurements on the top surface of the A EDG housing but was not present on the B EDG housing.
2. No cracking was present on the B EDG housing.
3. The filter housing was received without any physical damage.
4. The extent of bowing on the top plate at the time of installation is unknown.
5. The filter housing was installed in fall 2001 and has accumulated approximately 200 hours of run time. Damage to the housing was not observed during each of the three (3) subsequent refuel outages after installation; indicating that significant cracking did not occur until after the fall 2006 outage.
6. Natural frequency data for both EDG's suggests that factors other than fatigue contributed to the cracking, such as external force or high residual stress.

At the earliest convenience, affected users should inspect the air filter housings for any evidence of cracking and/or distortion that could indicate conditions of high residual stresses.
