Event # 43663

POTENTIAL FAILURE TO COMPLY WITH SPECIFICATION CONFIGURATION

Subject: 10CFR Part 21 Notification of Deviation re. Electroswitch Corp. P/N 700034K01 L-2 Auxiliary Switch Assemblies

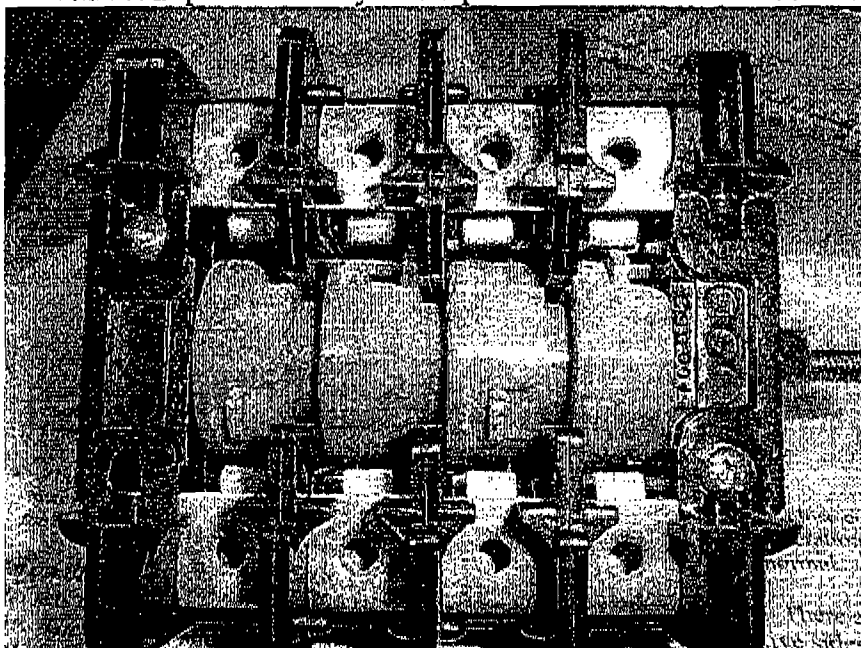
Figure 1: L-2 Auxiliary Switch Assembly Internals

The rotating assembly in the switch is made up of a shaft on which is mounted a series of electrical contacts in a molded plastic frame, with insulating spacer bushings positioning the contacts inside the frame. As the switch is rotated, the contacts will mate or break with the stationary contact terminals. Figure 1 shows that the spacer bushing is missing from the contact second from the left side. The absence of this bushing could allow the contact to move out of position, resulting in the loss of electrical contact, as depicted in Figure 1.

7. Corrective actions include:
 - a. Quarantine and physical inspection of all available on-hand inventory for the presence of spacer bushings. Action complete; (133) 4-stage switch assemblies were visually inspected for the presence of the spacer bushings with no deficiencies noted (P/N 700034K01). (50) 8-stage switch assemblies were visually inspected for the presence of the spacer bushings with no deficiencies noted (P/N 700038K03). (26) 8-stage switch assemblies (all short contacts) were visually inspected for the presence of the spacer bushings, with one switch (date code 0729) missing one spacer bushing.

- b. Notification of the potential existence of this deviation to affected customers. (to complete 9/30/07)
 - c. Revise dedication procedures to require physical inspection of the switch internals to confirm presence of the spacers. (complete 8/31/07)

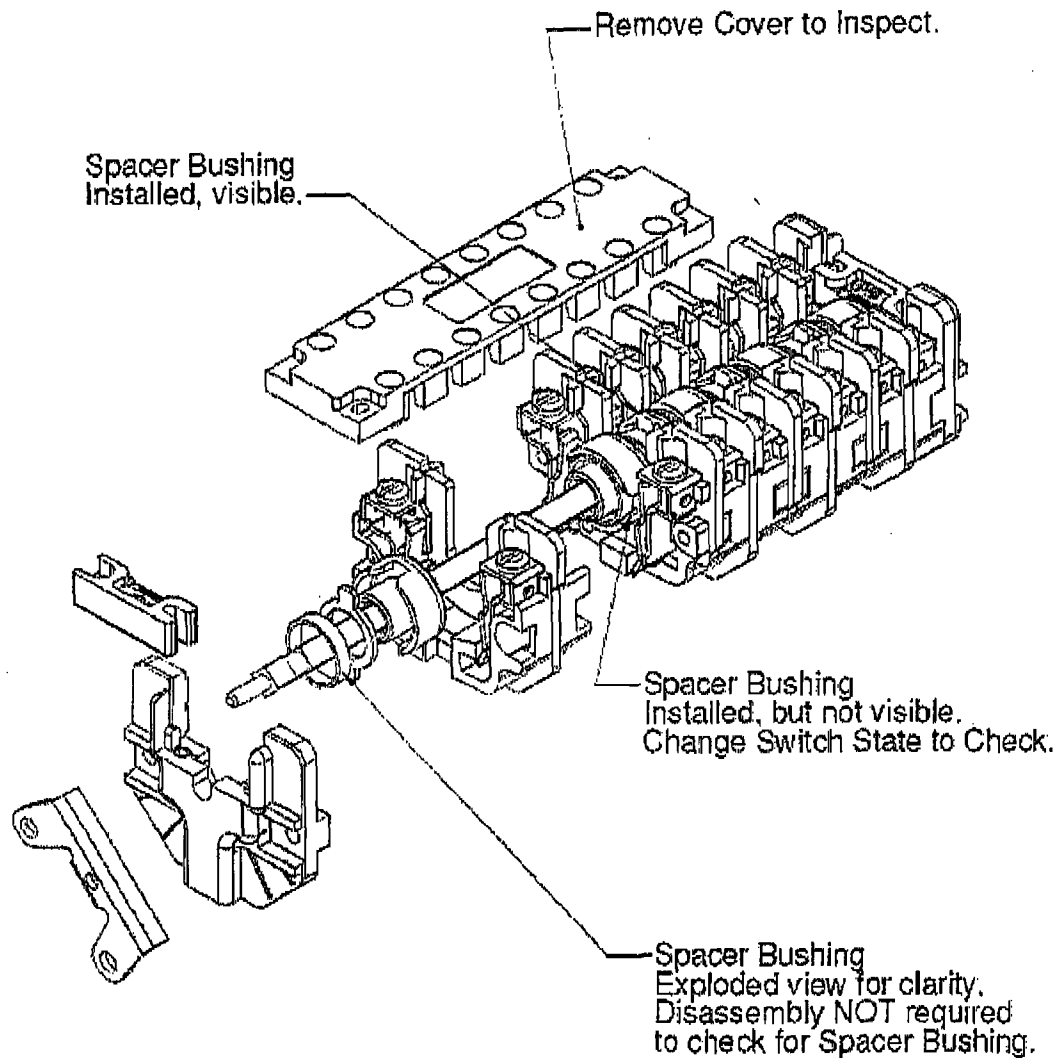
Because of the large variety of wiring configurations and usages of this switch, ABB (CBTS) cannot determine if the potential for a substantial safety hazard exists at this or any other licensee's facility if a similar nonconforming switch is identified, or whether any corrective actions should be taken. Licensees are requested to evaluate the history of inspections, maintenance practices, physical locations, failures, and system configurations where the switch assembly is used to determine whether the absence of the spacer would have been previously identified. If licensees wish to physically confirm the presence of the spacers, the internals of the switch assembly may be inspected by removing two screws on the face of the switch, removing the access plate, and visually sighting the spacers while rotating the switch 90 degrees to confirm all electrical contacts have a spacer present. See drawing, below:

Typical 8-Stage K-Line Type L-2 Aux. Switch
4 & 6 Stage Switches similar.
HK & Switchgear Installations use alternate crank arm.

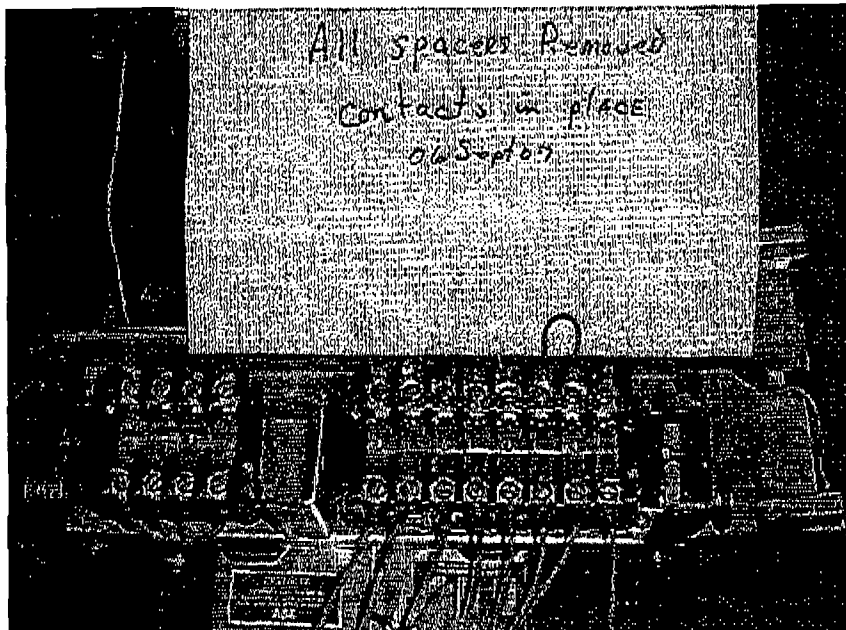
Image 1

The first failure occurred during the second cycle of the test, when contact 26 failed to register on the close and contact 20 and contact 32 failed to register on the open. The testing was paused to reset the 3 failed contacts. After two resets (with the last reset being after cycle 5 of the 50), contacts 20, 26, and 32 failed after the number of cycles as seen in **Table 1a**. Note that the blank spaces in Table 1 indicate there was no failure to register a change in state for the corresponding contact.

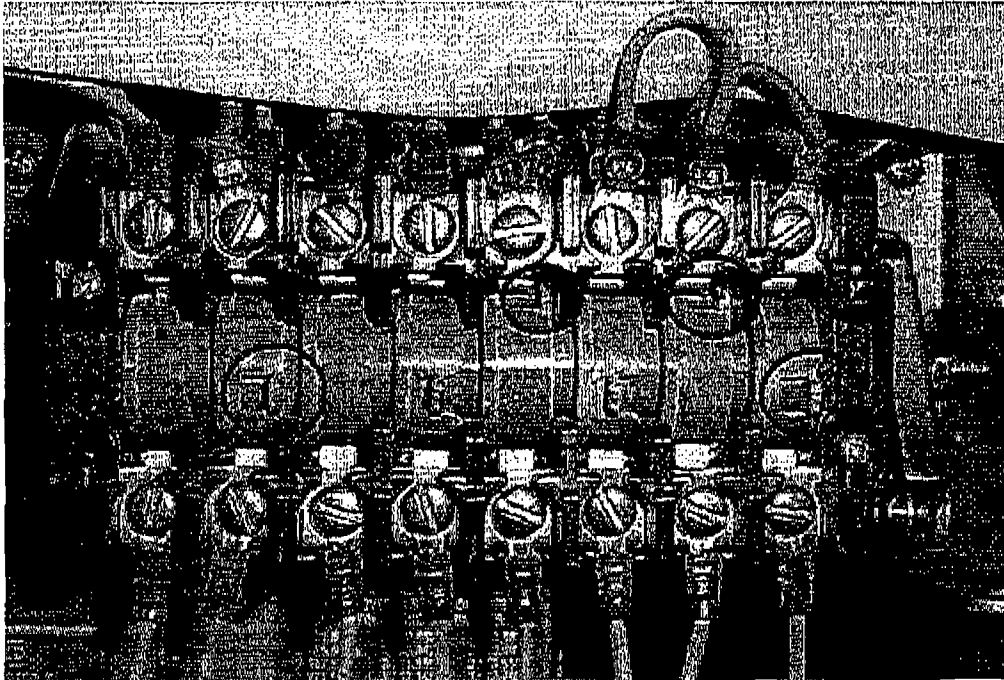
Image 2

None of the contacts which failed during the 50 cycles of the breaker ever came back to register the change of state properly. Once a contact failed to register, it continued to fail to register until manually reset. A picture of the four contacts, which failed, can be seen in **Image 2**.

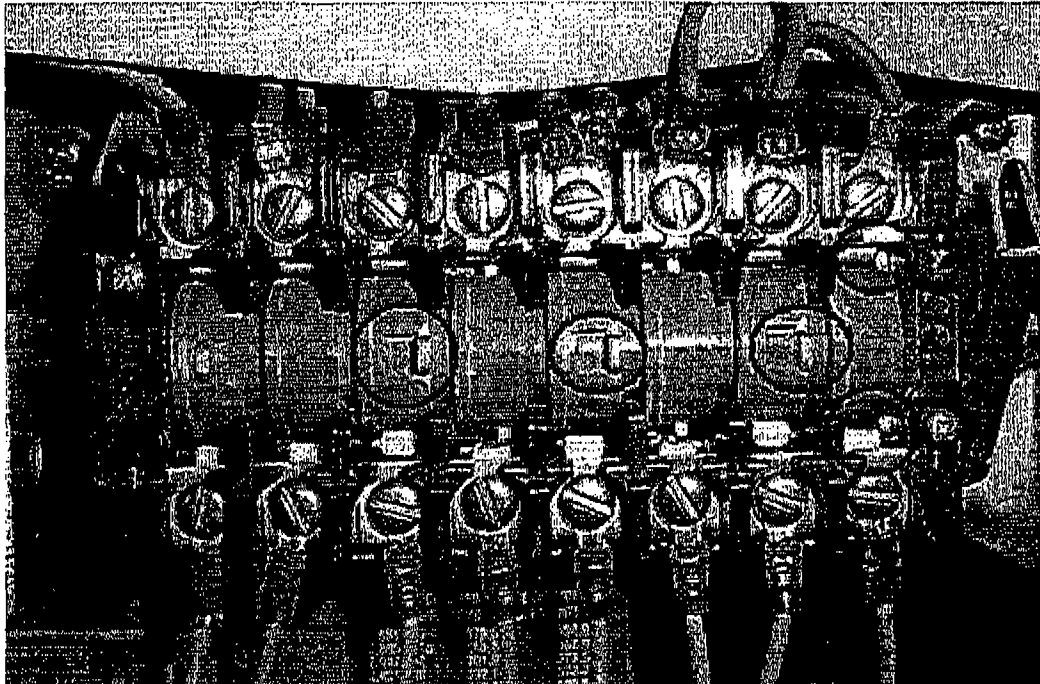
Image 4 shows 4 of the 5 contacts that failed during test 2. The number 22 contact, 2nd from the left, is not properly aligned but due to the camera angle it cannot be seen as easily as the other 4. The rotating contacts can be clearly seen to have moved axially in the picture.

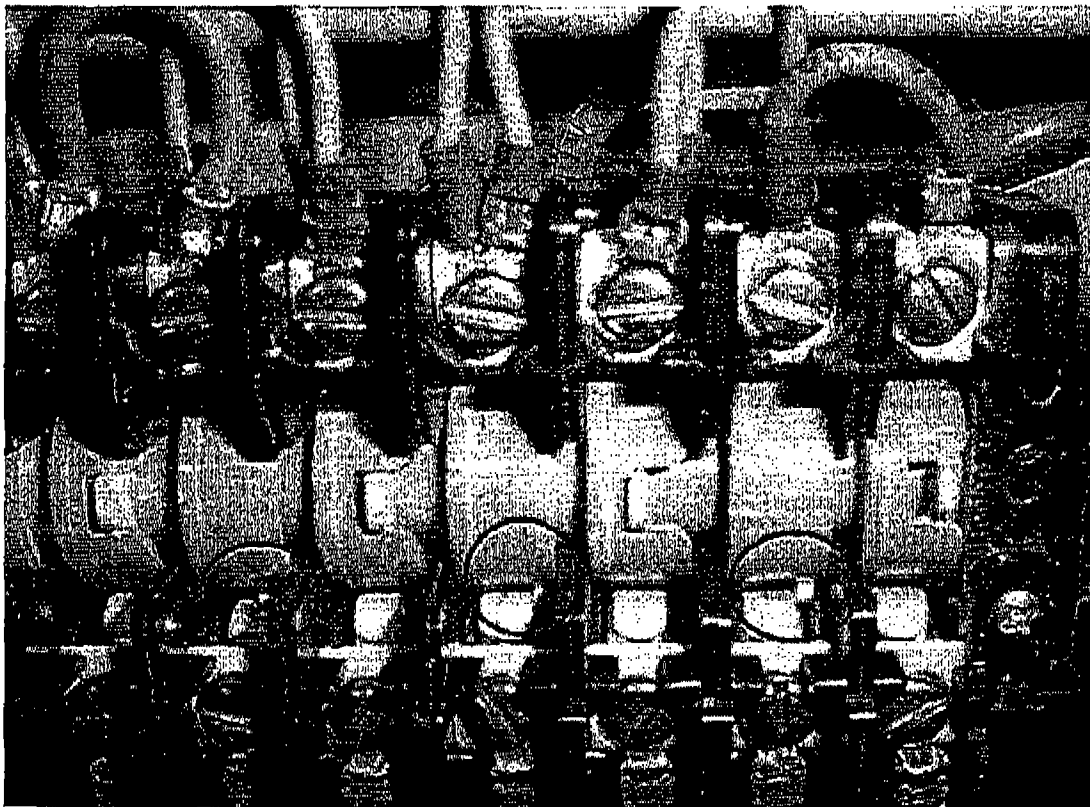
Image 6 shows the other 3 close contacts, which have drifted as well.

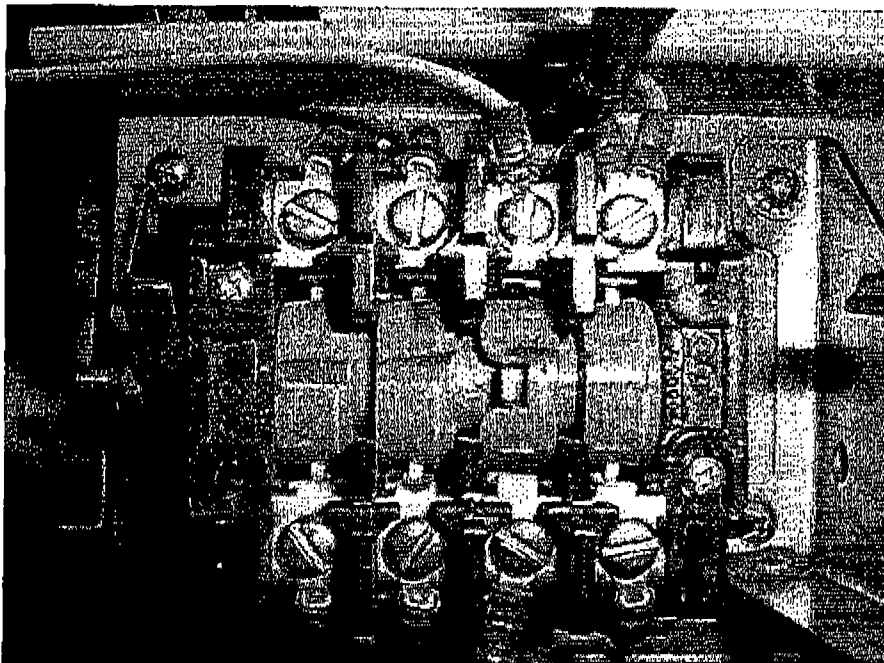
Image 7

For the fourth test, the spacer bushing in the number 4 contact (third position to the left from the arm of the switch) of the 4-stage switch [Switch 'E', Date Code: 0546] was removed. This contact was monitored while 50 open-close cycles were performed on the breaker. The number 4 contact was the only contact being monitored during this test and after 50 operations; the number 4 contact never failed so an additional 50 operations were ran. The contact after 100 operations had moved slightly, but the rotating contact fit tightly enough in the groove of the assembly to prevent the contact from moving completely out of line as seen in Image 7.

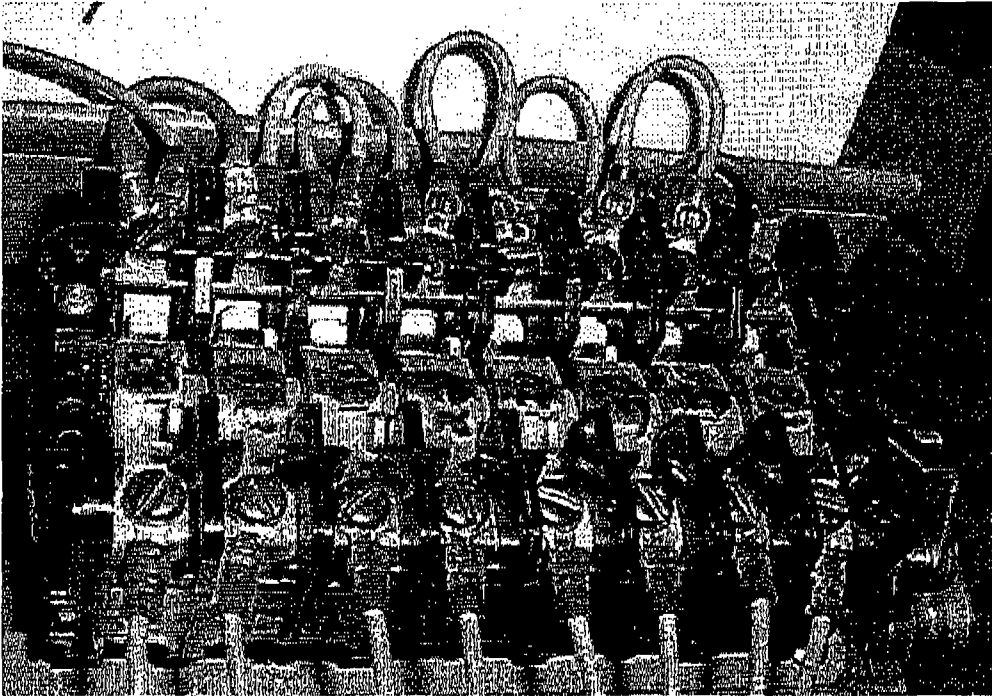
The contacts were all properly aligned and 50 close-open cycles of the breaker were to be run. The contacts all passed the first close-open cycle, but the second cycle resulted in failure of all of the contacts due to mechanical failure of the switch itself. The switch can be seen in Image 8 how it appeared after the testing was halted.

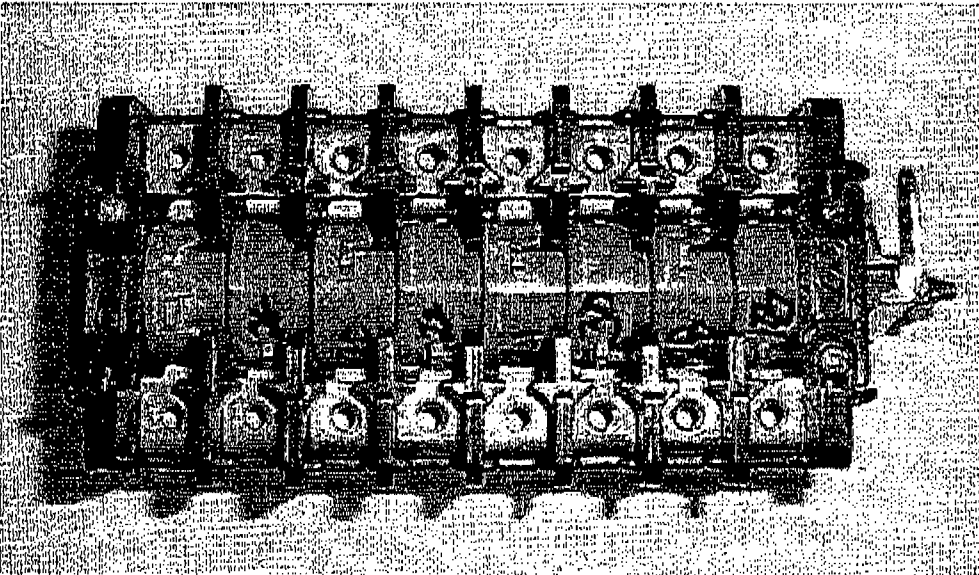
Image 9

The damage to the 32 contact bushing can be seen in **Image 9**. A plastic retaining notch that keeps the stationary contact from over-extending broke off due to contact with the rotating contact. This resulted in not only the retaining notch breaking off, but also the contact barrel itself sustaining damage that prevented the entire switch from rotating.

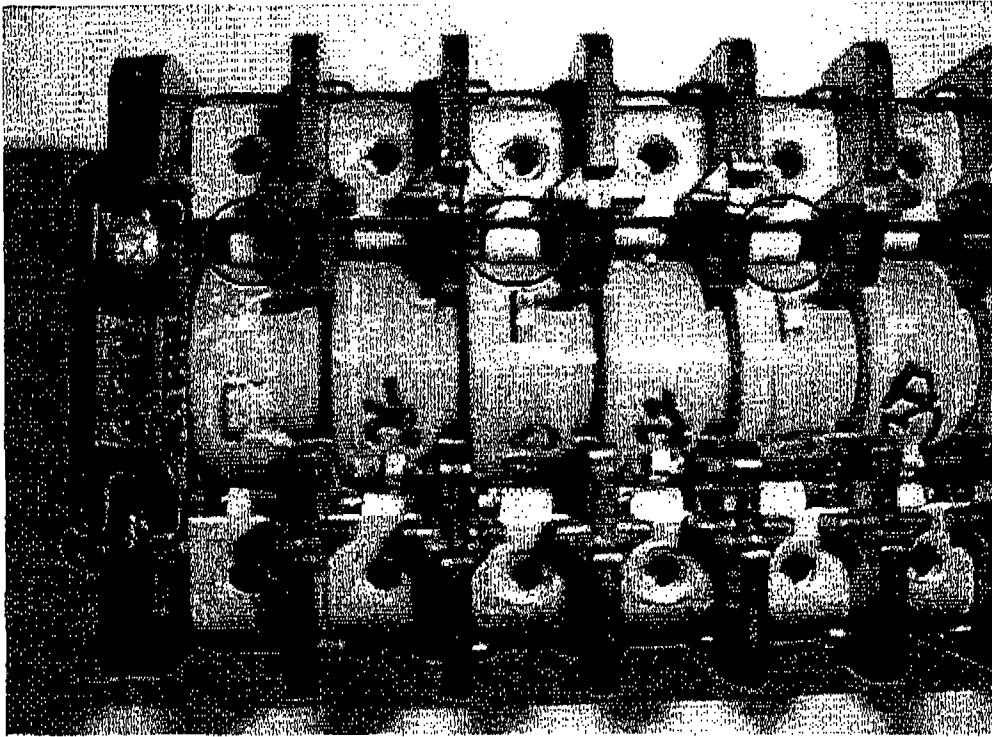
Image 10

It should also be noted, as in **Image 10**, the stationary contact retaining bosses had failed in other contacts as well.

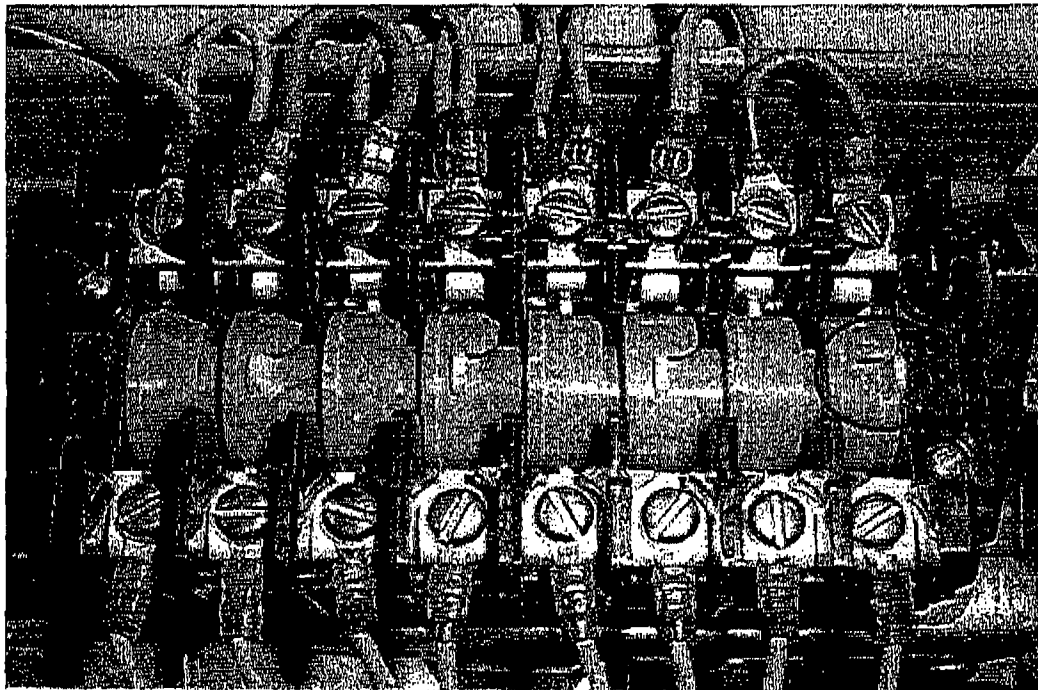
Image 11

In order to perform test number 7 the 8-state switch required replacement. A new switch [Date Code 0723] was installed and spacers were removed from contacts 20, 24, 30, and 32.

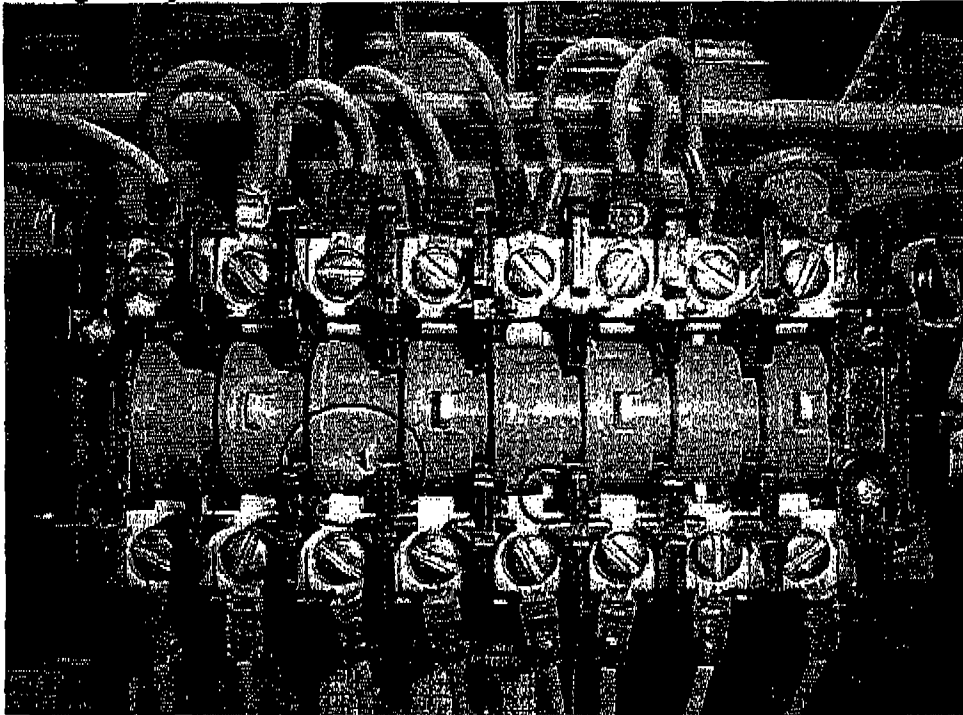
Image 12

At some point within the first 5 cycles of this test, the contact which had slipped out of alignment, damaging the barrel casing of the 22-position switch. Below in image 12 this damaged area may be viewed.

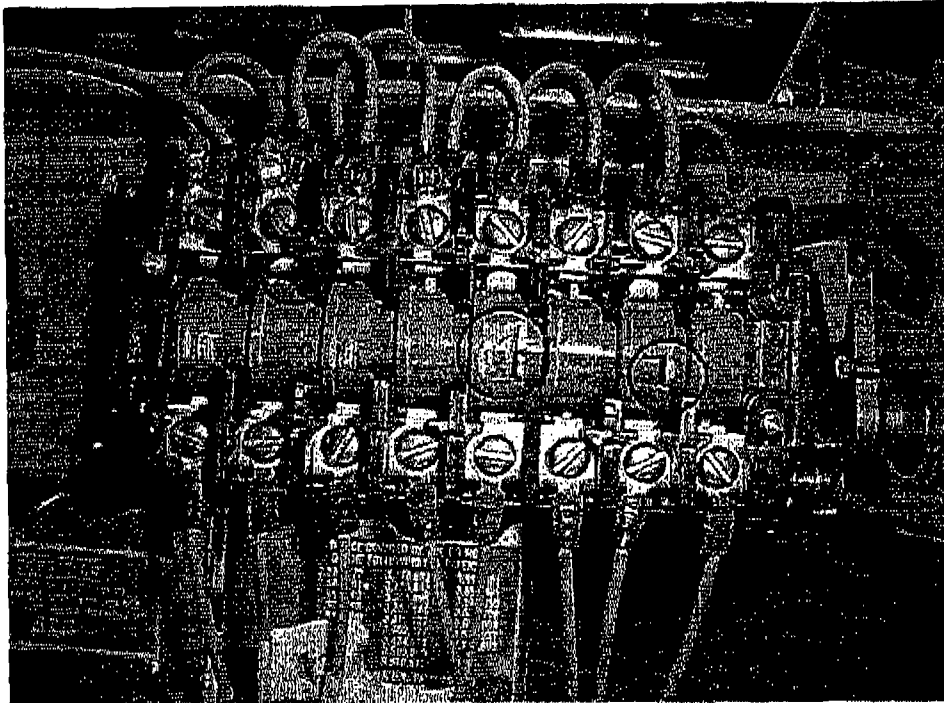
Image 13 below reveals the contacts that went out of position during this test. It should be noted that another switch barrel, of contact 26 suffered damage within the first 20 cycles of the test.
