Subject: Report of Defect in Accordance with 10 CFR 21

Report of Defect per 10CFR21 Basler Electric SBSR AVR Card Solder Joints

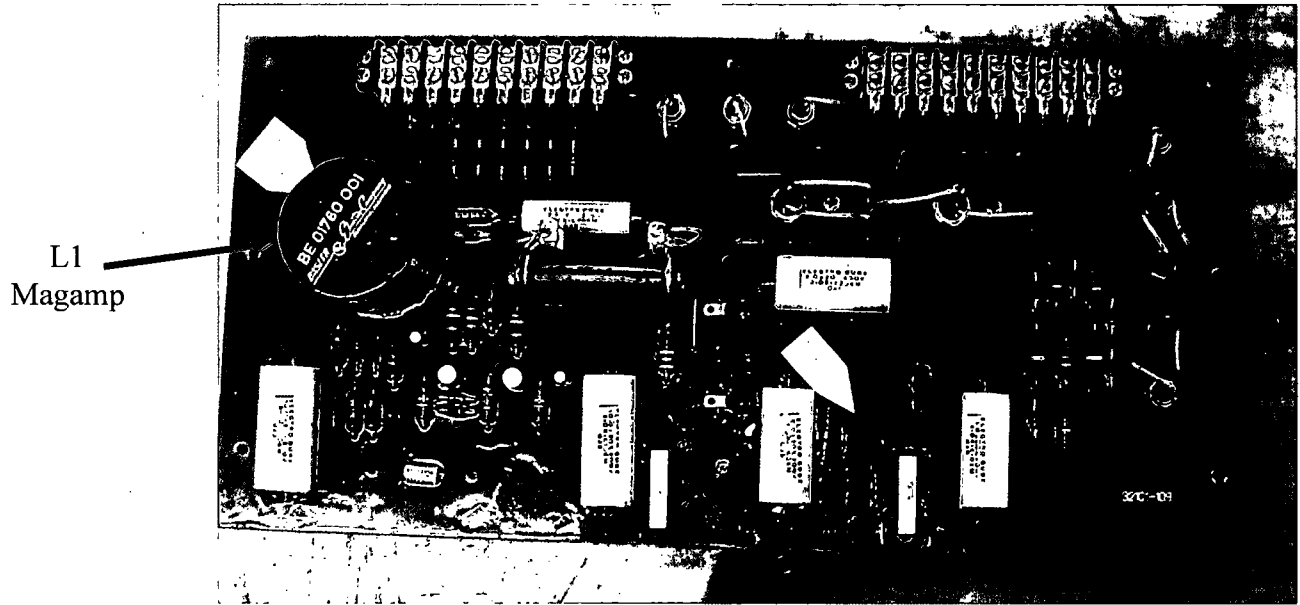
The SBSR AVR card contains a variety of mounted components (see Figure 1). The defect identified within this report deals specifically with the soldered electrical connections between the L1 magnetic amplifier module (magamp) and the card. While there are many Basler SBSR AVR card part numbers, all cards perform the same function and have similar components. Further, all cards utilize the same L1 magamp and all cards mount and electrically connect the L1 magamp in a similar manner.

Figure 1. Photograph of SBSR AVR Circuit Card (Card is 8 by 16 inches)
