PART 21 REPORT - POPPET NUT AND STEM ASSEMBLY DEGRADATION ON MSIV

Subject: Beaver Valley Power Station, Unit No. 2

10 CFR Part 21 Notification

Subject: Main Steam Isolation Valves (MSIV) Beaver Valley Power Station Unit 2

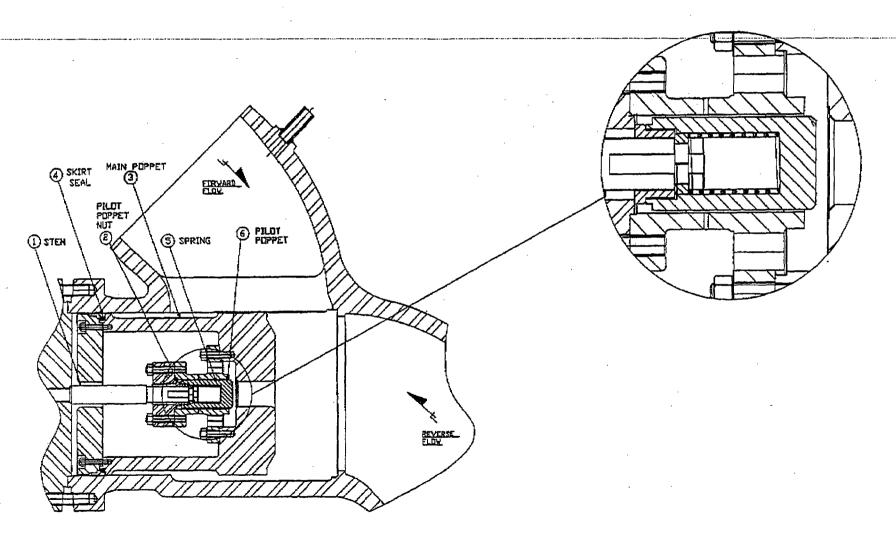
SKETCH 1 VALVE BACKSEATED OPEN

Refer to the attached Sketches 1, 2 & 3. Specifically, the valve design relies on a sliding axial fit between the valve stem (pc1), pilot poppet nut (pc2) and pilot poppet (pc 6) so that during reverse flow closure, sufficient steam flow is provided to the top side of the main poppet (pc3) through the pilot seat to allow full closure of the main poppet and subsequent seating of the skirt seal (pc4). This function is designed to be accomplished by the reverse steam flow forcing the pilot poppet towards the open position throughout the main valve stroke. As designed, the spring (pc5) is intended to generally bias the pilot poppet towards the closed position, but the spring force is insufficient to provide complete closure and tight shut off of the pilot poppet.

Because of the wear and vibration damage, a condition may exist where the stem and pilot poppet nut become locked together thus not allowing a sliding axial fit (see Sketch 3). Upon closure of the MSIV in this condition, the stem, pilot poppet nut and pilot poppet (pc6) will move axially as one piece and seat the pilot poppet against the main poppet thus preventing flow of steam into the top of the main poppet as described above. Without sufficient steam flow into the top side of the main poppet, the required pressure balance is not achieved and the valve actuator closure force may be insufficient to fully close the main poppet and seat the skirt seal. When the skirt seal is properly seated, a net pressure load exists acting in the direction to seat the main poppet.

WVC believes the damage described is a result of fluid born vibrations transmitted from unstable steam flow. WVC is providing this notification to BVPS for evaluation regarding further notifications that may be required by regulatory requirements. A similar notification is being sent to STP Nuclear Operating Company as such notification applies to STP Units 1 & 2.

STEM/PILOT POPPET NUT LOCKED NOT ALLOWING SLIDING AXIAL FIT

STEM/PILOT POPPET NUT UNLOCKED ALLOWING SLIDING AXIAL FIT

SKETCH 2 VALVE CLOSED
