THREE MILE ISLAND NUCLEAR STATION, UNIT 1 (TMI-1)  
OPERATING LICENSE NO. DPR-50  
DOCKET NO. 50-289

SUBJECT: 10 CFR 21 NOTIFICATION – IDENTIFICATION OF DEFECT  
Issue Report 741412

Joslyn Clark Controls

- N/C (Normally Closed) open top contact assemblies
- Vendor Part Numbers:
  1. KPM-44
  2. KPM-46
  3. KPM-6A
  4. KPM-4A

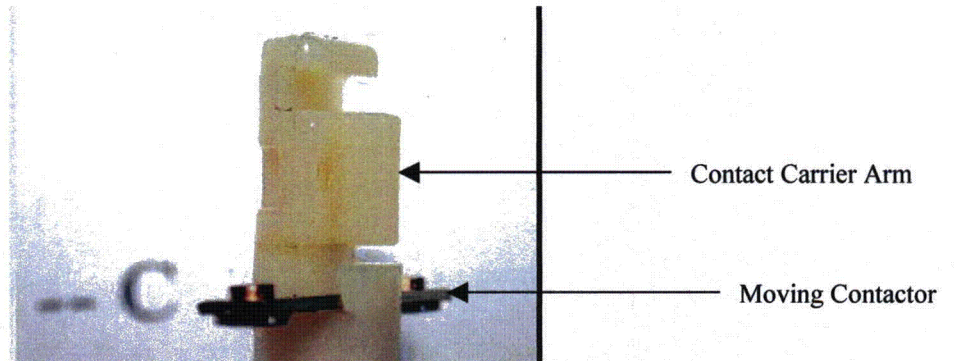
Moving contactor placed in slot of the contact carrier arm.

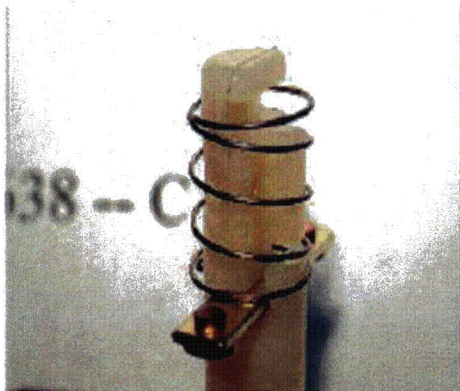
Moving contactor held in place by spring.

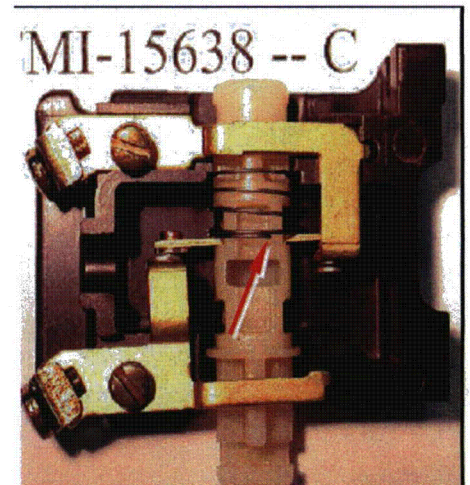
Properly assembled contact in housing.

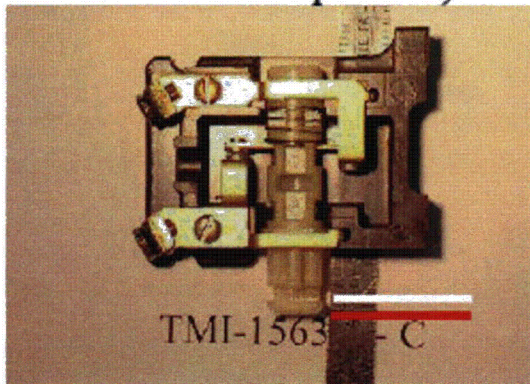
When the nylon carrier is allowed to drop to the full down position as demonstrated below in the picture on the left, the moving contactor is parallel with the lip of the slot, and there is a potential for the moving contactor to become hung-up on the lip of the slot. The nylon carrier is allowed to drop to the full down position prior to installation, and when the magnet kit and coil have been removed from the relay. Once installed in a relay, the magnet kit/coil keep the contact in the reference position as shown in the picture on the right, and the moving contactor cannot become hung-up on the lip of the slot.

**Actuator in extreme full down position (-5/32 inch from installed reference position).**

1. The Commercial Grade Dedication (CGD) plans as well as the maintenance procedures have been enhanced to prevent a relay from being placed into service with an improperly configured contact. The CGD plans have been revised such that the contacts are verified to be configured correctly during receipt inspection. Maintenance procedures have also been revised to ensure the contact configuration is correct after the relay is fully assembled and following maintenance involving magnet kit/coil replacement, contact replacement, or entire relay replacement. This type of maintenance creates a scenario where the contact carrier is allowed to drop down, which creates a potential for the moving contactor to get hung-up.

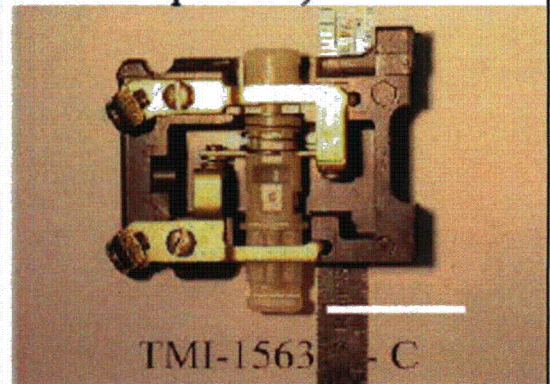
**Actuator in installed down position (0.0 inches installed reference position).**

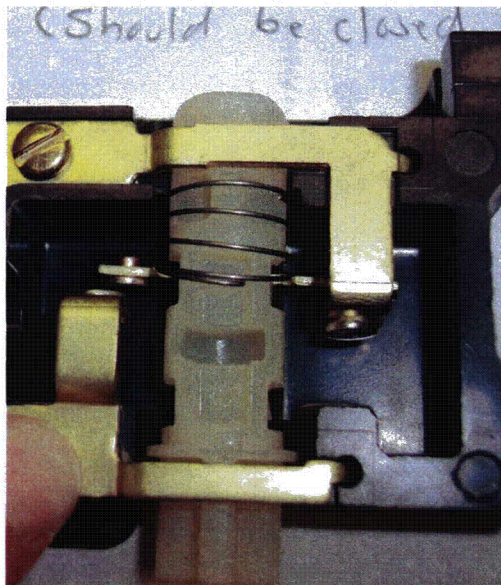
Moving contactor shown hung-up on the lip. Note the contact should be closed in this state, but is not able to fully close due to being hung-up.

The potential for a N/C Joslyn Clark contact to become hung-up does result in a substantial safety hazard since it jeopardizes the capability to actuate emergency core cooling components that are utilized to mitigate the consequences of accidents that could result in potential offsite exposure.

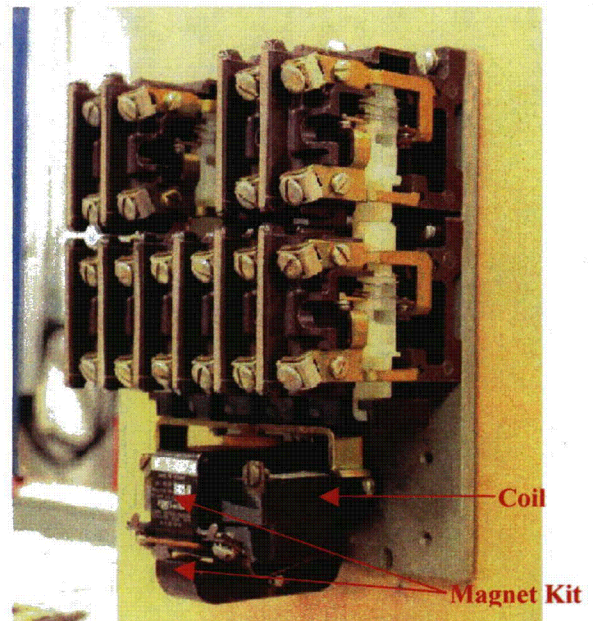
Fully assembled relay with magnet kit and coil.

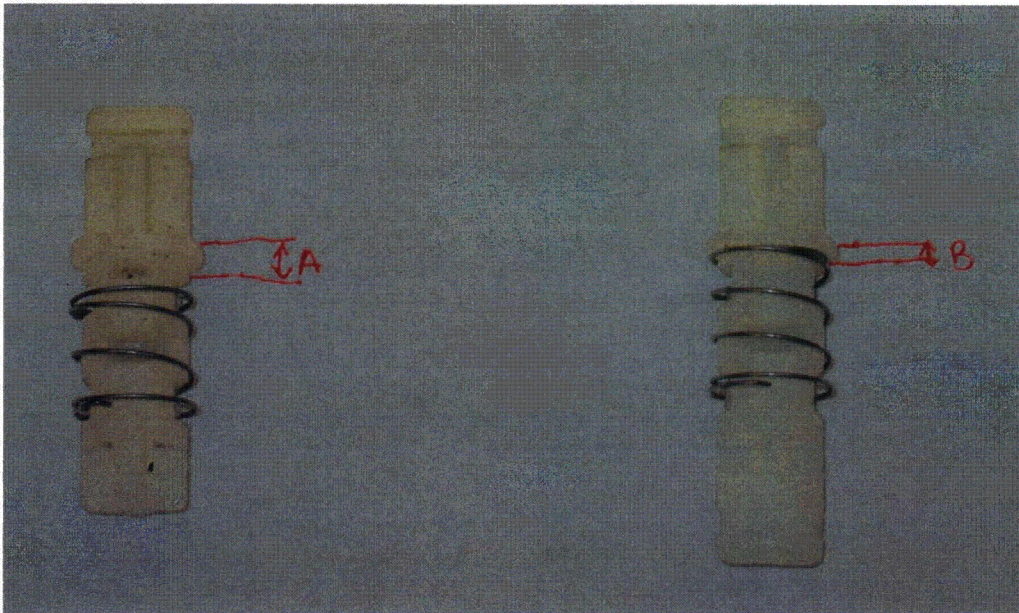
Only the open top N/C contact assemblies are subject to this vulnerability, due to the difference in the size of a retaining ring between the closed top and open top assemblies. The larger ring utilized in the closed top contact assemblies prevents the nylon arm from dropping down. (A in the picture below) The smaller ring utilized in the open-top assemblies allows the nylon arm to drop down. (B in the picture below)
