Subject: 10CFR21 Reporting of Defects and Non-Compliance -
Engine Systems, Inc. Report No. 10CFR21-0095, Rev. 0

Ingersoll-Rand Series 89 Air Start Motors, P/N 8367694-ESI

Report No. 10CFR21-0095

COMPONENT: Ingersoll-Rand series 89 air start motors
P/N 8367694-ESI

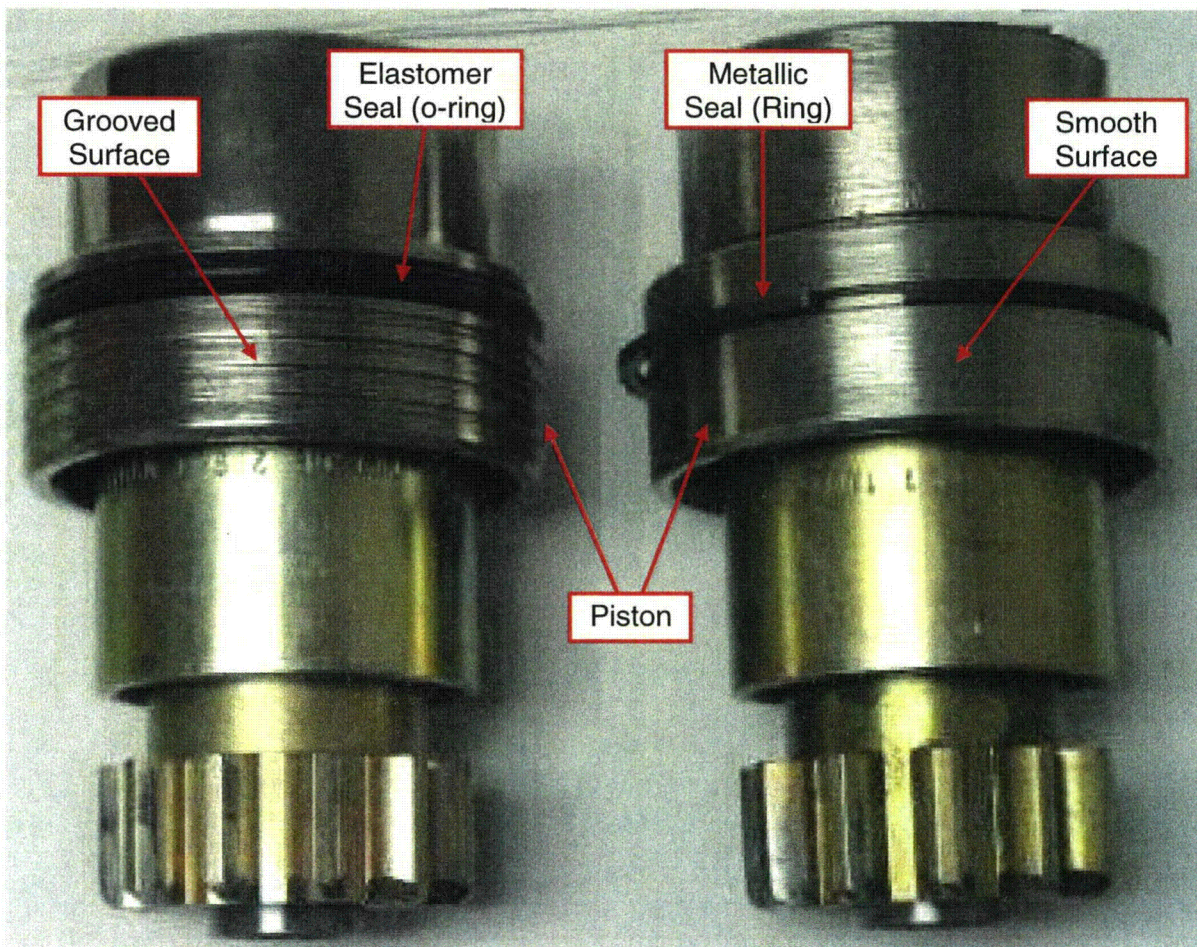
ESI inspection determined that Ingersoll-Rand used the wrong pinion engagement piston during assembly of the air motors. A new style piston with an elastomer seal ring (used in I-R's series 88 air starters) was incorrectly installed in the drive housing instead of the required piston with a metallic seal ring (required for the series 89 motor).

Series 88 Drive Pinion
INCORRECT

Series 89 Drive Pinion
CORRECT

- (1) the elastomer seal is located further away from the drive gear on the piston; this requires increased travel of the piston to port air from the pinion outlet port. During abutment of the starter drive gear with the engine ring gear, air will not port from the starter to activate the main air start valve and thus engine cranking will not occur.
- (2) the elastomer seal can be cut by the pinion outlet port hole in the starter drive housing after a number of starter engagements. This could cause binding of the piston within the drive housing and or excessive air leakage past the seal. Both conditions could increase the time required for the pinion to engage with the engine flywheel and thus compromise the fast start capability of the engine.

1. ESI has contacted all affected customers that were shipped the incorrectly assembled starters. All starters have been returned to ESI.
2. ESI has added verification of correct pinion piston and seal assembly to the critical characteristic inspection activity for future starter shipments.
3. If desired, users can inspect other starters in their inventory to verify correct assembly of the pinion piston and seal. An inspection procedure is provided on the following page.

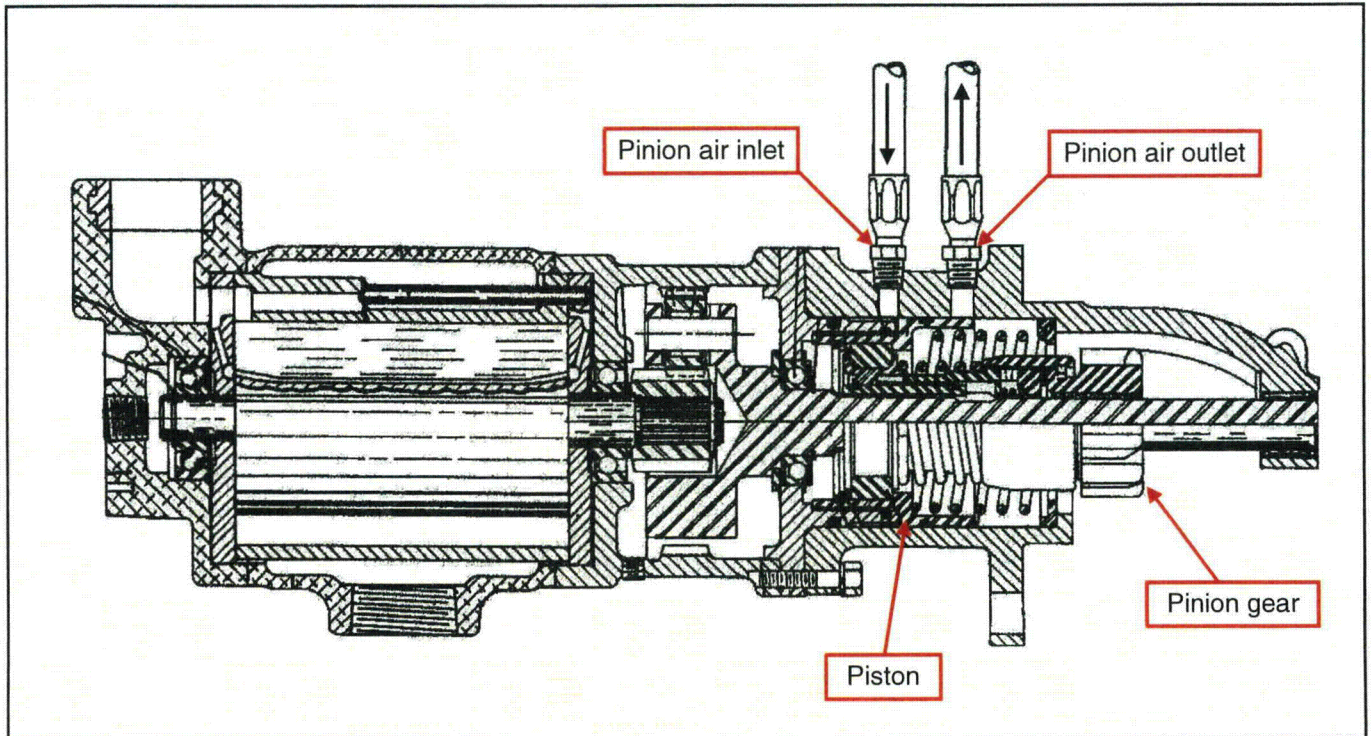
AIR START MOTOR CROSS-SECTION

Installation of the elastomer seal and piston within the series 89 starter could impact starting reliability of the diesel engine for the following reasons:

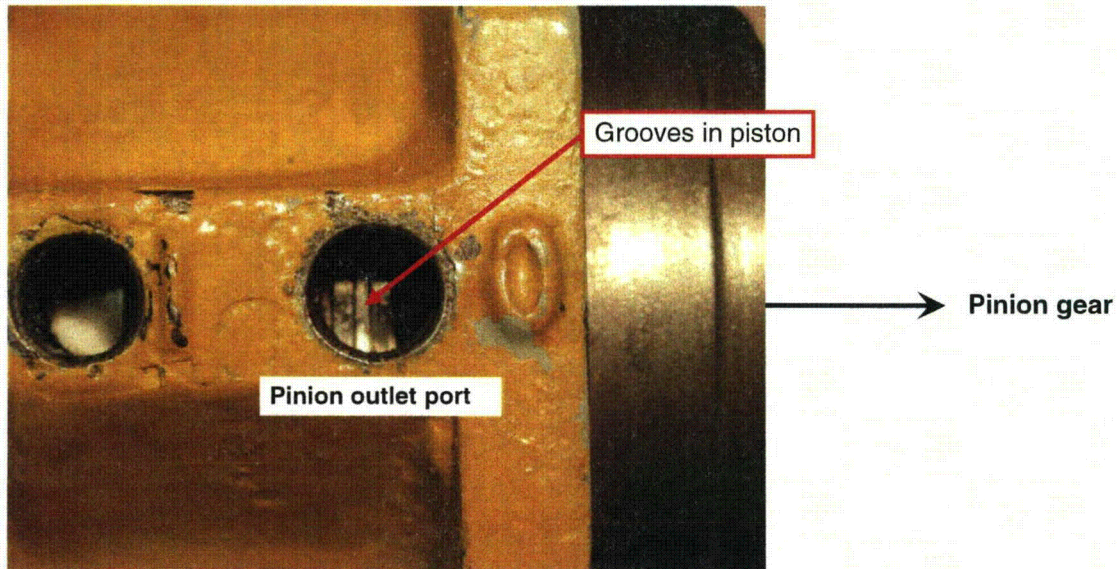
The pinion piston can be viewed through the pinion air outlet port to determine proper configuration. Refer to photos below.

INCORRECT

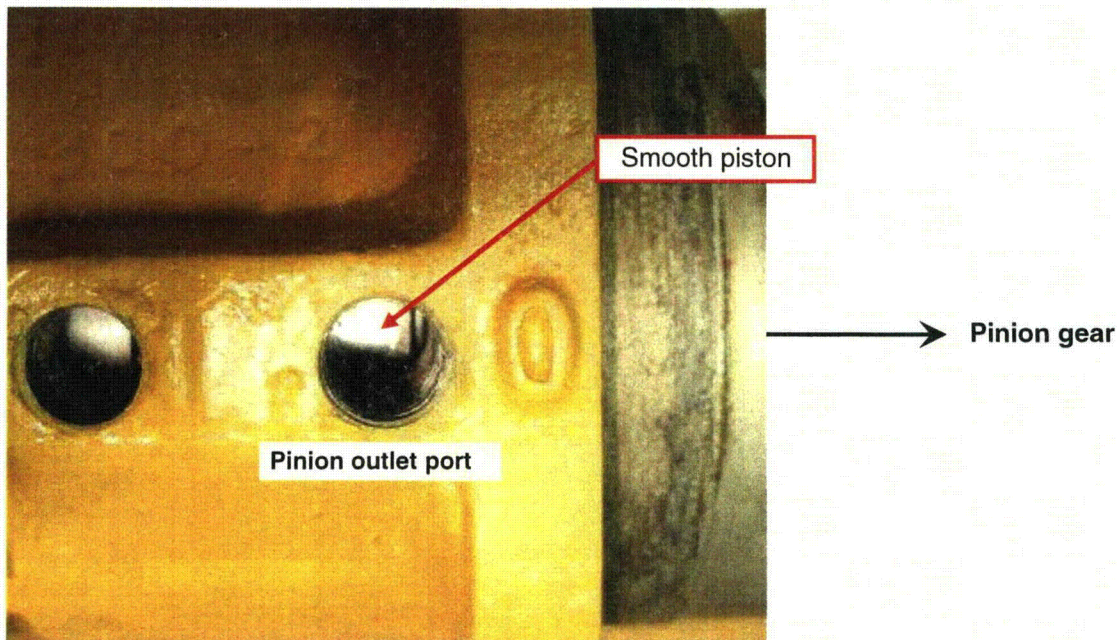
CORRECT
