NUREG/CR-6987

# Analysis of Structural Materials Exposed to a Severe Fire Environment

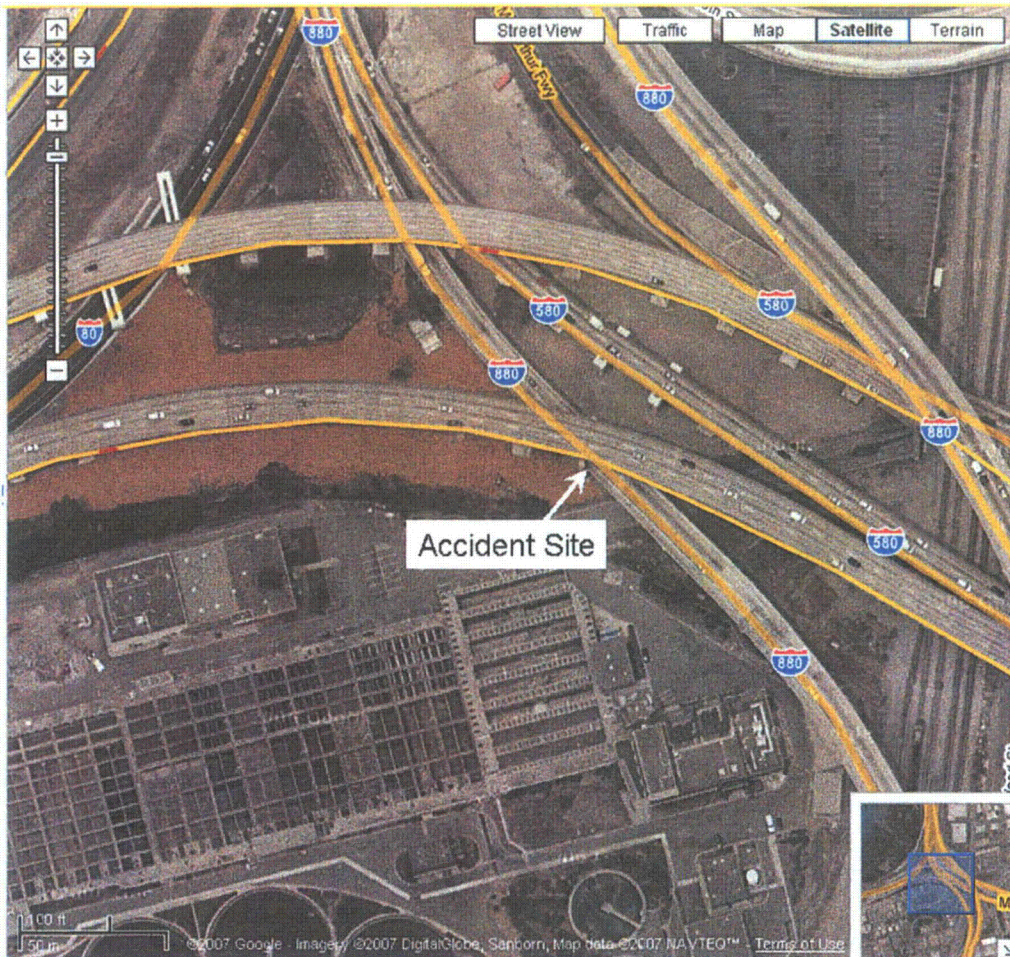
**Figure 1-2. Aerial Photograph of Interstate Interchange. The Accident Occurred on Interstate-880 Just Under the Interstate-580 Overpass (www.google.com).**

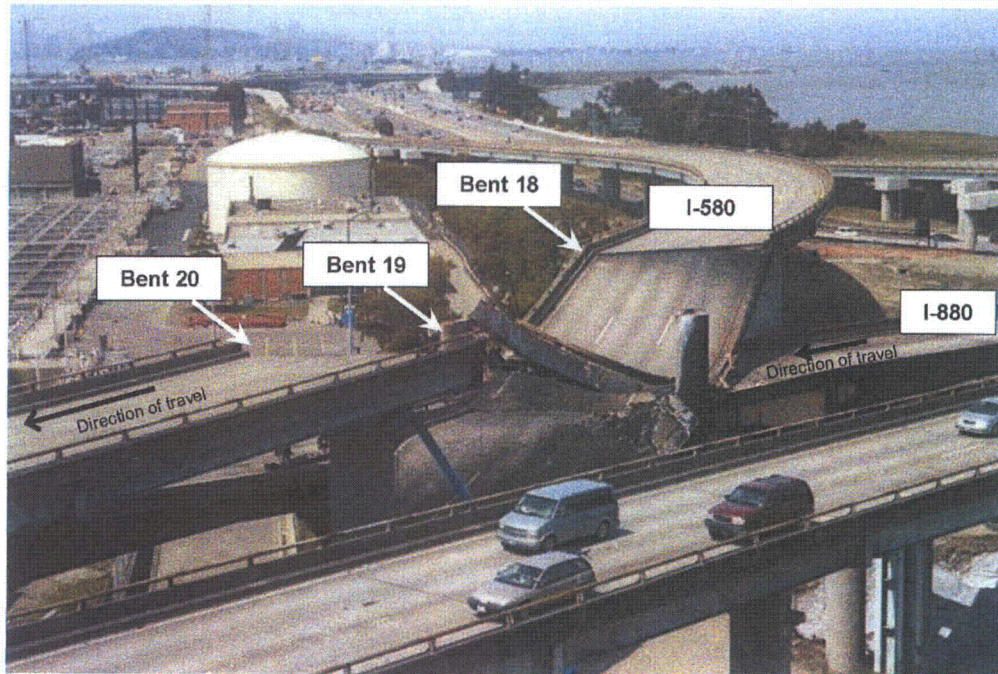
**Figure 1-3. Post Fire Aerial View of Collapsed Section of Interstate-580 Looking West  
California Department of Transportation (2007a)**

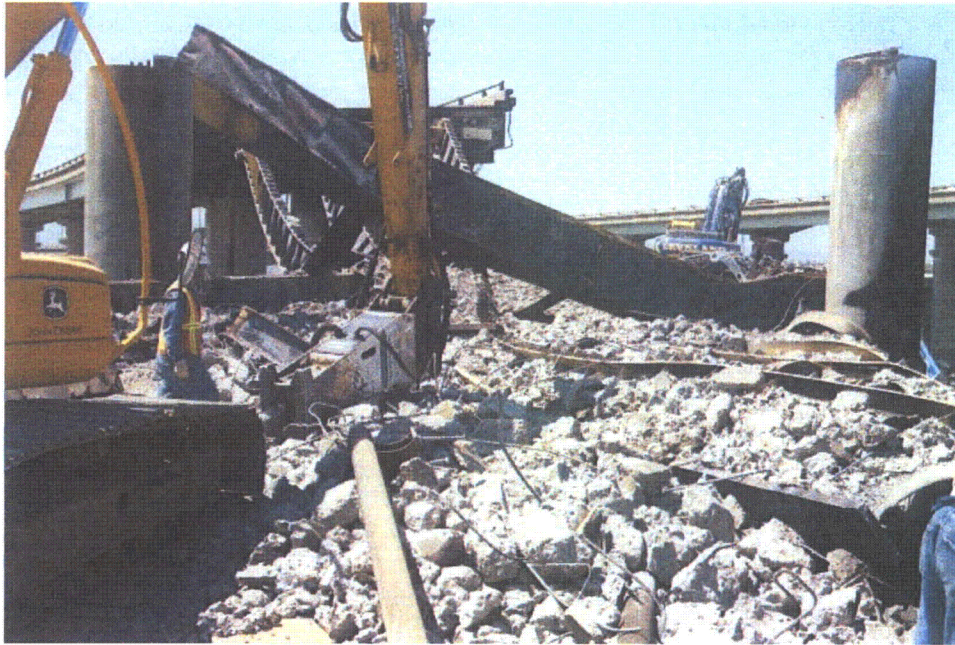
**Figure 2-1. Photo During Demolition. Large Hydraulic Hammers Were Used to Break up the Concrete Bridge Deck. The West End of Box Beam Cap 19 Was Still Connected to the Support Column, Whereas the East End Collapsed and Was in Contact With Interstate-880. Picture From California Department of Transportation (2007b).**

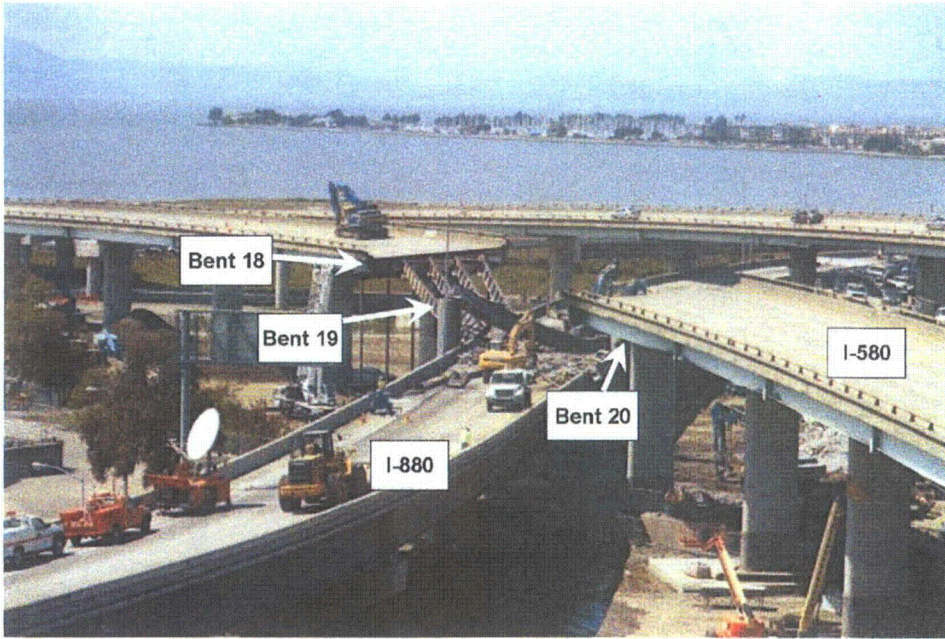
Figure 2-3. Aerial View of Damage During Demolition Looking Northwest. Picture From California Department of Transportation (2007c).

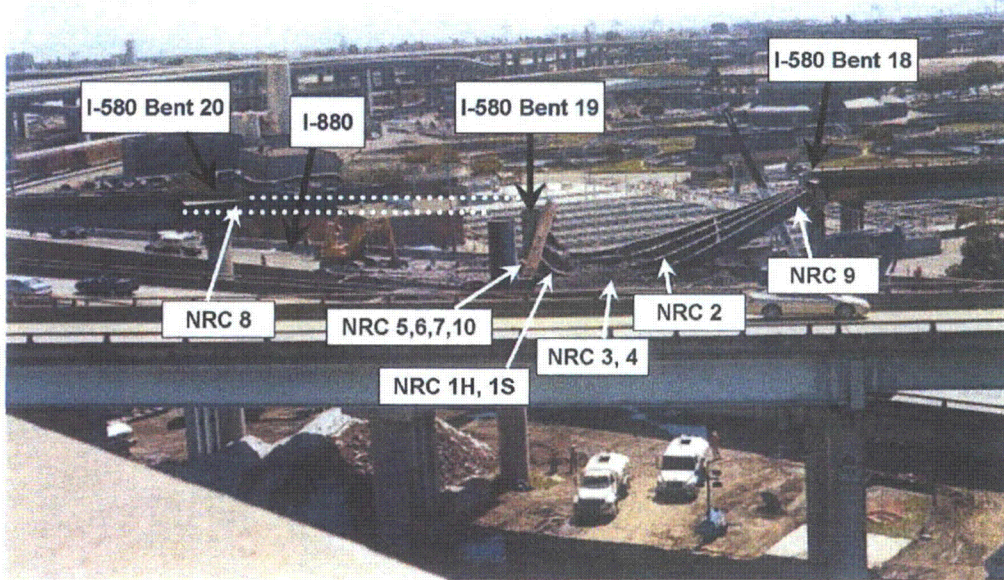
Figure 2-4. View of Damage During Demolition Looking Southwest. Added Labels Show the Locations of Bents 18, 19, and 20 and Approximate Locations of Collected Specimens. Dotted Lines Represent Preaccident Overpass Structure That Was Demolished and Removed Prior to This Photograph. Original Picture From California Department of Transportation (2007c).

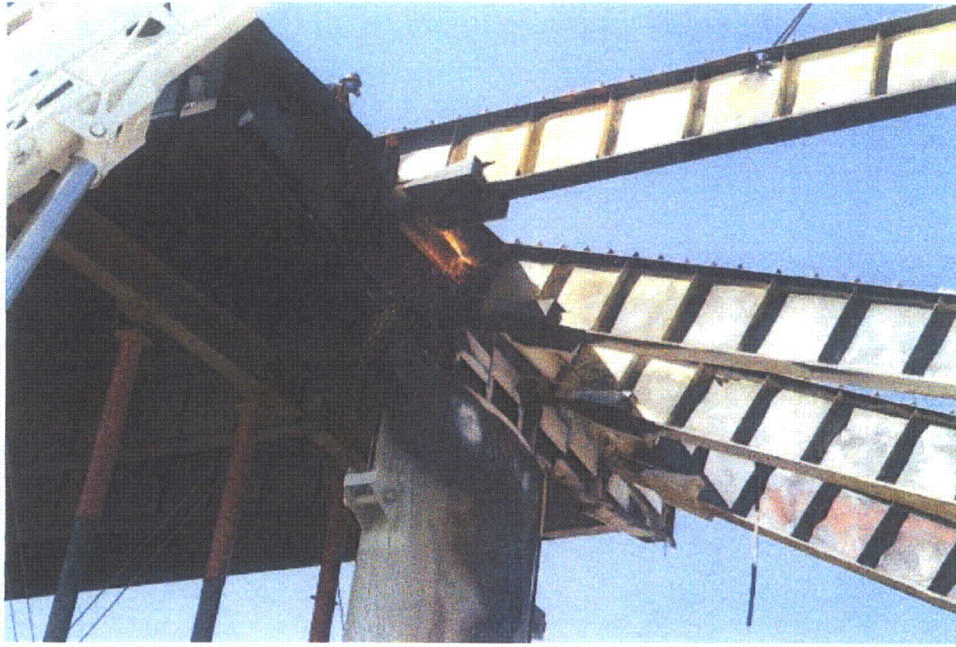
**Figure 2-5. Torch Cutting of Plate Girders at Bent 18. Picture From California Department of Transportation (2007c).**

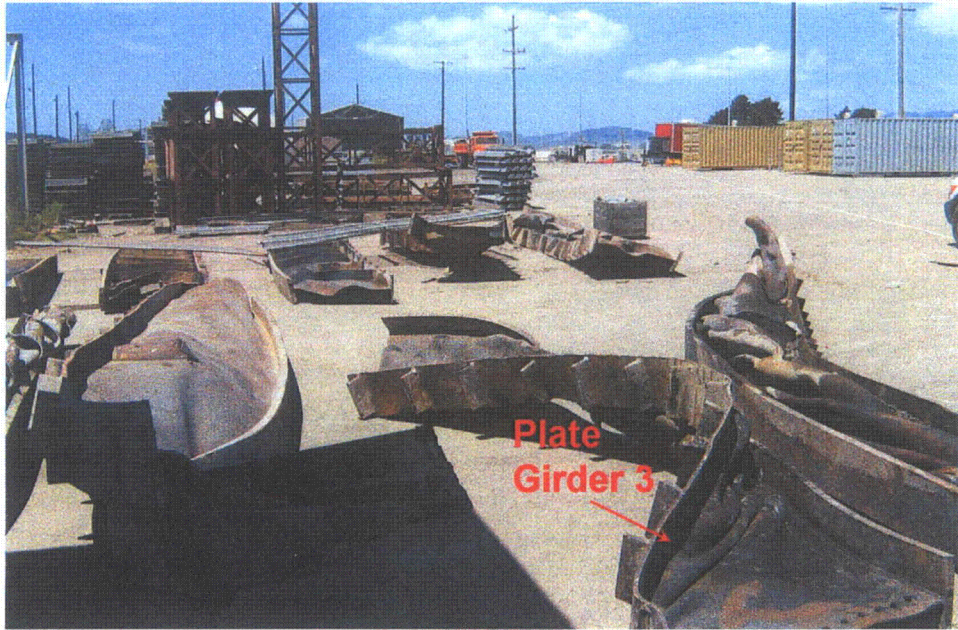
**Figure 2-9. Photograph at the California Department of Transportation Storage Yard Showing the Significant Damage on Plate Girder 3, Which Was Attached to the Box Beam Cap at Bent 19. Rivet Holes in Plate Girder 3 Are Visible at the Bottom of the Image.**

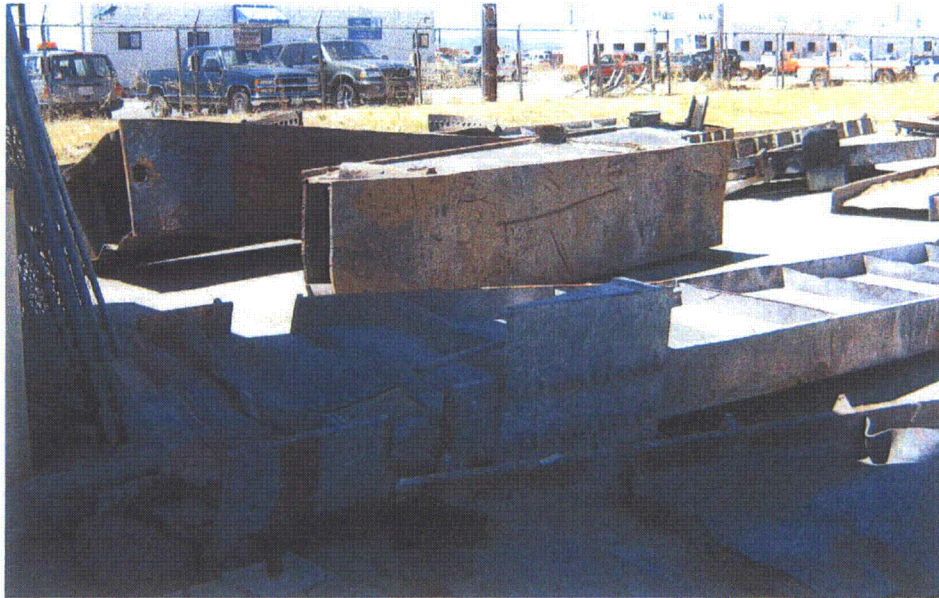
**Figure 2-10. Photograph at the California Department of Transportation Storage Yard Showing the Two Box Beam Cap Sections and Other Plate Girder Sections**

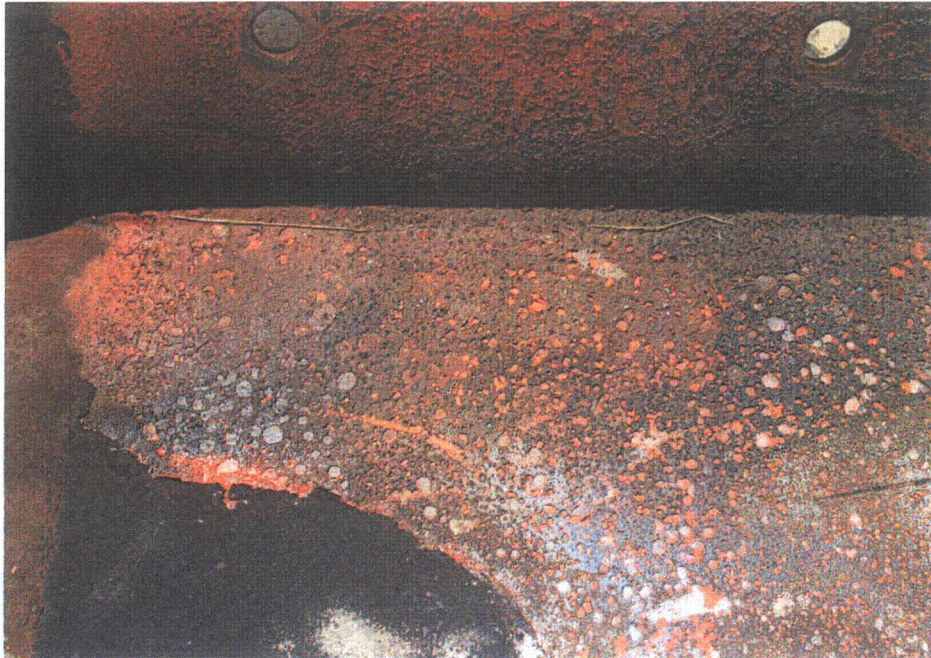
**Figure 2-13. Photograph of Plate Girder 9 at the California Department of Transportation Storage Yard. Latex Paint Was Heavily Damaged, Exposing the Red-Colored Lead-Containing Paint.**

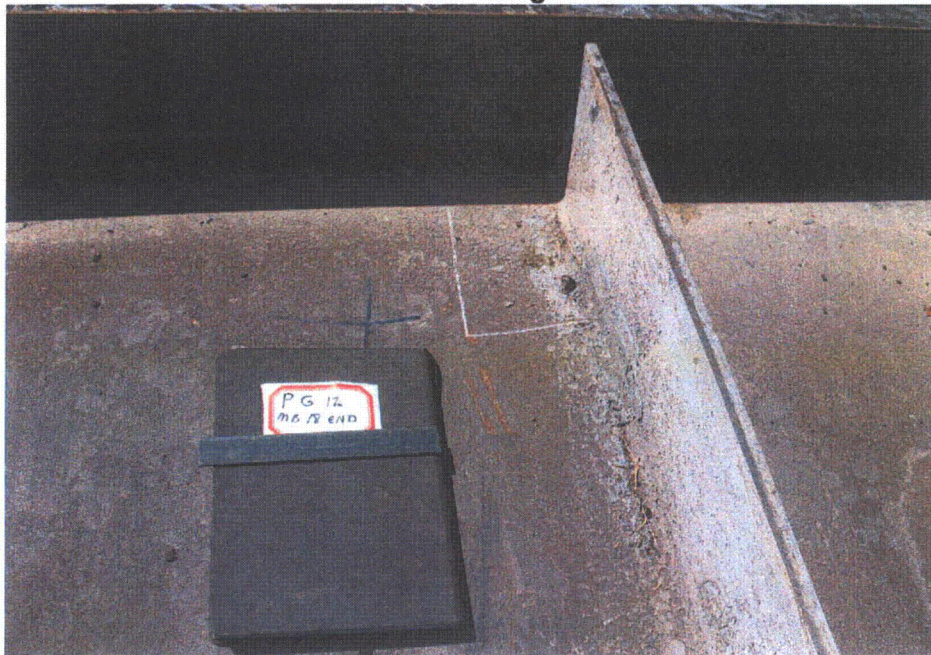
**Figure 2-14. Photograph at California Department of Transportation Storage Yard of Plate Girder 12 Near the Bent 18 End. The Latex Paint Was Mostly Intact at This Location.**

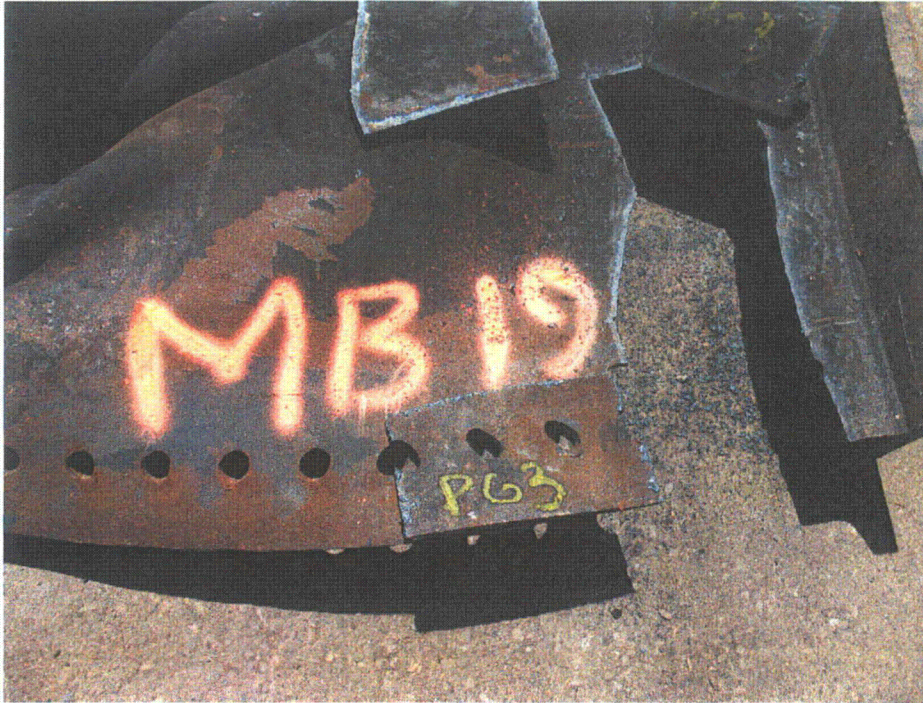
Figure 2-17. Photograph of Plate Girder 3 and Samples NRC 1H (With Holes) and NRC 1S (With Stiffener). Samples Were Located Near Bent 19.

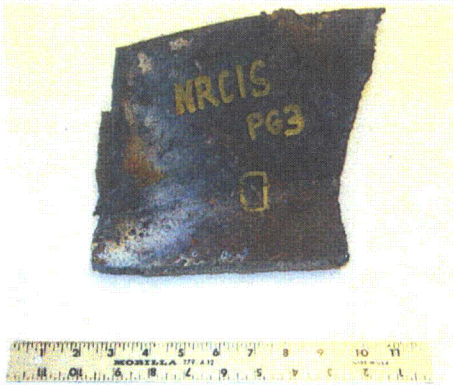
NRC 10	Flakes peeled off of plate girder angles on Box Beam Cap Section 8.	Fe and Pb.

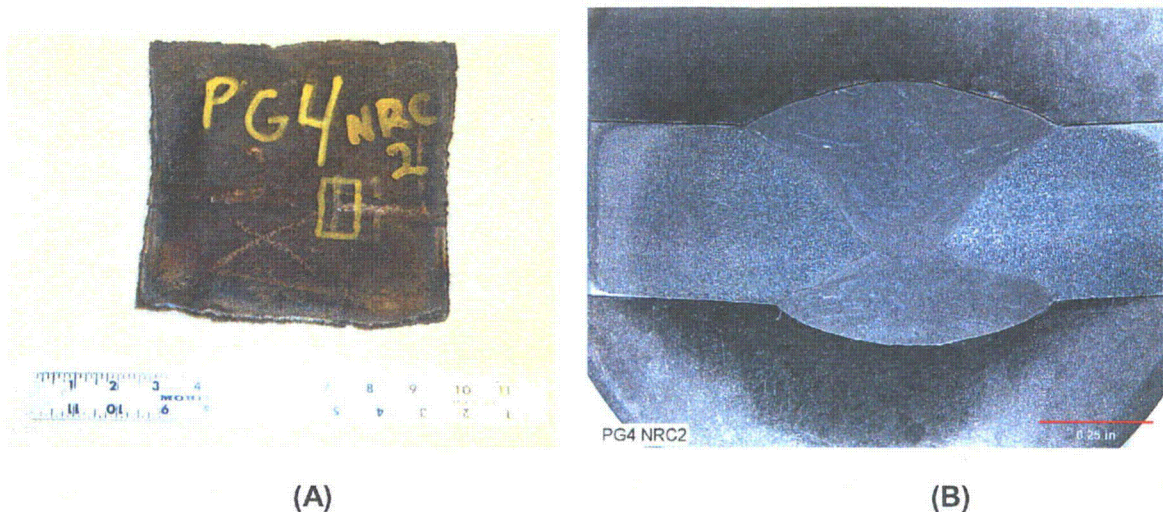
**Figure 3-4. (A) Photograph of Collected Sample NRC 2; (B) Metallurgical Specimen From NRC 2 After Mounting, Polishing, and Etching**

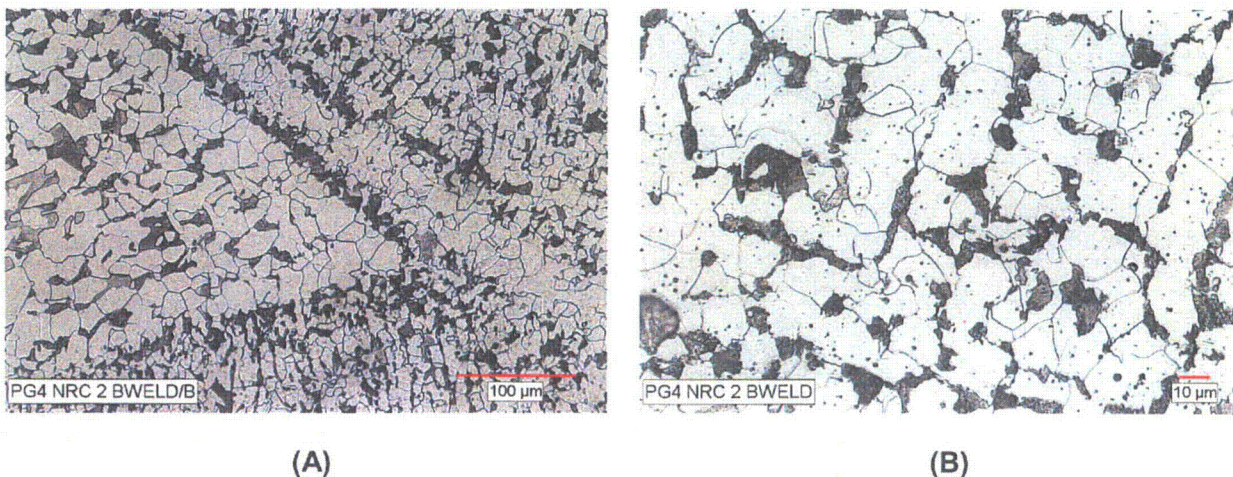
**Figure 3-5. (A) Microstructure of Plate Girder and Weld on Sample NRC 2 Showing Ferrite and Pearlite; (B) Microstructure of Plate Girder Butt Weld Ferrite and Pearlite**

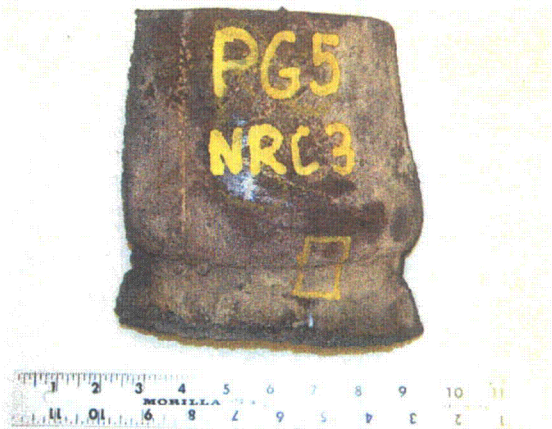
Figure 3-6 shows Sample NRC 3 and the specimen after mounting, polishing, and etching. The distortion of the plate and the stiffener are obvious, given that the plate and stiffener were originally perpendicular to one another. Figure 3-7 shows the microstructures of the plate girder, the stiffener, and the weld. As expected, the plate and the stiffener consist of ferrite and pearlite. The welds are also ferrite and pearlite and contain no indication of a dendritic structure that would have been present immediately after welding. A higher magnification image of the weld, shown in Figure 3-7(D), clearly indicates pearlite in a ferrite matrix.

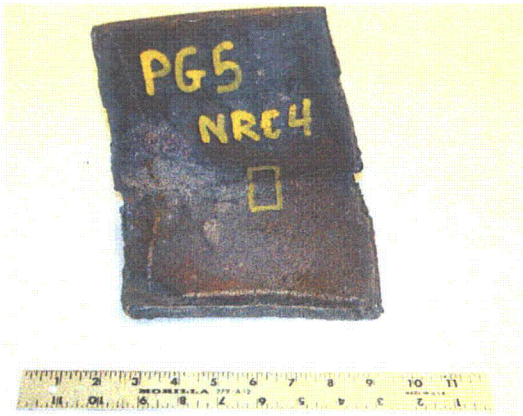
When the samples were collected, it was recognized that the microstructure of the weld may be a useful indication of temperature. Sample NRC 9 was significantly larger than the other

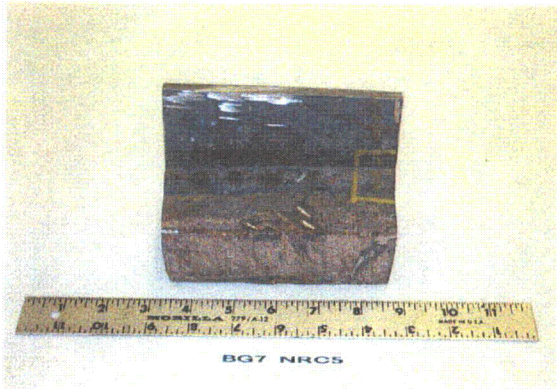
Figure 3-9. (A) Microstructure of Stiffener Fillet Weld Plate Girder and Stiffener on Sample NRC 4; (B) Higher Magnification of Microstructure of Plate Girder; (C,D) Microstructure of Fillet Weld Showing Ferrite and Pearlite

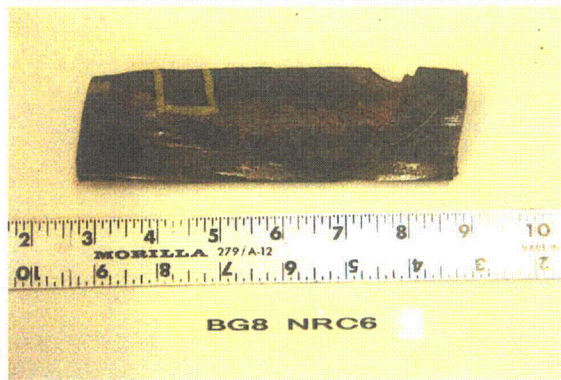
Figure 3-11. (A,B) Microstructure of Box Beam Cap Plate From Sample NRC 5; (C,D) Microstructure of Fillet Weld Showing As-Welded Appearance Indications of Ferrite and Pearlite

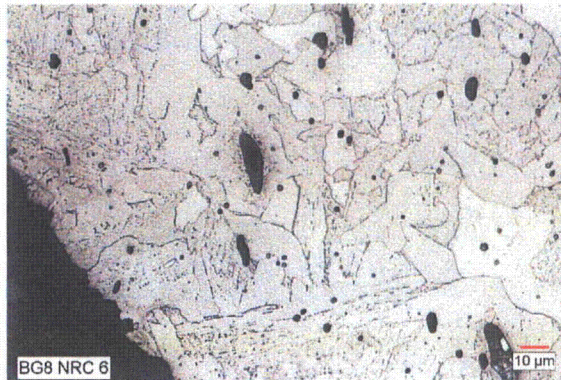
**Figure 3-12. (A) Photograph of Collected Sample NRC 6; (B) Metallurgical Specimen From NRC 6 After Mounting, Polishing, and Etching. The Sample Was Part of a Plate Girder Found Attached to Box Beam Cap Section 8 as Shown in Figure 2-22.**

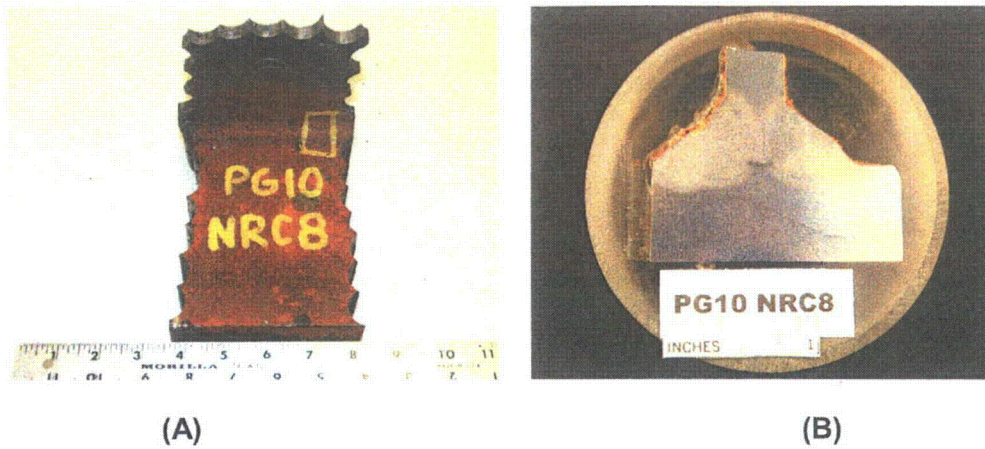
Figure 3-14. (A) Photograph of Collected Sample NRC 8; (B) Metallurgical Specimen From NRC 8 After Mounting, Polishing, and Etching

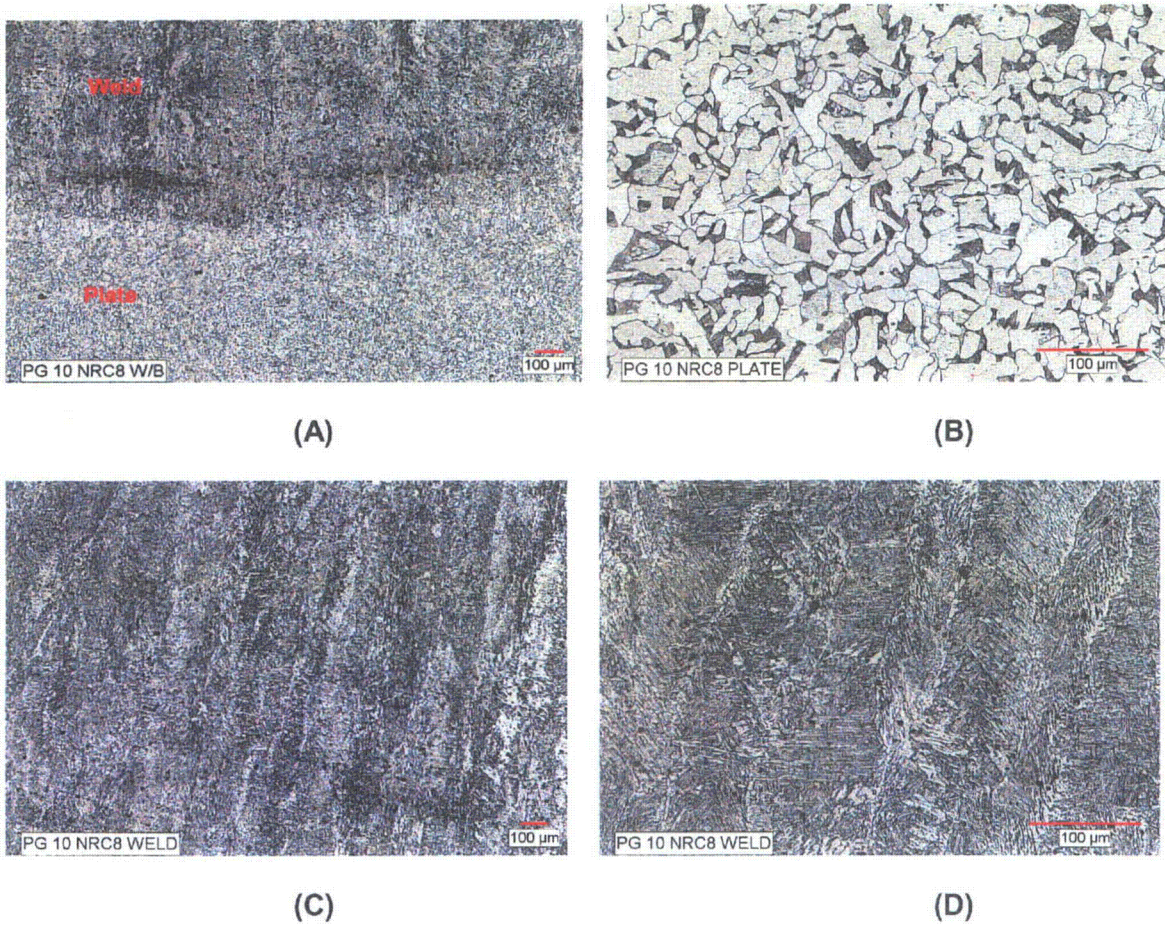
Figure 3-15. (A) Microstructure of the Weld and Plate for Sample NRC 8; (B) Microstructure of Plate Showing Ferrite and Pearlite Regions; (C,D) Microstructure of Fillet Weld Showing As-Welded Appearance and No Evidence of Ferrite and Pearlite

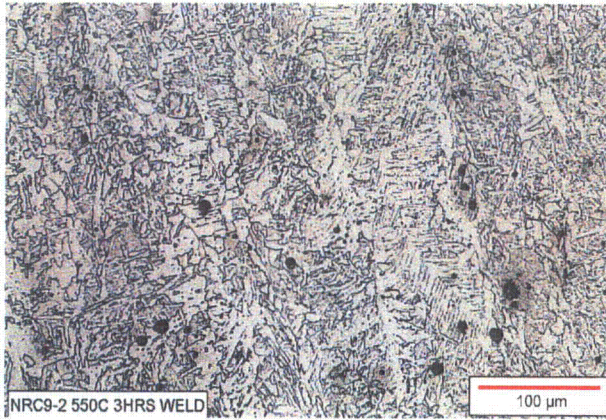
<b>NRC Sample Number</b>	<b>Thermal Exposure Temperature</b>	<b>Microstructure</b>
NRC 9-1	None	As-deposited weld metal with dendritic and equiaxed grains
NRC 9-2	550 °C [1,022 °F]	As-deposited weld metal with dendritic and equiaxed grains
NRC 9-3	600 °C [1,112 °F]	As-deposited weld metal with dendritic and equiaxed grains
NRC 9-4	650 °C [1,202 °F]	As-deposited weld metal with dendritic and equiaxed grains
NRC 9-5	700 °C [1,292 °F]	As-deposited weld metal with dendritic and equiaxed grains
NRC 9-6	750 °C [1,382 °F]	As-deposited weld metal with dendritic and equiaxed grains
NRC 9-7	800 °C [1,472 °F]	Partially transformed with dendritic and equiaxed grains and small regions of pearlite
NRC 9-8	850 °C [1,562 °F]	Mostly transformed weld metal with significant ferrite with pearlite
NRC 9-9	900 °C [1,652 °F]	Fully transformed microstructure consisting of ferrite with pearlite

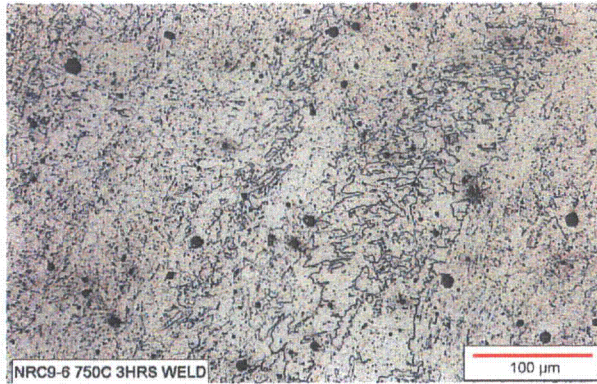
**Figure 3-18. Microstructure of Welds on Specimens NRC 9-2 to NRC 9-9 After Thermal Exposure for 3 Hours at Temperatures of 550 to 900 °C [1,022 to 1,652 °F]. (A) NRC 9-2, 550 °C [1,022 °F]; (B) NRC 9-3, 600 °C [1,112 °F]; (C) NRC 9-4, 650 °C [1,202 °F]; (D) NRC 9-5, 700 °C [1,292 °F].**

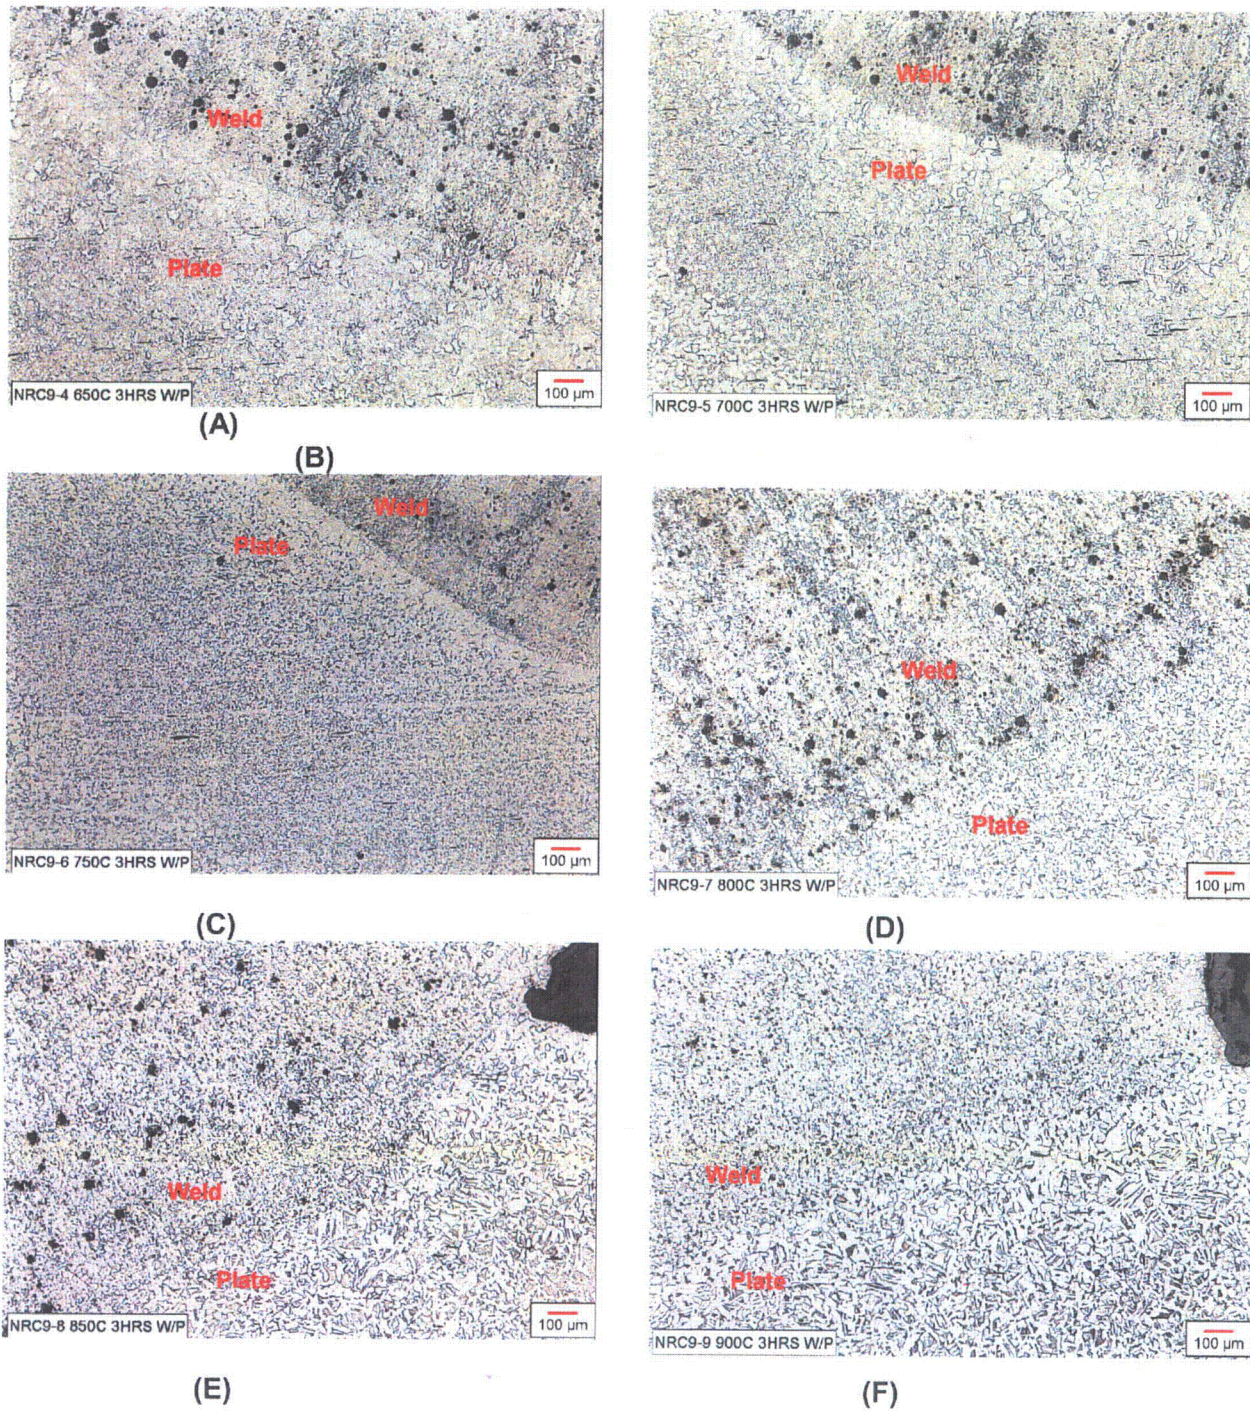
**Figure 3-19. Microstructure of Welds and Plate Sections on Specimens NRC 9-4 to NRC 9-9 After Thermal Exposure for 3 Hours at Temperatures of 650 to 900 °C [1,202 to 1,652 °F]. (A) NRC 9-4, 650 °C [1,202 °F]; (B) NRC 9-5, 700 °C [1,292 °F]; (C) NRC 9-6, 750 °C [1,382 °F]; (D) NRC 9-7, 800 °C [1,472 °F]; (E) NRC 9-4 to NRC 9-9 After Thermal Exposure for 3 Hours at Temperatures of 650 to 900 °C [1,202 to 1,652 °F]; and (F) NRC 9-9, 900 °C [1,652 °F].**

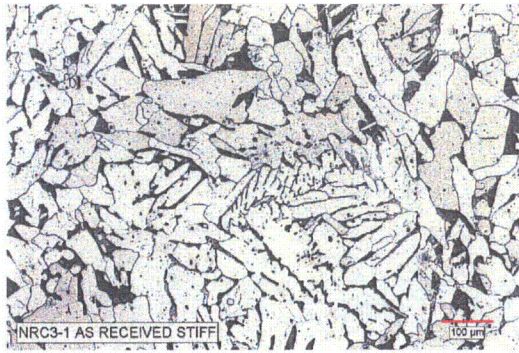
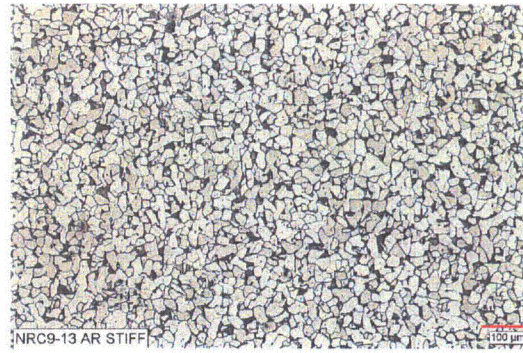
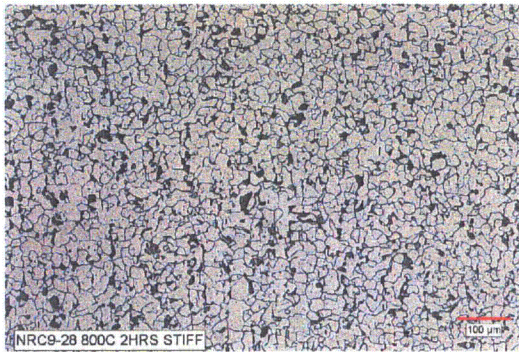
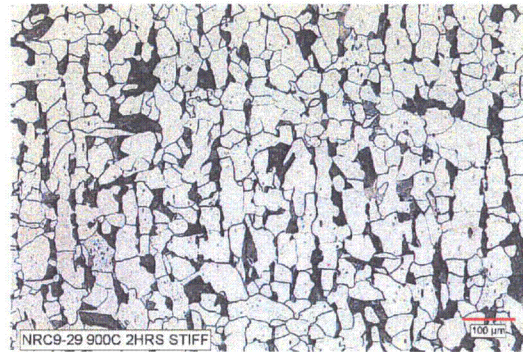
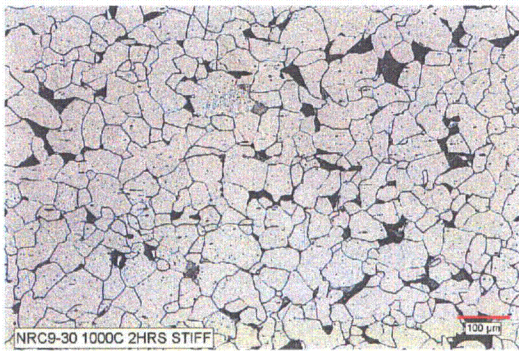
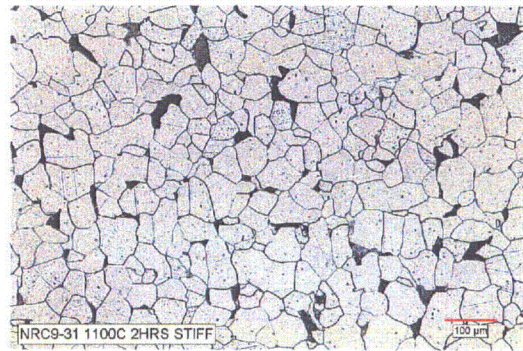
**Figure 3-21. Microstructure of As-Received NRC 3, As-Received NRC 9, and NRC 9 Specimens Slow Cooled After Thermal Exposure at 800; 900; 1,000; and 1,100 °C [1,492; 1,652; 1,832; and 2,012 °F]**

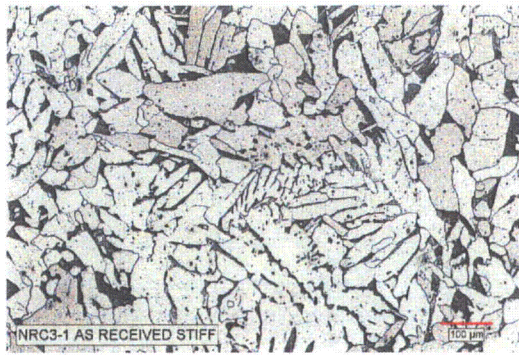
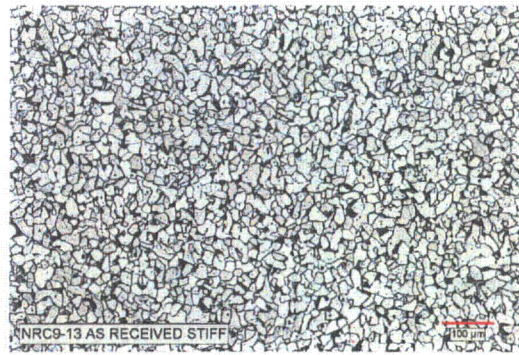
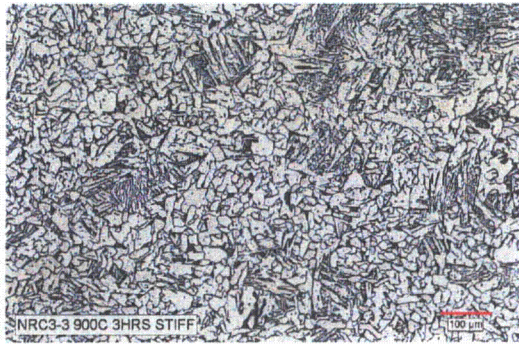
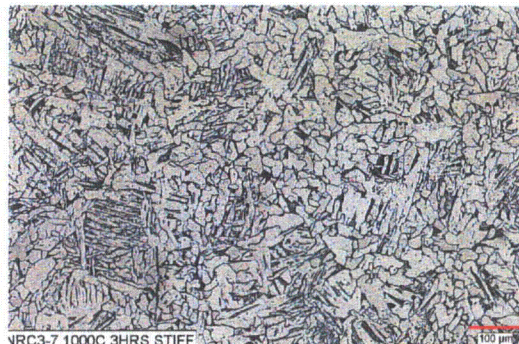
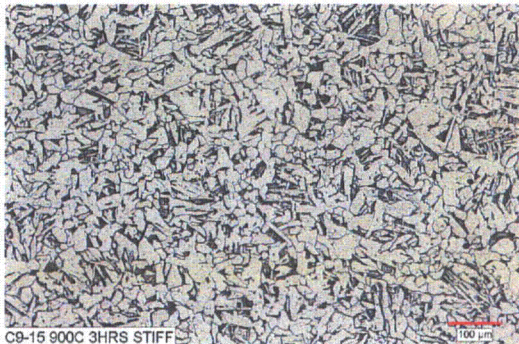
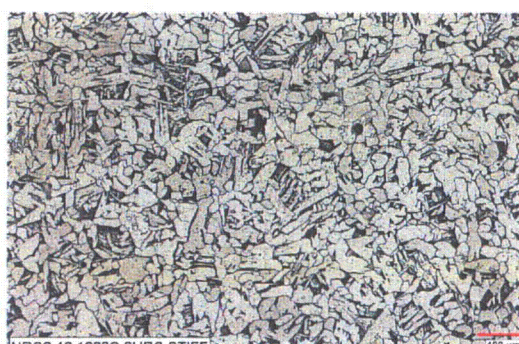
**Figure 3-22. Microstructure of As-Received NRC 3, As-Received NRC 9, and NRC 9 Specimens Air Cooled After Thermal Exposure at 700; 800; 900; and 1,000 °C [1,292; 1,492; 1,652; and 1,832 °F]**

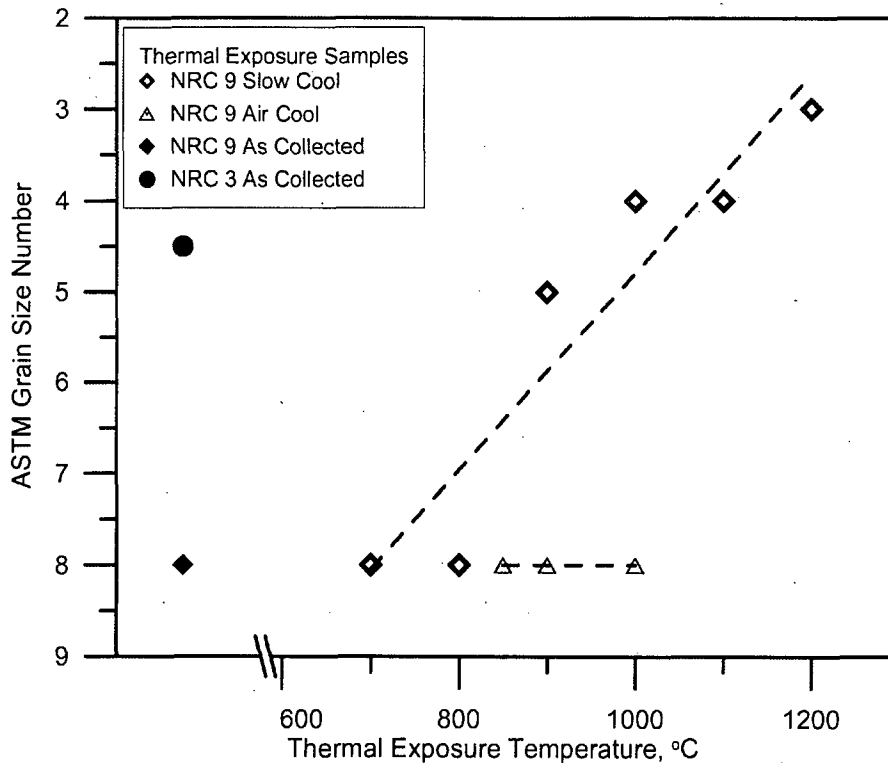
**Figure 3-23. ASTM Grain Size as a Function of Thermal Exposure Conditions**

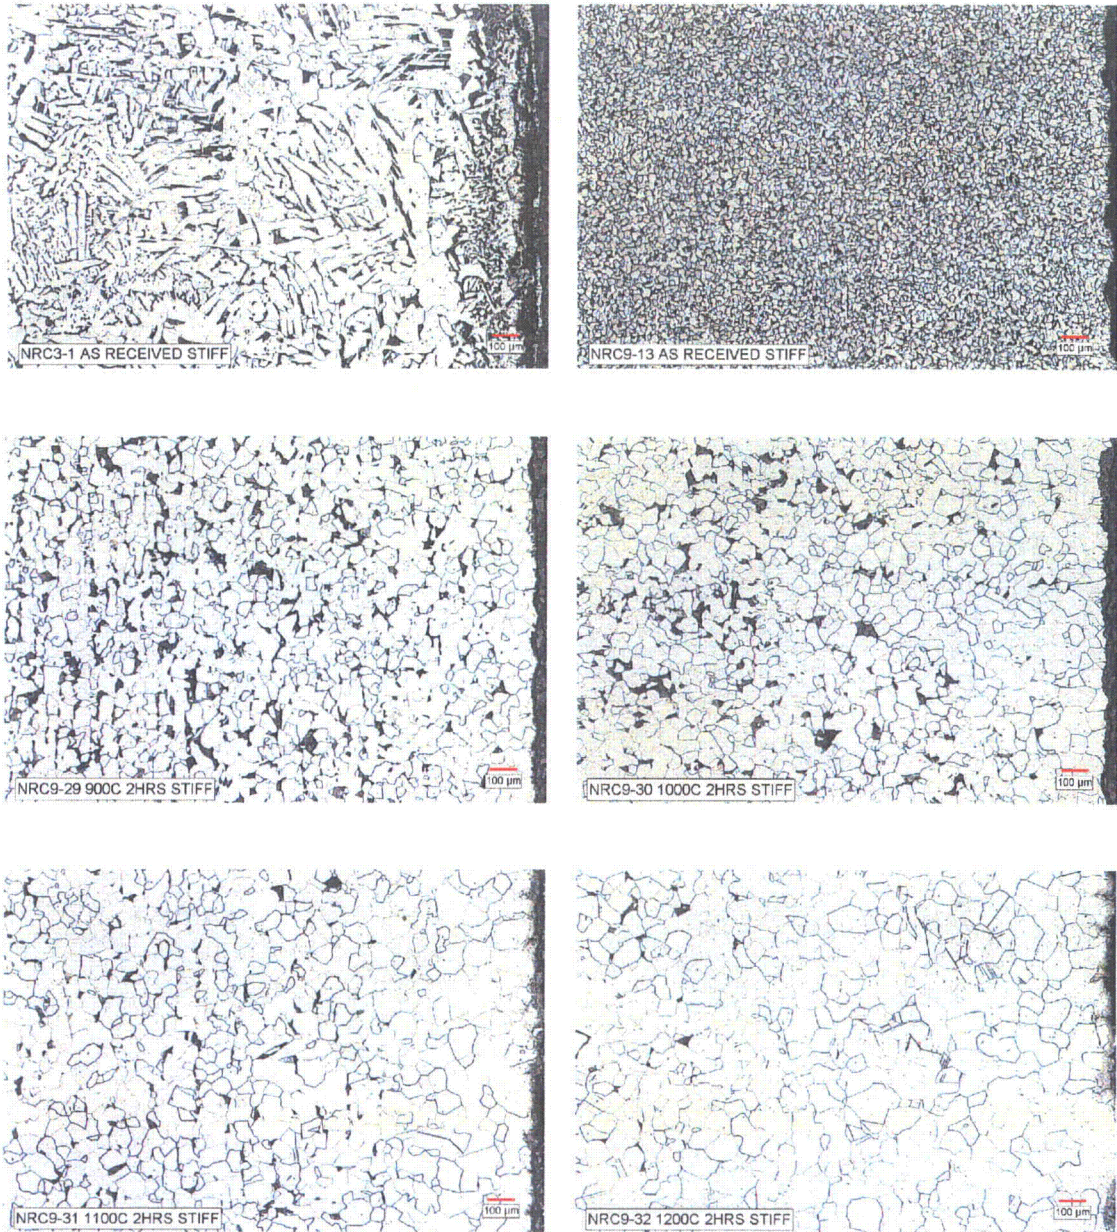
**Figure 3-24. Microstructure of the As-Received NRC 3 Sample, As-Received a Sample, NRC 9 Samples Slow Cooled After Thermal Exposure at 900; 1,000; 1,100; and 1,200 °C [1,652; 1,832; 2,012; 2,192 °F]. The Edge of the Samples Is Uniformly Positioned on the Right Edge of Each Photograph (American Society for Metals, 1978b).**

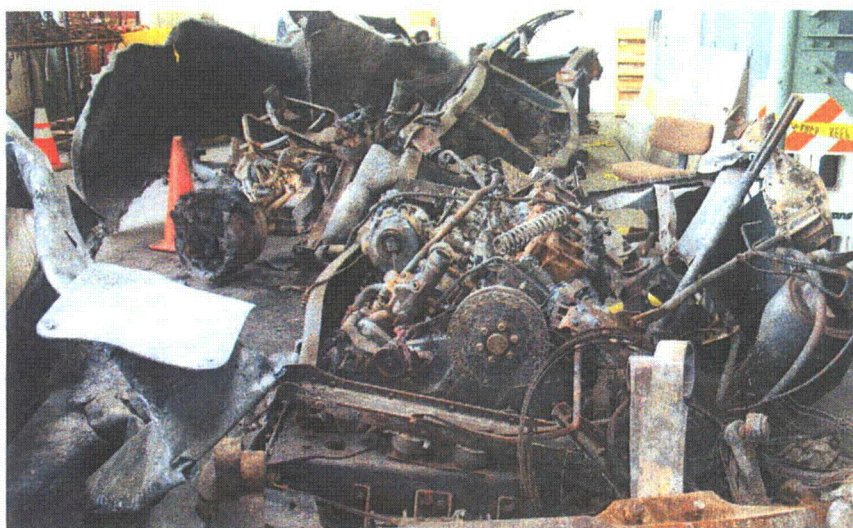
Figure 4-1. Overall View of the Tanker Truck After Recovery From the Accident Site

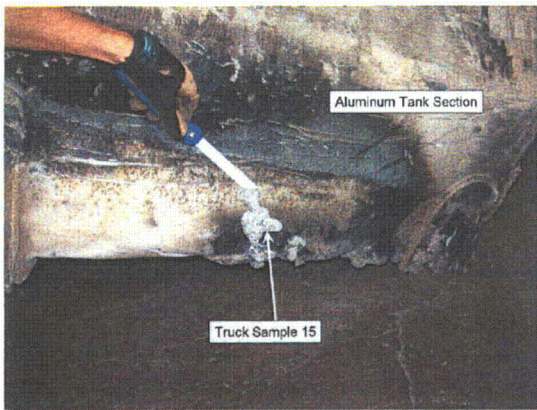
Table 4-2. Compositional Analysis and Estimated Solidus and Liquidus Temperatures for Aluminum Alloys Obtained From the Tanker Truck									
Truck Sample	Composition, Weight Percent							Estimated Solidus	Estimated Liquidus
	Al	Si	Cu	Zn	Mg	Fe	Mn		
4	73	22	2.6	1.5	—	0.7	—	577 °C [1,071 °F]	720 °C [1,330 °F]
14	97.5	0.2	—	—	2.3	—	—	610 °C [1,130 °F]	650 °C [1,200 °F]
15	93.4	0.3	—	—	5.3	0.4	0.6	570 °C [1,058 °F]	640 °C [1,184 °F]
12	74.8	14.4	3.0	2	—	4	1.1	577 °C [1,071 °F]	600 °C [1,112 °F]
10	68.1	3.9	22.7	3.5	—	0.6	—	548 °C [1,018 °F]	590 °C [1,094 °F]

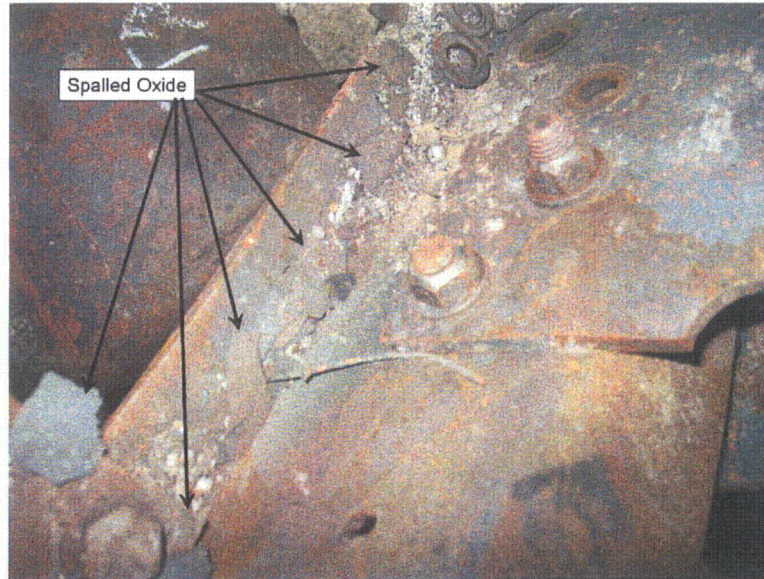
**Figure 4-4. Spalled Oxide From the Carbon Steel Frame**

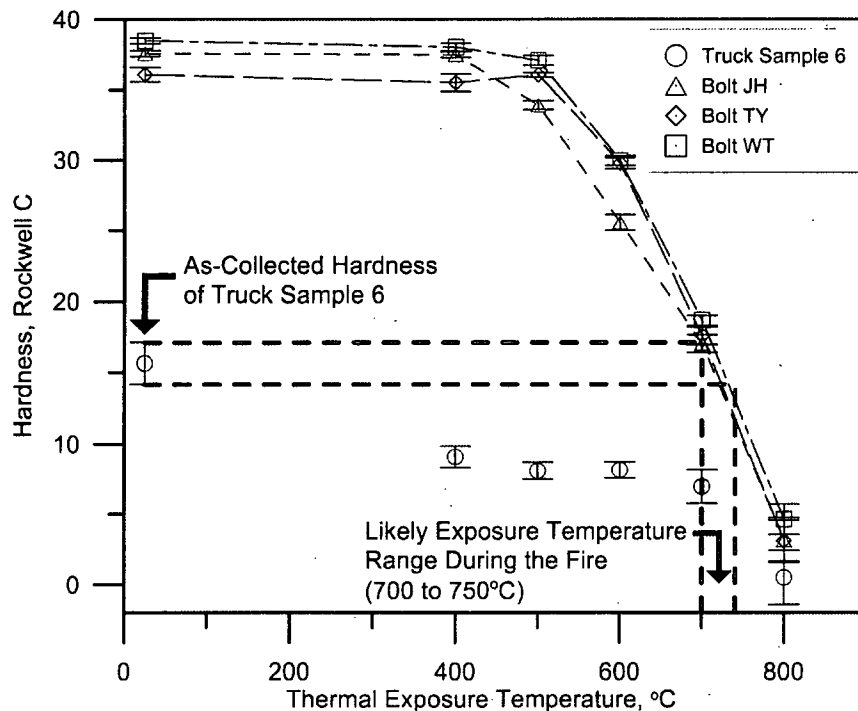
**Figure 4-6. Effect of Exposure Temperature on the Hardness of Truck Sample 6 and Commercially Available Grade 8 Bolts**
