Event # 46340

POTENTIAL EXTERNAL LEAKAGE IN SOLENOID VALVE

Subject: External leakage in NP8320 solenoid valve

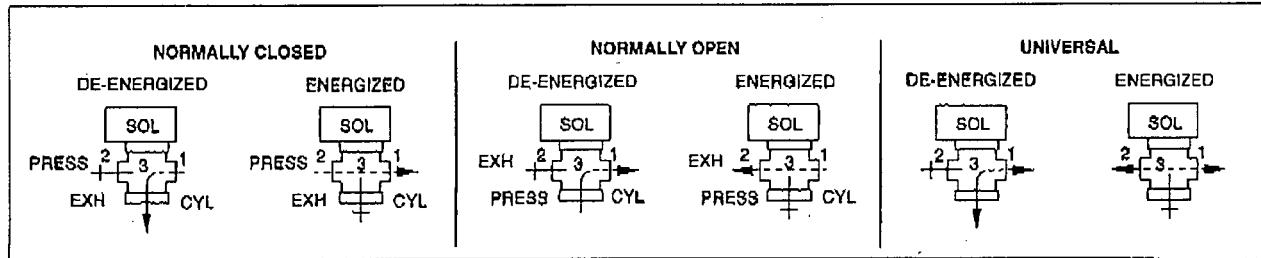
For Normally-Closed valves, air pressure is to be applied at port 2. This port is blocked when the valve is de-energized and the cylinder port 1 is exhausted through the exhaust port 3. When the valve is energized pressure is allowed to flow to the cylinder port at 1, and the exhaust port at 3 is blocked. See Figure 1 on next page.
