## PART 21 REPORT - UPS MOTHERBOARD FAILED PRE-SERVICE INSPECTION

**10 CFR 21 Report**  
**Dependable Power System (DPS) Motherboard Failures for use in the**  
**Turbine Driven Auxiliary Feedwater Pump**  
**Uninterruptible Power Supply**

QualTech NP  
Report No.: DPS2010.0  
Revision: 1

EVALUATION REPORT  
FOR VARIOUS  
DEPENDABLE POWER SYSTEMS, INC.  
UPS CIRCUIT CARDS

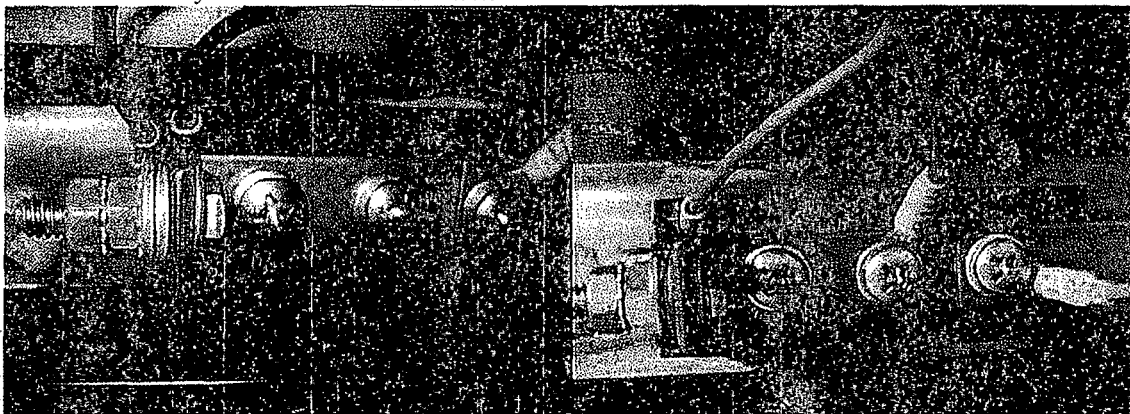
QualTech NP has also identified through communication with Farley personnel & DPS that the B section of UPS in Farley Unit 1 has seen ambient temperatures which apparently exceeded the service temperature for which the unit was designed (50C external ambient conditions & 55C internally). About a year ago (July 2009), the exhaust fan/blower for the room in which it is installed failed resulting in an extended over-temperature condition. The high heat conditions were significant enough during the replacement of the fan/blower that time limits have now been set for personnel time in the room. QualTech NP understands that the UPS was operating during this time period and that specific operating half of the redundant UPS failed shortly thereafter. For this unit to be restored to a reliable operable condition, all temperature sensitive sub-components need replaced at the same time to preclude temperature stressed components from failing and damaging, as a secondary failure, components recently replaced. RI

Left photo is section A of the Qualification Sample and is the desired configuration of wiring. Right photo is section B of the Qualification Sample and is the wiring configuration that can damage the motherboard as a secondary failure. Both attachments were qualified.

1. Change the feed wire as shown in the photos below to preclude damaging a motherboard as a secondary failure when an SCR fails:
