Event # 46340

POTENTIAL EXTERNAL LEAKAGE IN SOLENOID VALVE

Subject: Update to Report of Oct. 18, 2010 - External leakage in NP8320 solenoid valve

Subject: External leakage in NP8320 solenoid valve

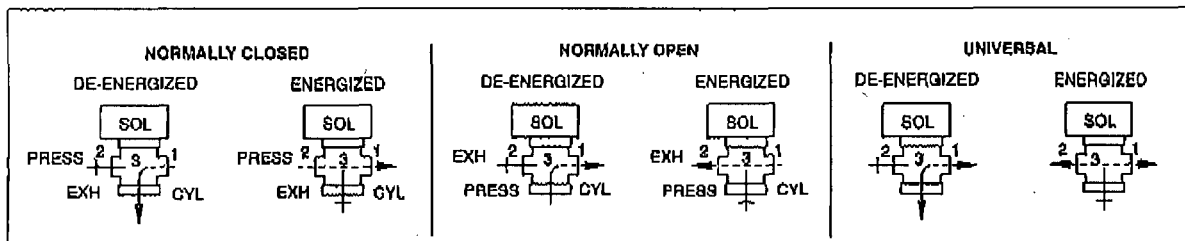
For Normally-Closed valves, air pressure is to be applied at port 2. This port is blocked when the valve is de-energized and the cylinder port 1 is exhausted through the exhaust port 3. When the valve is energized pressure is allowed to flow to the cylinder port at 1, and the exhaust port at 3 is blocked. See Figure 1 on next page.

For Normally-Open valves, pressure is applied at port 3. This port is connected to port 1 when de-energized and port 2 is blocked. When the valve is energized, port 3 is blocked and the pressure at the cylinder port 1 is exhausted through port 2.
