Part 21 (PAR)

Event # 46692

VALVE PLUNGER GUIDE MALFUNCTION

10 CFR PART 21 Notification:

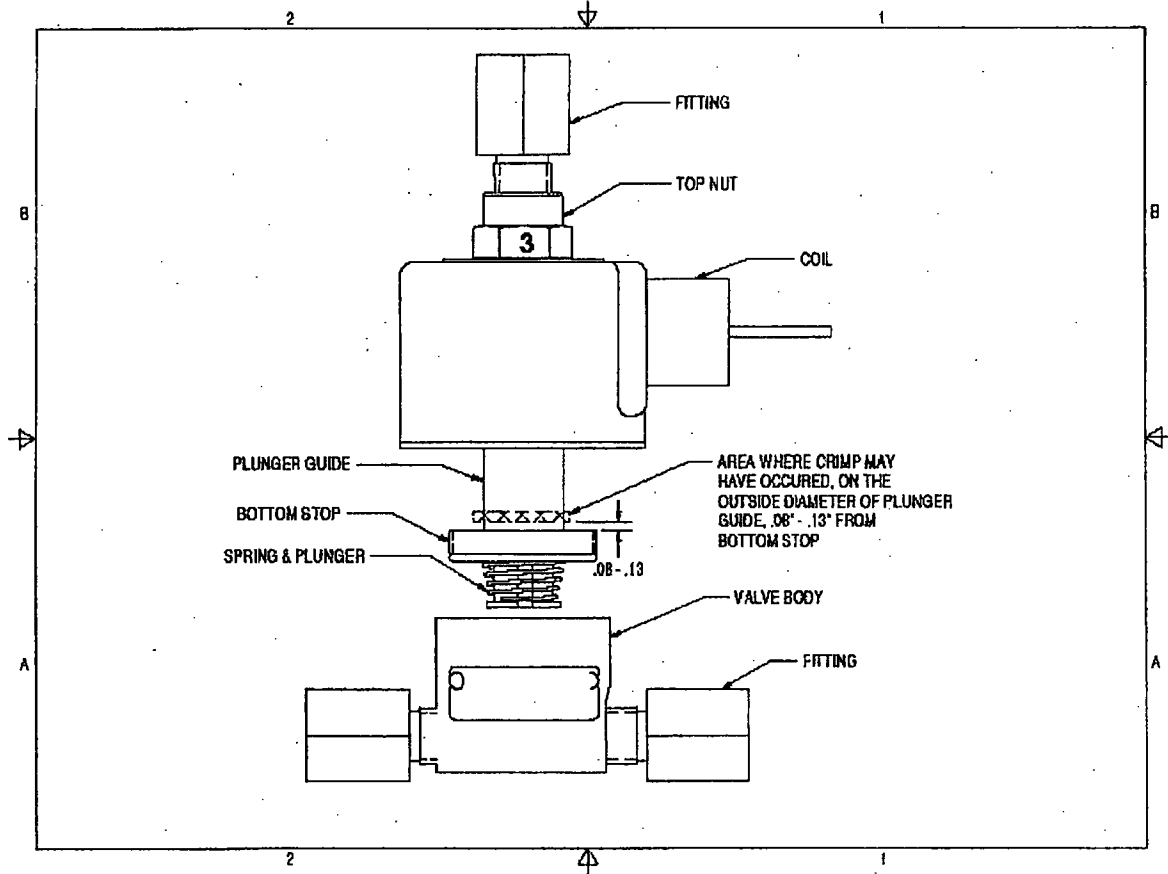
A dent in the plunger guide may prevent the valve from changing state.

4. Root Cause/s of Problem: 10 CFR Part 21 Report Required: YES		
U0204GBBR-AA is a valve constructed with 3/8 inch NPT adaptors inserted into 1/4 inch NPTF ports.		
The adaptors are installed after the basic unit is built and tested. The adaptors are then leak checked; but the valve is not functionally re-tested after the installation of the adaptor.		
The solenoid plunger guide was accidentally crimped when the adaptor fitting was installed.		
The crimp in the plunger guide may interfere with the movement of the plunger. If the interference prevents the plunger from completing its full stroke, the valve will not return to its closed position. If this occurs, the valve will fail to close.		
The failure was noted when Exelon staff tested the valve, prior to installation.		
Approved by:	Title: President	Date: 03.23.11

Illustration 1: Pictorial of Valve showing Area where damage was noted:

5. Corrective Action:		
Install all fittings in the valve body prior to the installation of the plunger guide into the body.		
Approved by:	Title: President	Date: 03.23.11

6. Implementation:		
CN 9780 specifies the assembly order of the fittings into the valve body and plunger guide. This is done prior to assembly of the plunger guide into the body.		
Approved by:	Title: President	Date: 03.23.11
